**CALIFORNIA DEPARTMENT OF FISH AND GAME
STREAM INVENTORY REPORT**

Ward Creek

Report Revised April 14, 2006

Assessment 1996

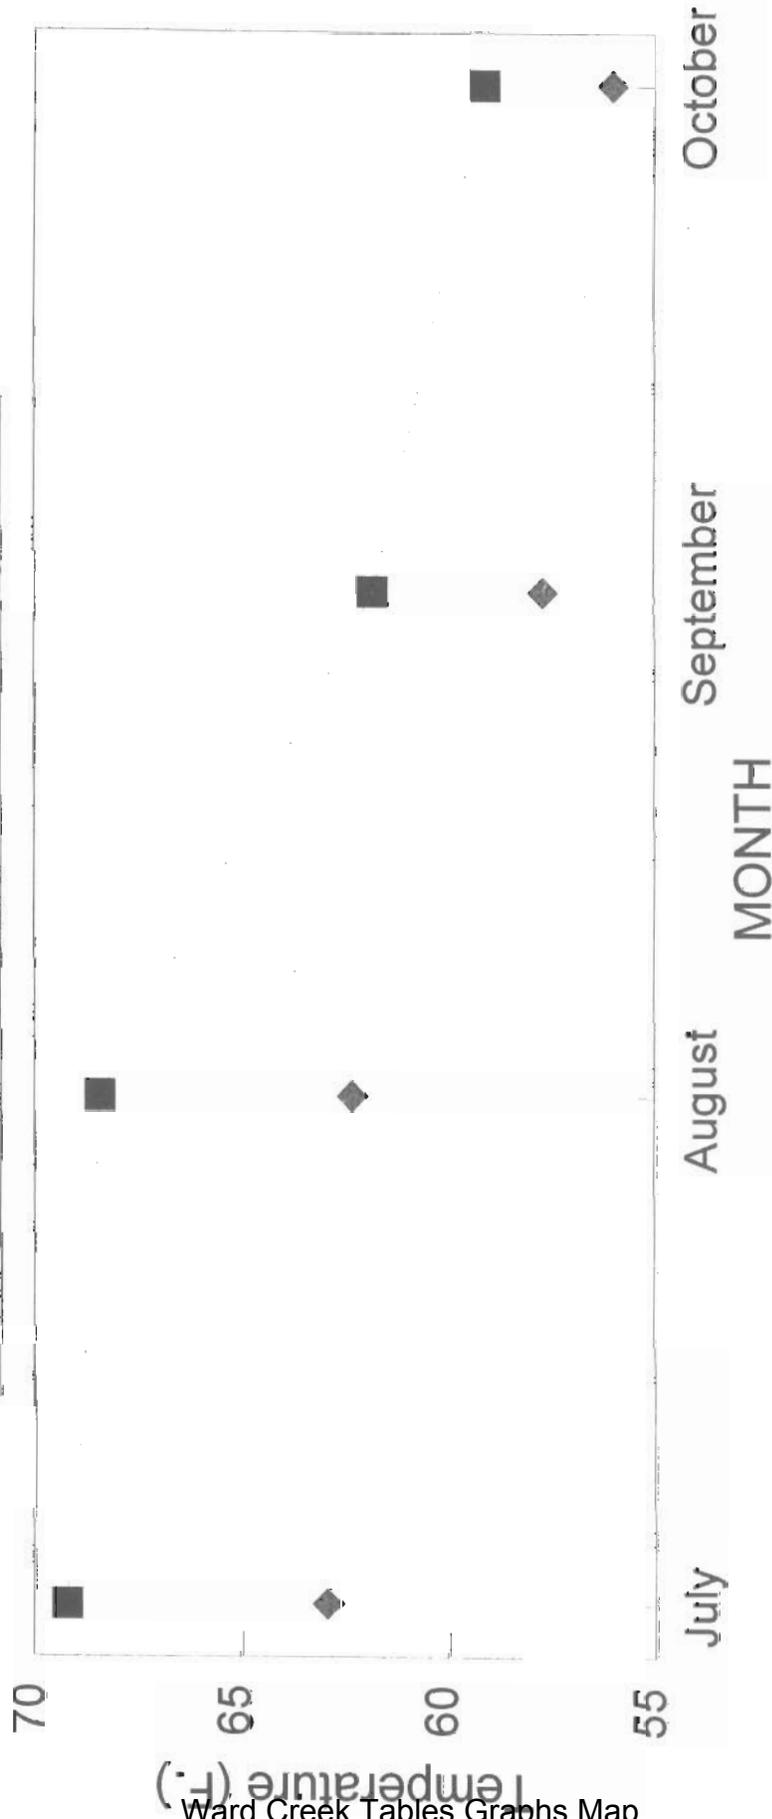
Tempmentor Summary

Water temperatures ranged from 57-77°F. Air temperatures ranged from 50-97°F. Summer temperatures were also measured using a remote temperature recorder placed in a pool (see Temperature Summary graph at end of report). The recorder was placed in a pool at the confluence of the first tributary on the right bank and logged temperatures every 2 hours from July 16 - October 6, 1996. The highest temperature recorded was 73°F in August and the lowest was

55°F in October. The mean of the daily highs was 69°F for the month of July, 68°F for August and 62°F for September.

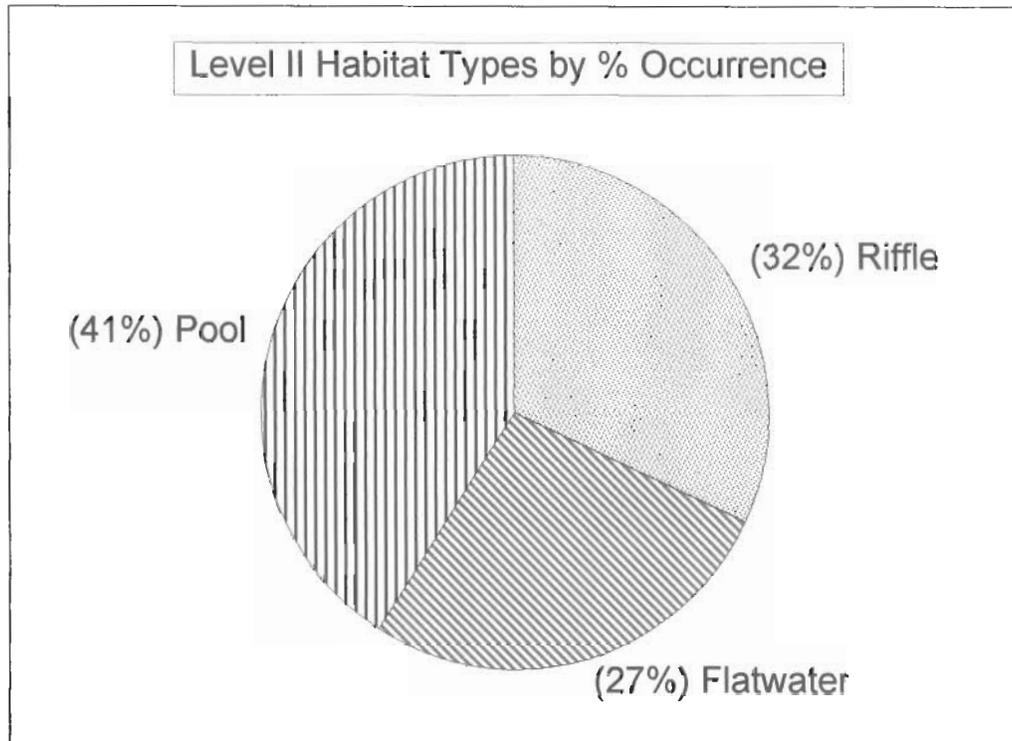
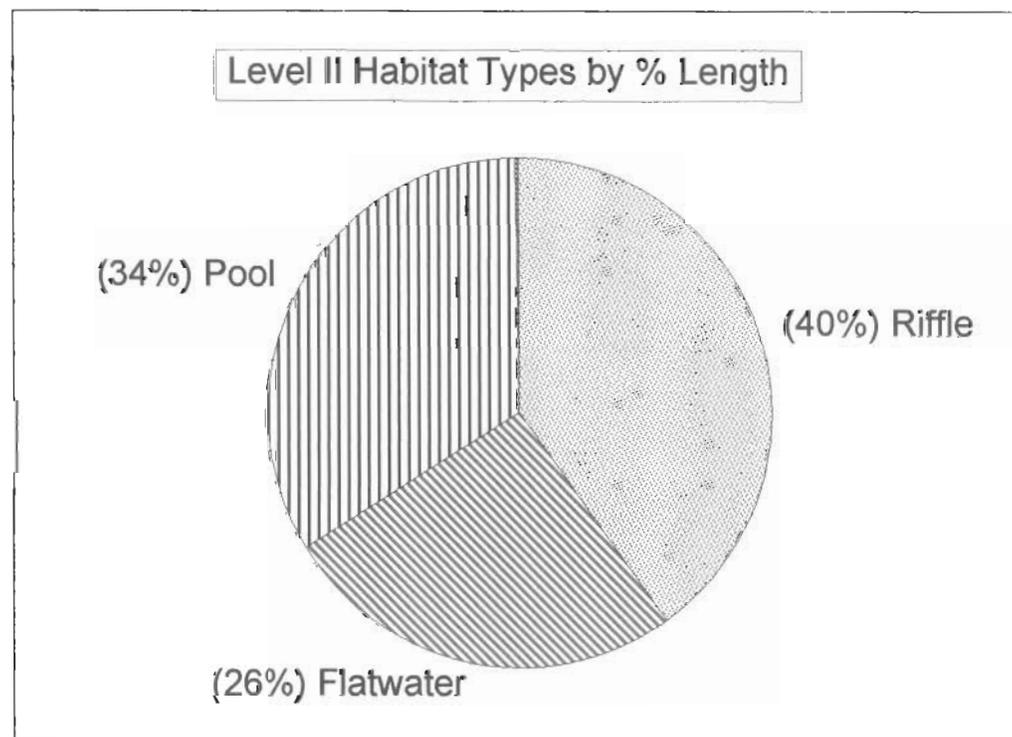
Level II Habitat Types

Table 1 summarizes the Level II riffle, flatwater, and pool habitat types. Based on frequency of **occurrence** there were 41% pool units, 32% riffle units, and 27% flatwater units. Based on total **length** there were 40% riffle units, 34% pool units, and 26% flatwater units.

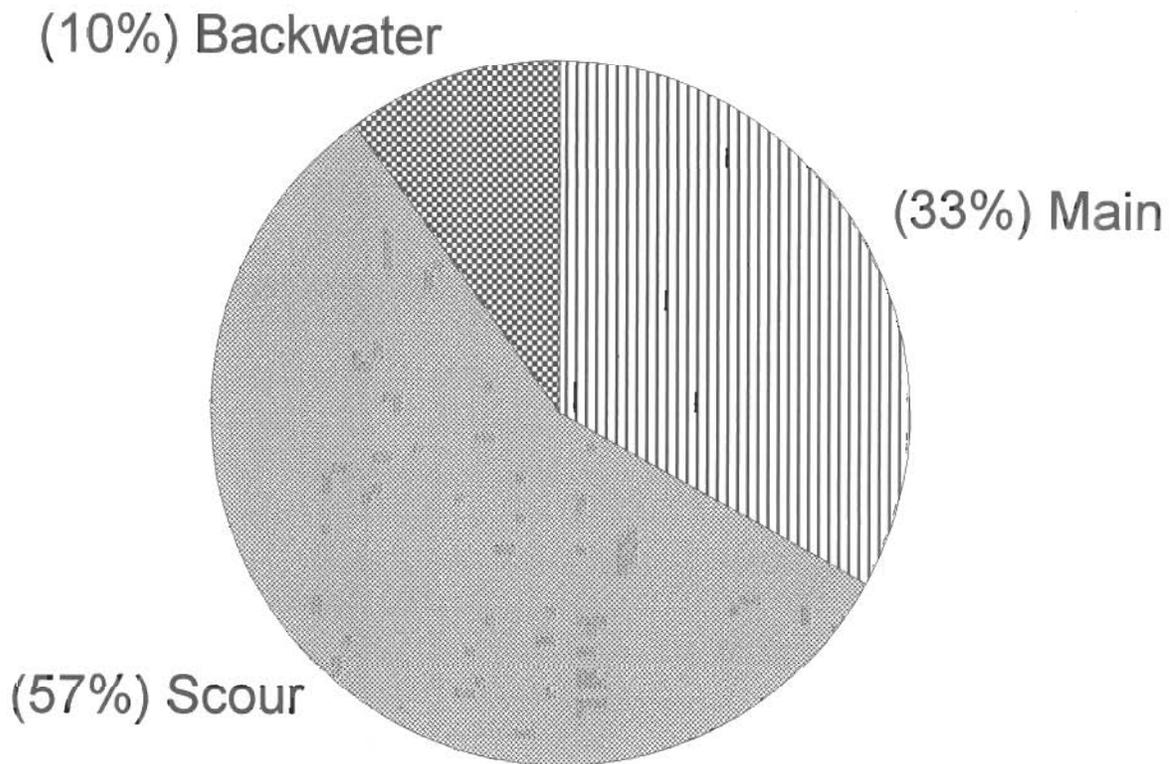
Graph 3

Four hundred, forty-five pools were identified (Table 3). Scour pools were most often encountered at 57%, and comprised 57% of the total length of pools (Graph 3).

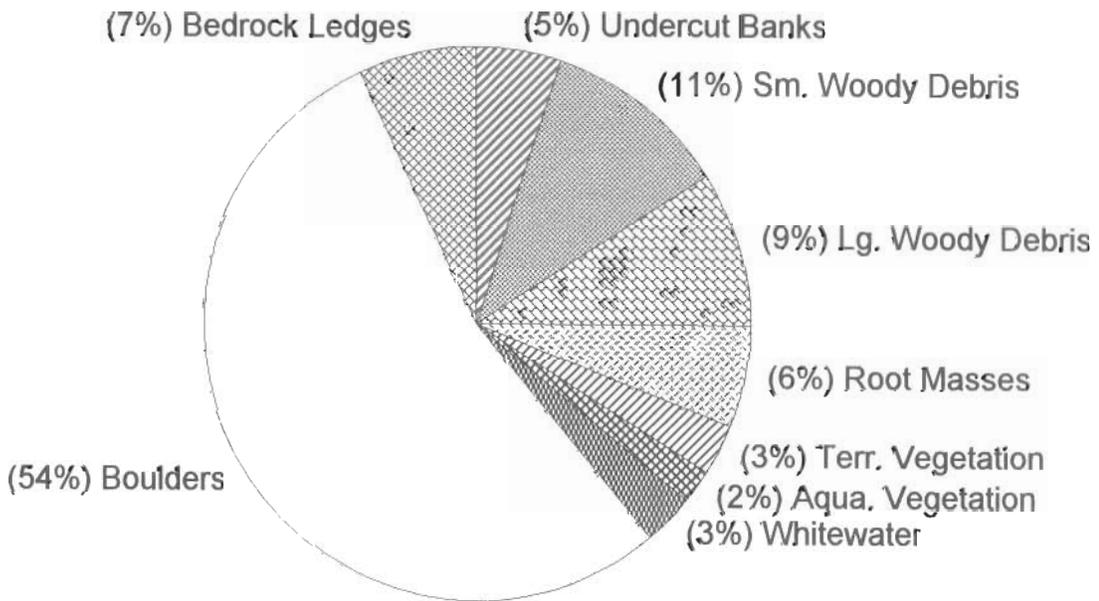
Table 5 summarizes fish shelter by habitat type. By percent area, the dominant pool shelter types were boulders at 54% and small woody debris at 11%. Graph 5 describes the pool shelter in Ward Creek.

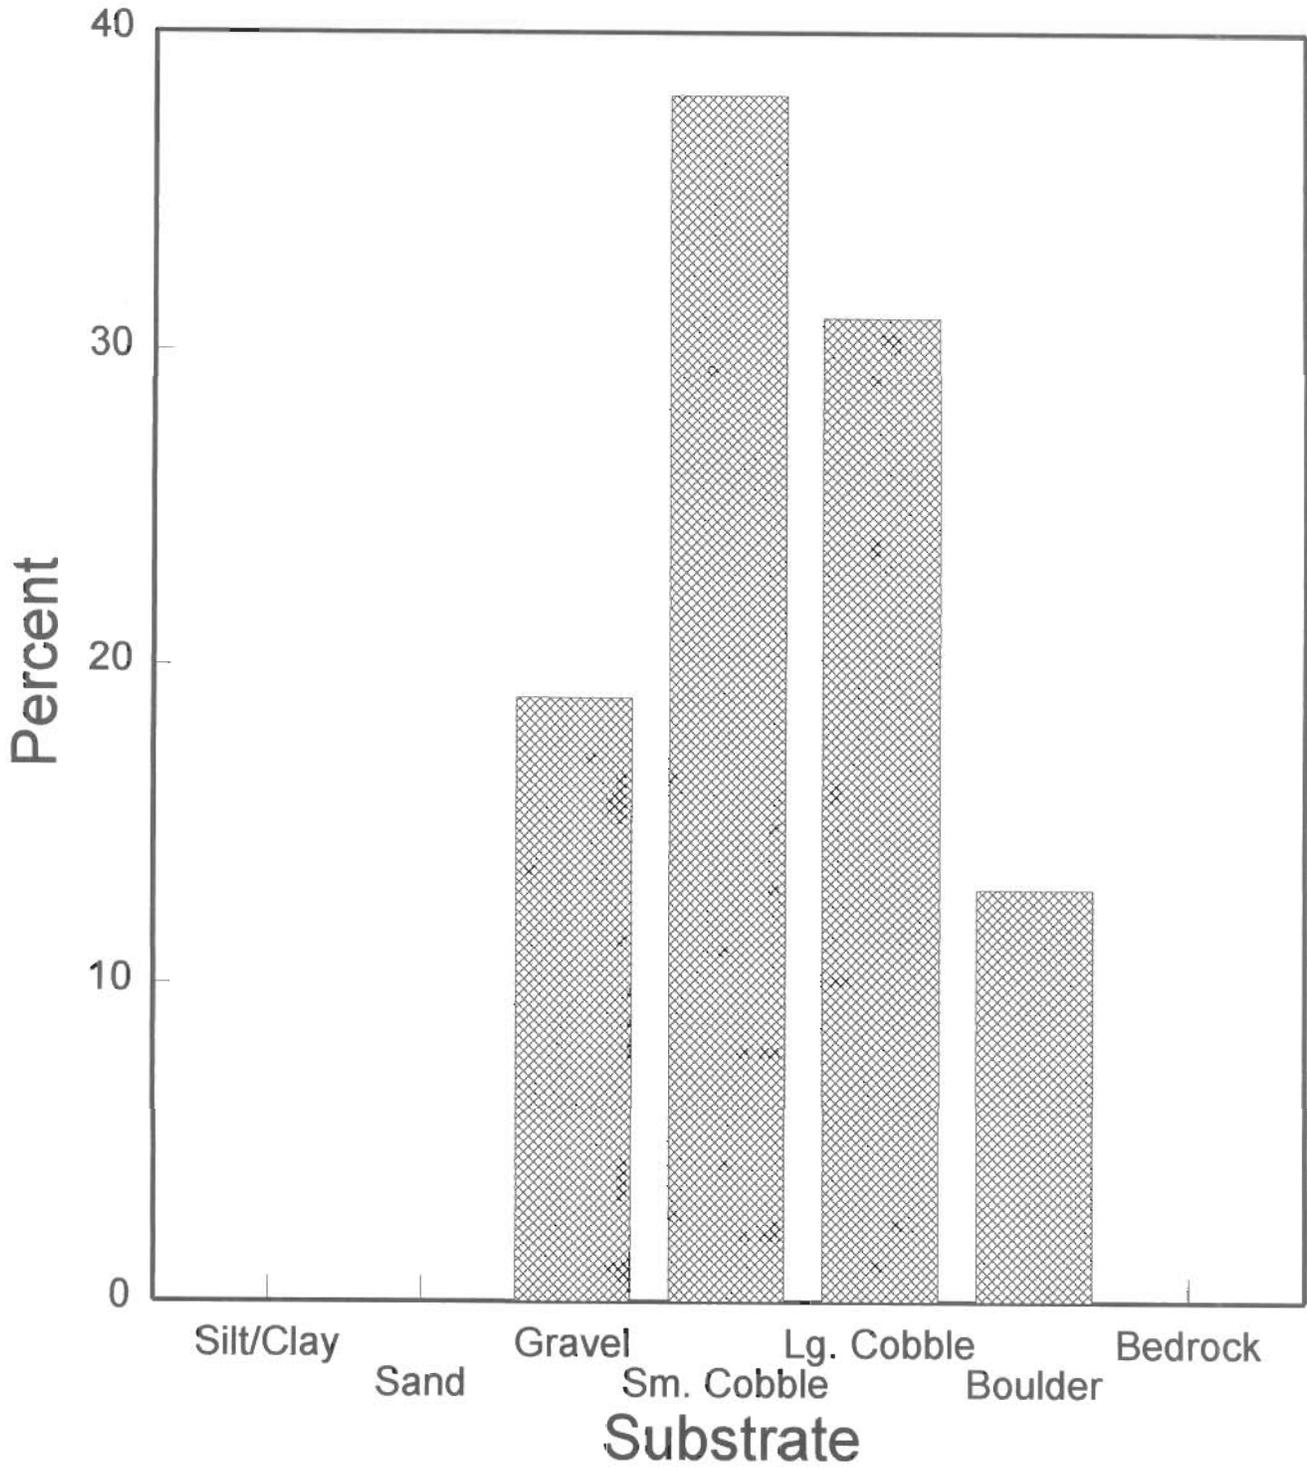
Graph 6

Table 6 summarizes the dominant substrate by habitat type. Gravel was the dominant substrate observed in 9 of the 48 low gradient riffles measured. Small cobble was dominant in 18 of the low gradient riffles (Graph 6).

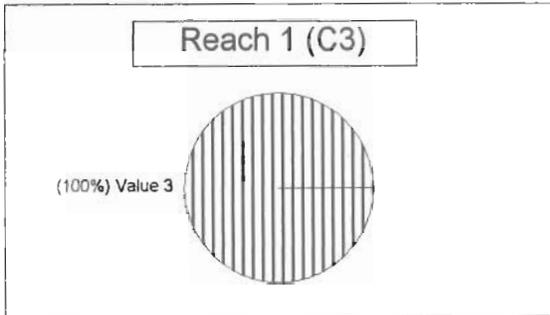
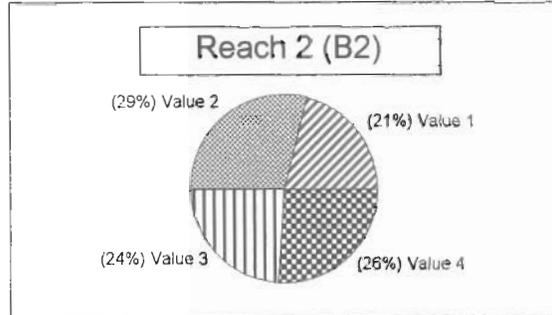
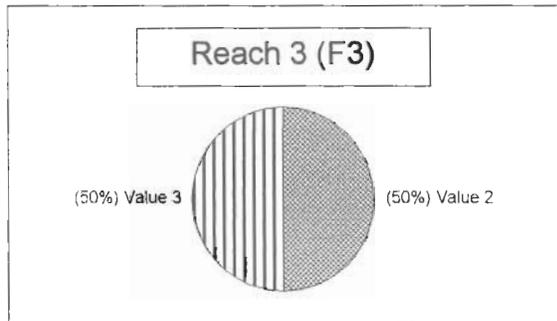
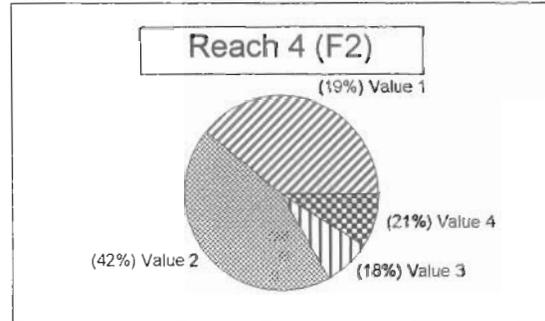
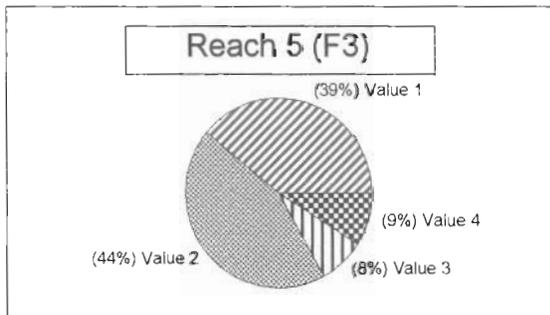
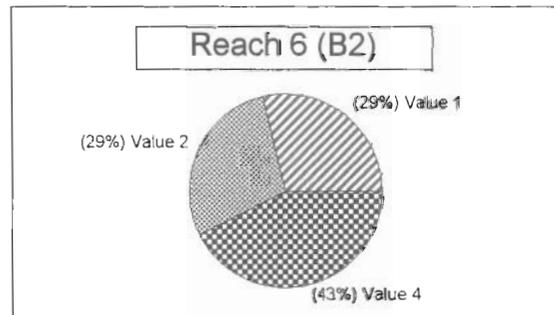
The depth of cobble embeddedness was estimated at pool tail-outs. Of the 414 pool tail-outs measured, 139 had a value of 1 (34%); 156

had a value of 2 (38%); 55 had a value of 3 (13%); and 64 had a value of 4 (15%). On this scale, a value of one is best for fisheries. Graph 7 describes percent embeddedness by reach. The mean percent canopy density for the stream reach surveyed was 70%. The mean percentages of deciduous and evergreen trees were 51% and 49%, respectively. Graph 8 describes the canopy for the entire survey and graph 9 describes the canopy by reach.

with more than half the pool tail-outs having either a 3 or 4 embeddedness rating.

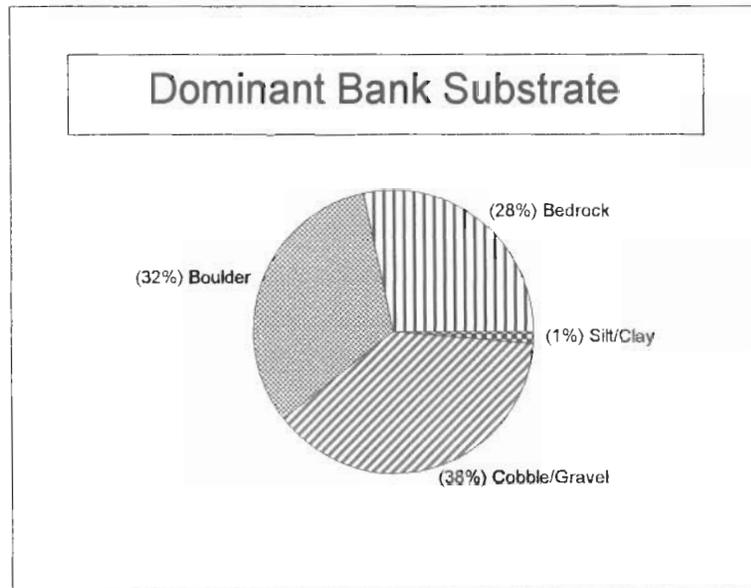
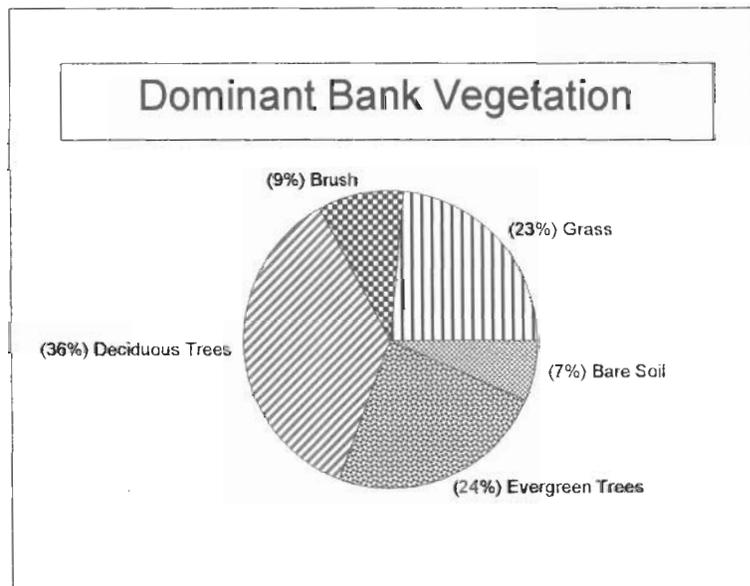
Graph 10

For the entire stream reach surveyed, the mean percent right bank vegetated was 24% and the mean percent left bank vegetated was 23%. For the habitat units measured, the dominant vegetation types for the stream banks were: 36% deciduous trees, 24% evergreen trees, 23% grass, 9% brush and 7% bare soil. The dominant substrate for the stream banks were: 38% cobble/gravel, 32% boulder, 28% bedrock and 1% silt/clay/sand (Graph 10).
