Evaluation of Fish Entrainment in 12 Unscreened Sacramento River Diversions

Final Report

July 2013

Prepared by:
Dave Vogel
Natural Resource Scientists, Inc.
P.O. Box 1210
Red Bluff, CA 96080

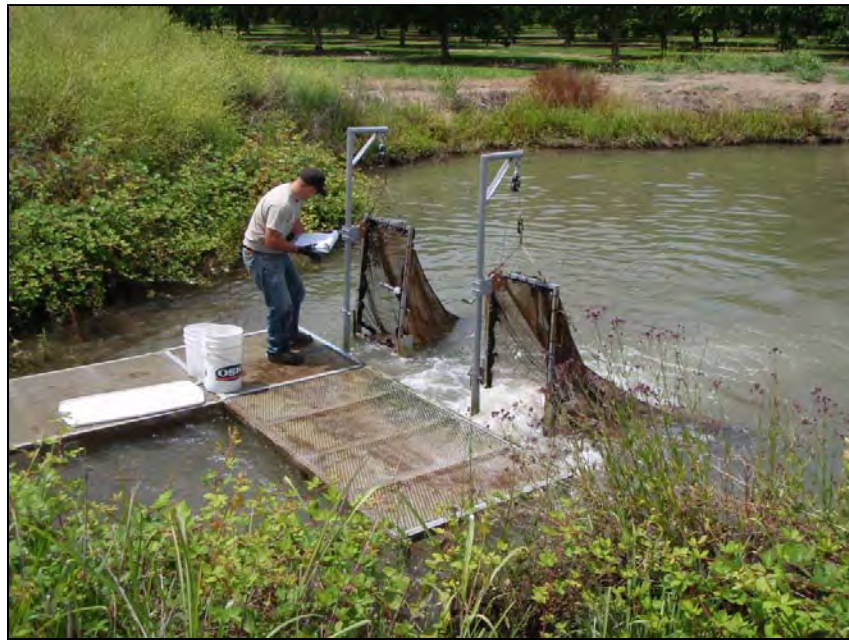
Figure 2. Fyke apparatus and nets used to sample for fish entrainment at the Sycamore canal.

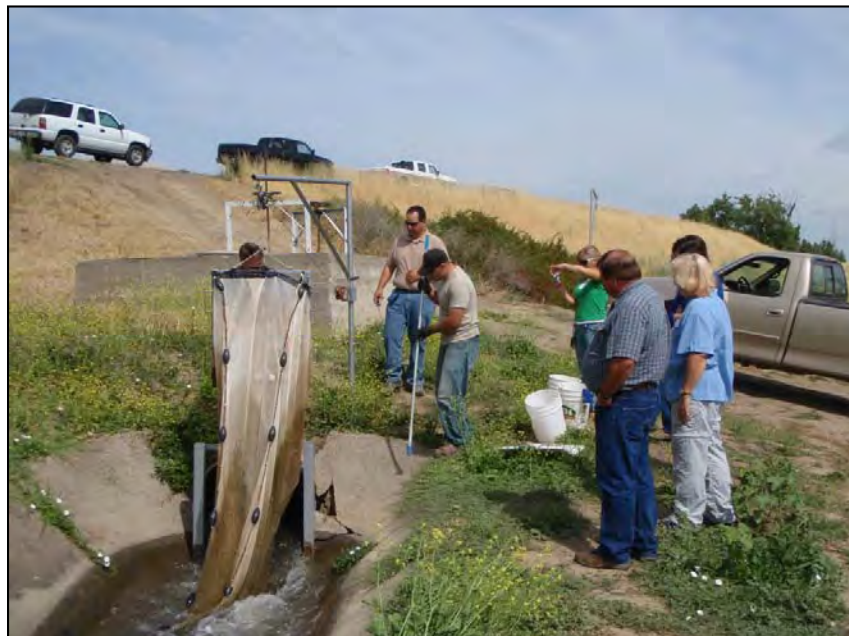
Figure 3. Fyke apparatus and net used to sample for fish entrainment in one of two canals at River Garden Farms No. 2.

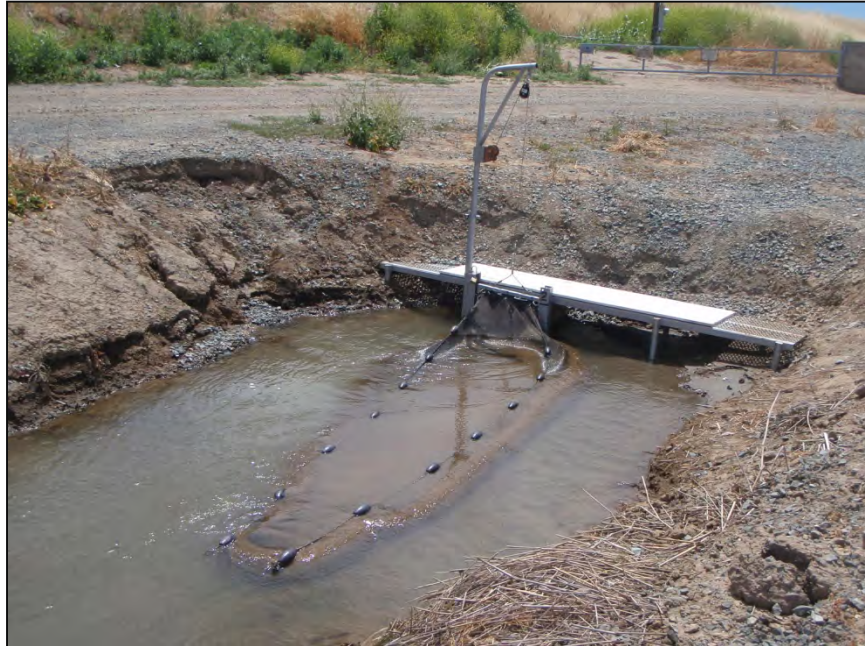
Figure 5. Fyke apparatus, fyke net, and sampling platform used to sample for fish entrainment in the South Steiner earth canal.

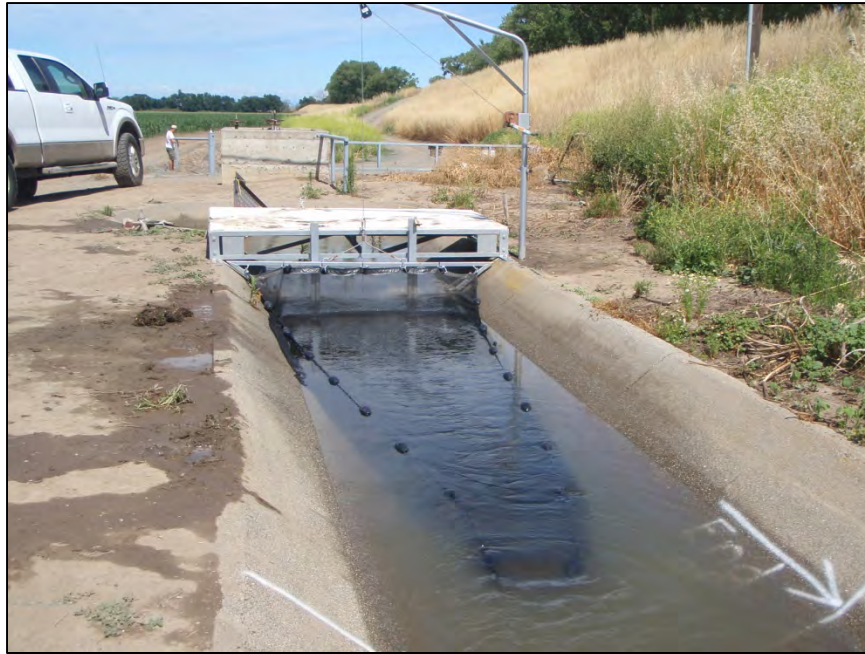
Figure 6. Fyke apparatus and sampling platform used for fish entrainment sampling in the South Steiner concrete canal.

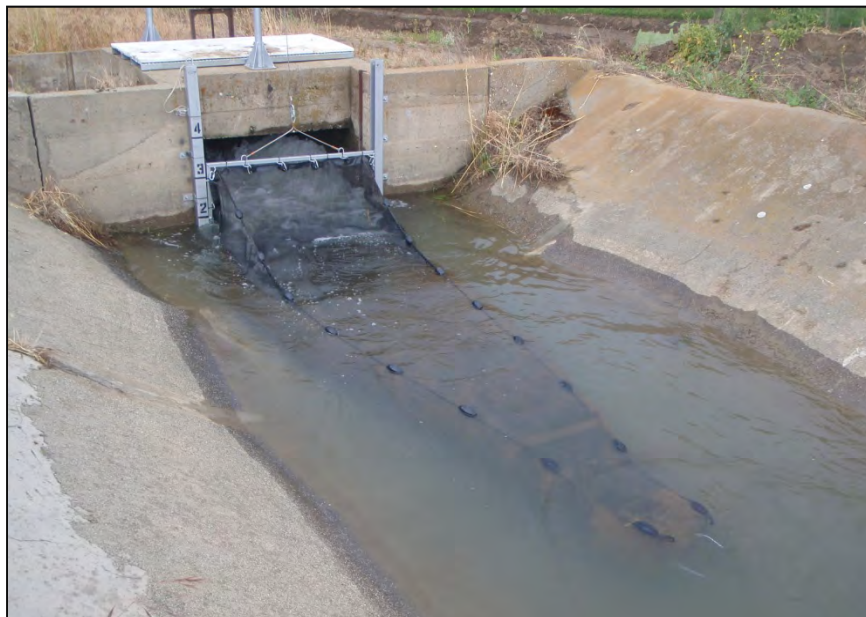
Figure 8. Fyke apparatus, fyke net, and sampling platform used to sample for fish entrainment in the Windswept canal.

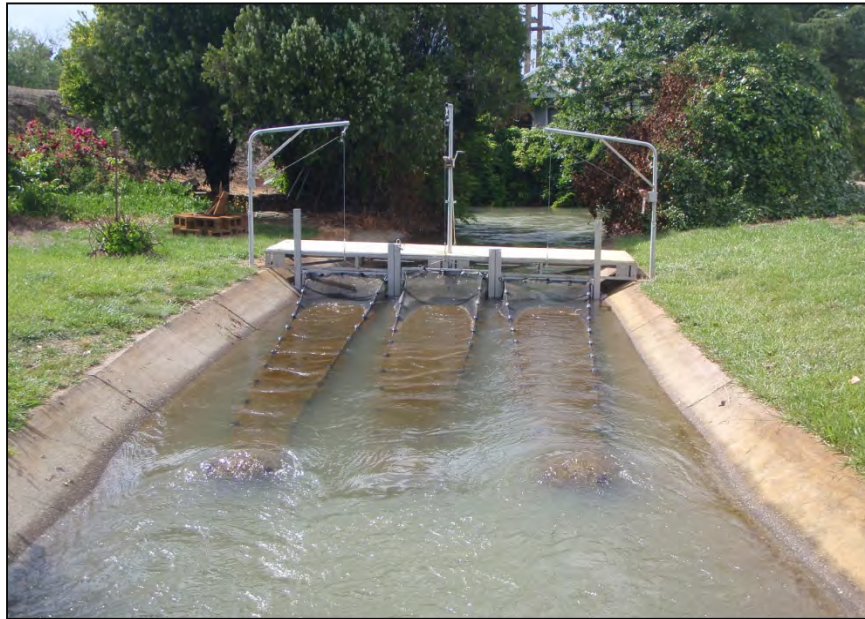
Figure 9. Three fyke nets, sampling platform, and associated apparatus used to sample for fish entrainment in the Portuguese Bend canal.

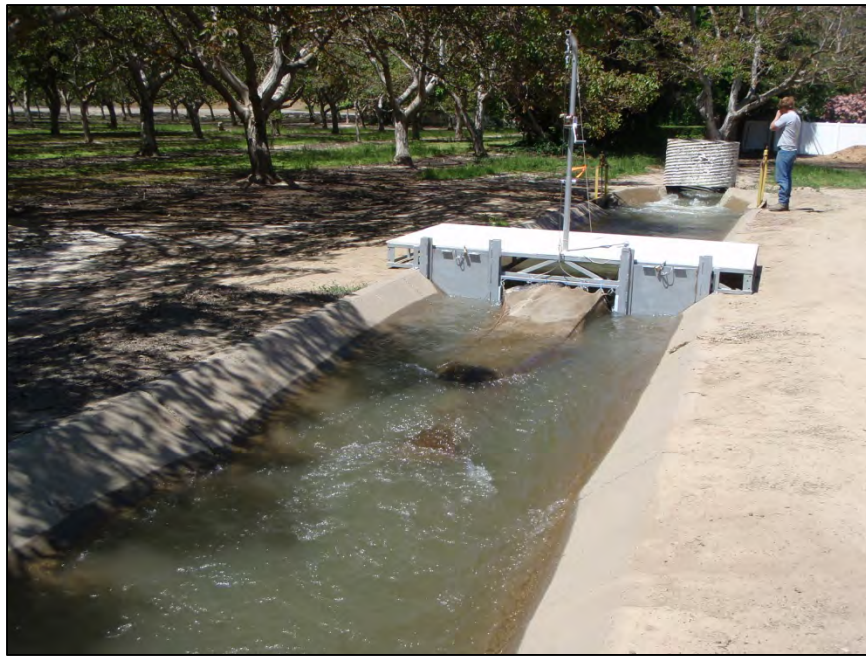
Figure 10. The fyke net, sampling platform, and associated apparatus used to sample for fish entrainment in the Alamo trapezoidal concrete canal.

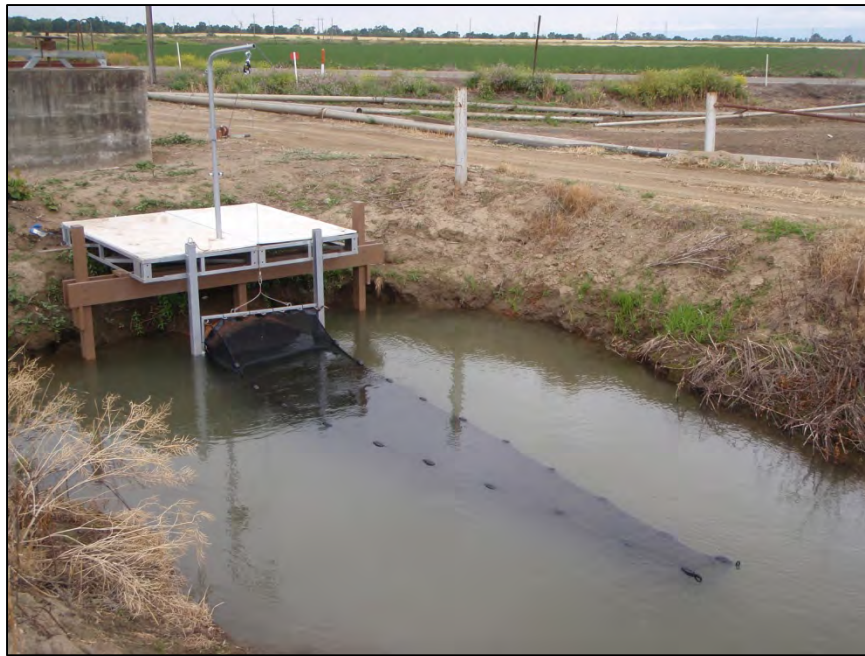
Figure 10. The fyke net, sampling platform, and associated apparatus used to sample for fish entrainment in the Townsite north canal.

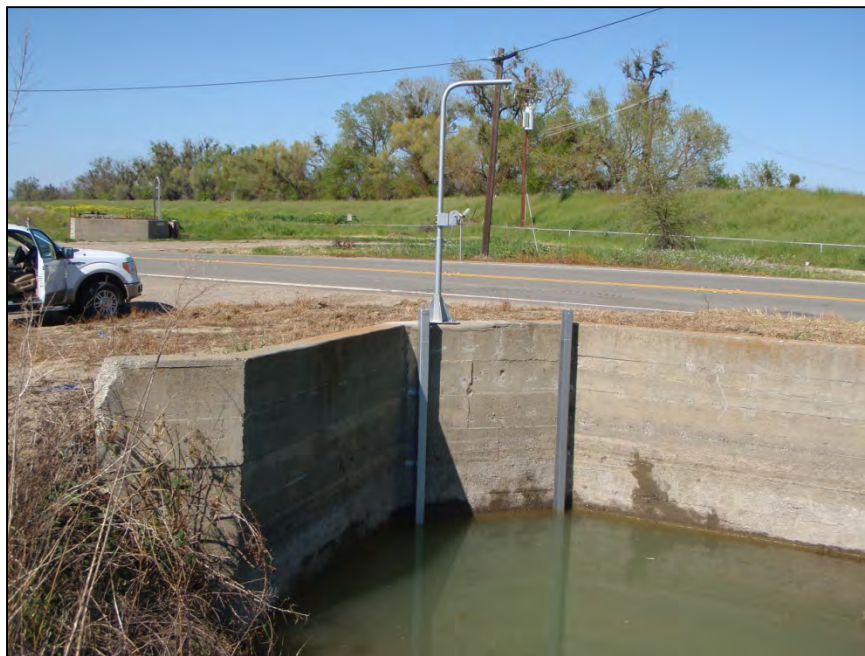
Figure 11. The fyke apparatus used to sample for fish entrainment in the Townsite south canal.

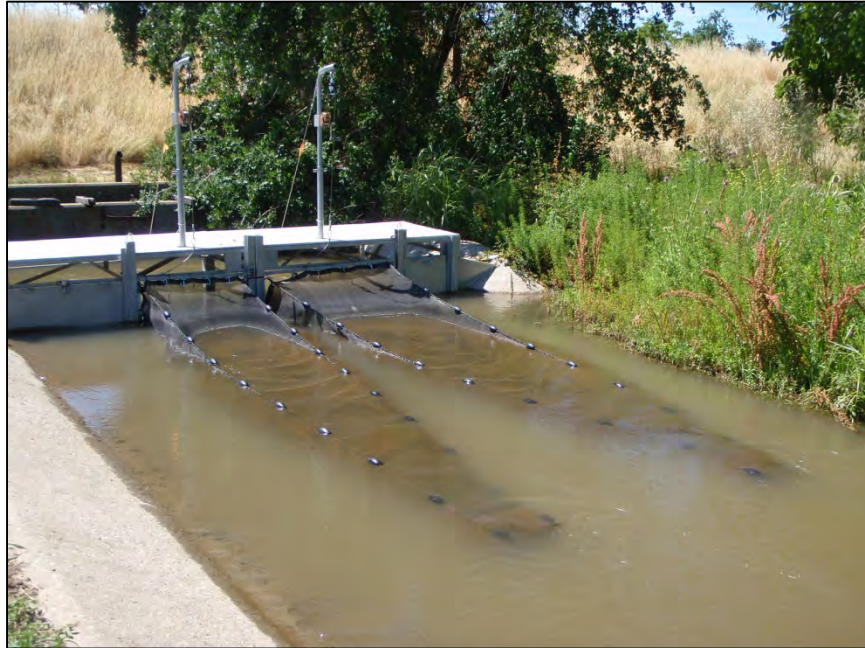
Figure 12. Two fyke nets, sampling platform, and associated apparatus used to sample for fish entrainment in the Tisdale canal.

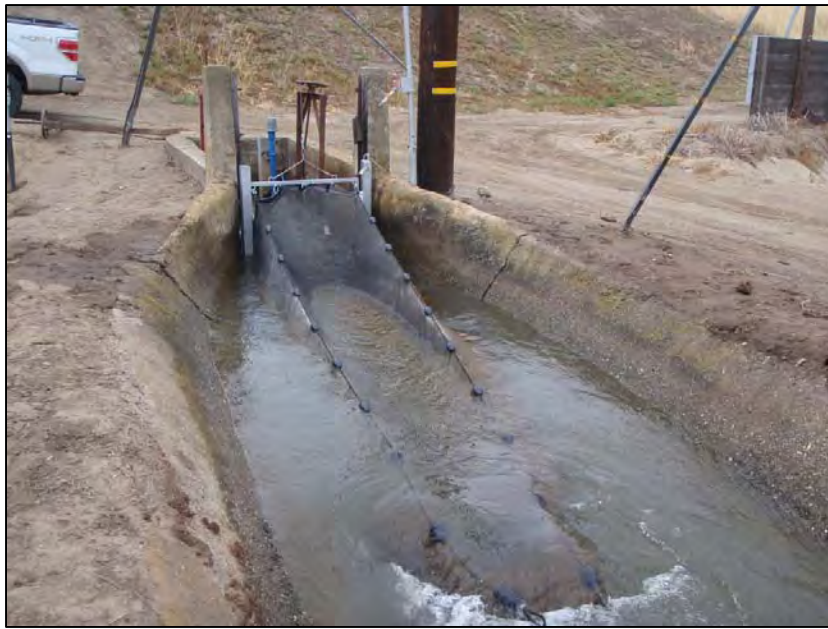
Figure 13. The fyke net and associated apparatus used to sample for fish entrainment in the Cranmore trapezoidal concrete canal.

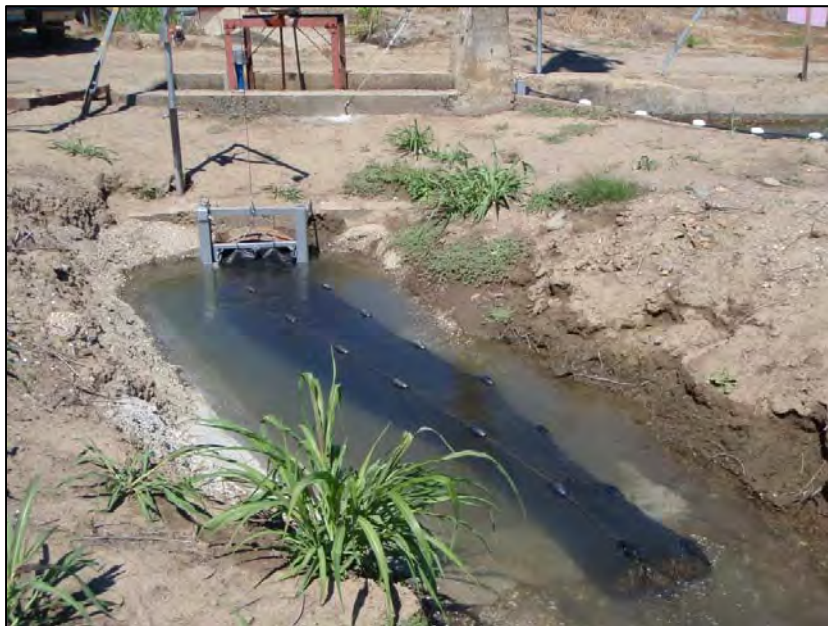
Figure 14. The fyke net and associated apparatus used to sample for fish entrainment in the Cranmore irregular-shaped concrete canal.

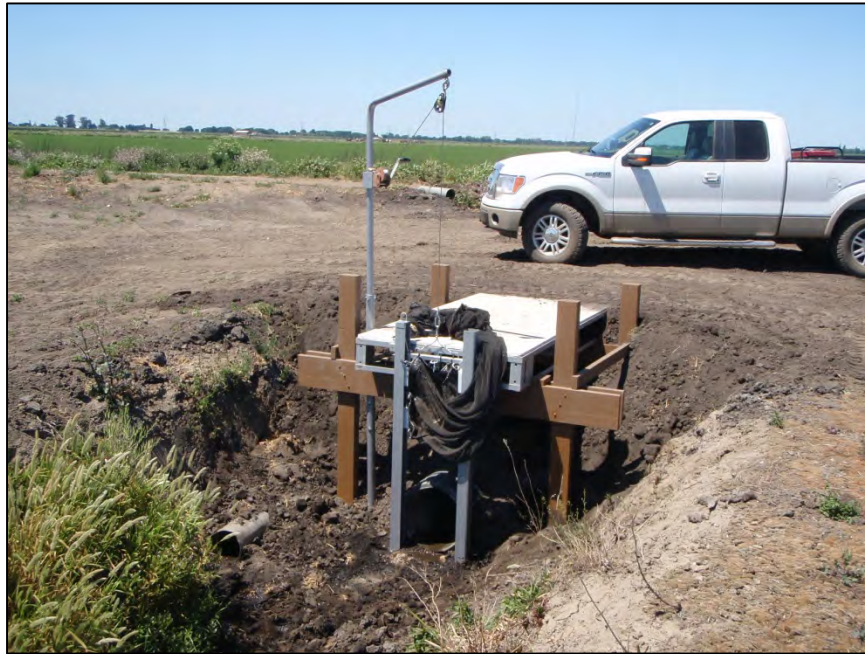
Figure 15. The fyke net, sampling platform, and associated apparatus used to sample for fish entrainment in the Sanchez east canal.

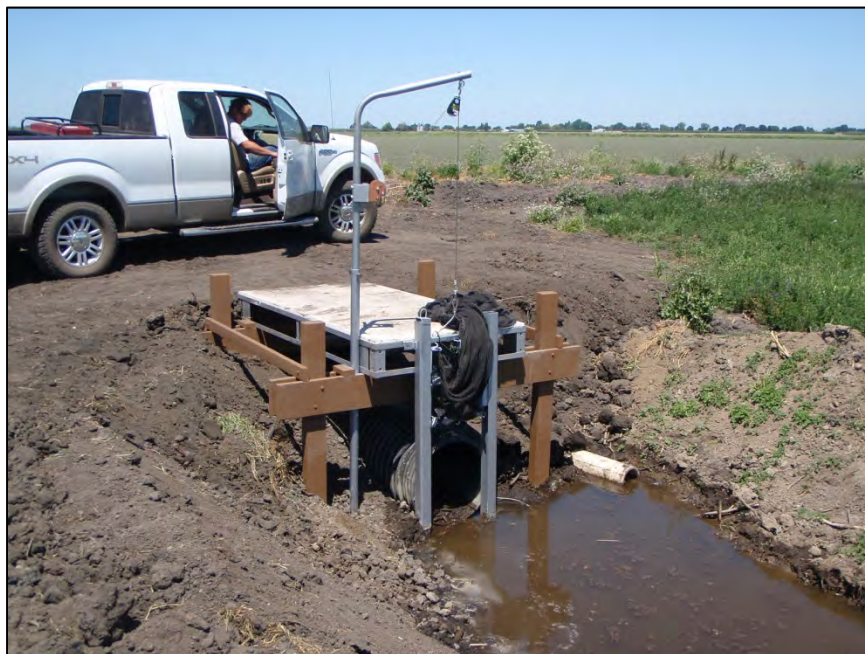
Figure 16. The fyke net, sampling platform, and associated apparatus used to sample for fish entrainment in the Sanchez west canal.

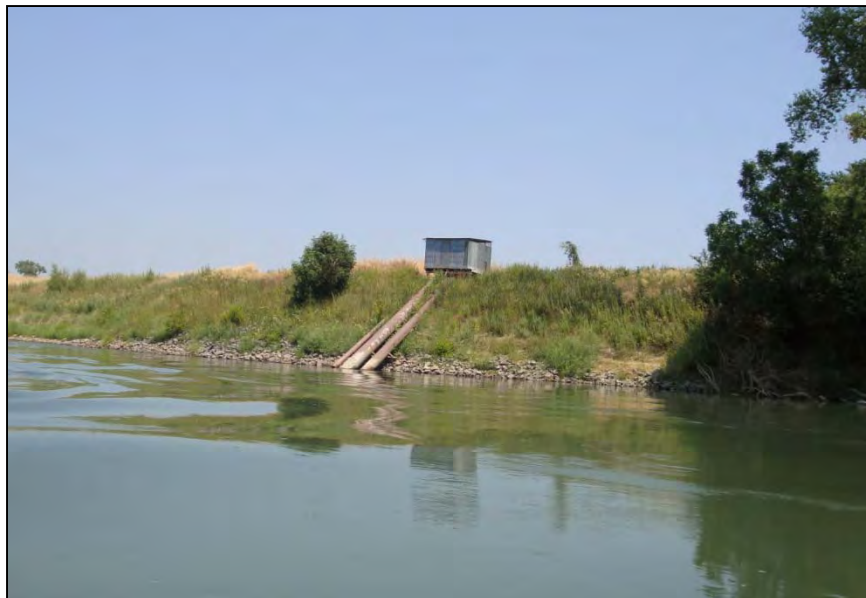
Appendix Figure 9. The River Garden Farms No. 2 pump intakes looking in a downstream direction.
