Sacramento River Ecological Flows Study: Off-Channel Habitat Study Final Report

Kondolf, G. M. and Stillwater Sciences. 2007. Sacramento River Ecological Flows Study: Off-Channel Habitat Study Results. Technical Report prepared for The Nature Conservancy, Chico, California by G. Mathias Kondolf and Stillwater Sciences, Berkeley, California

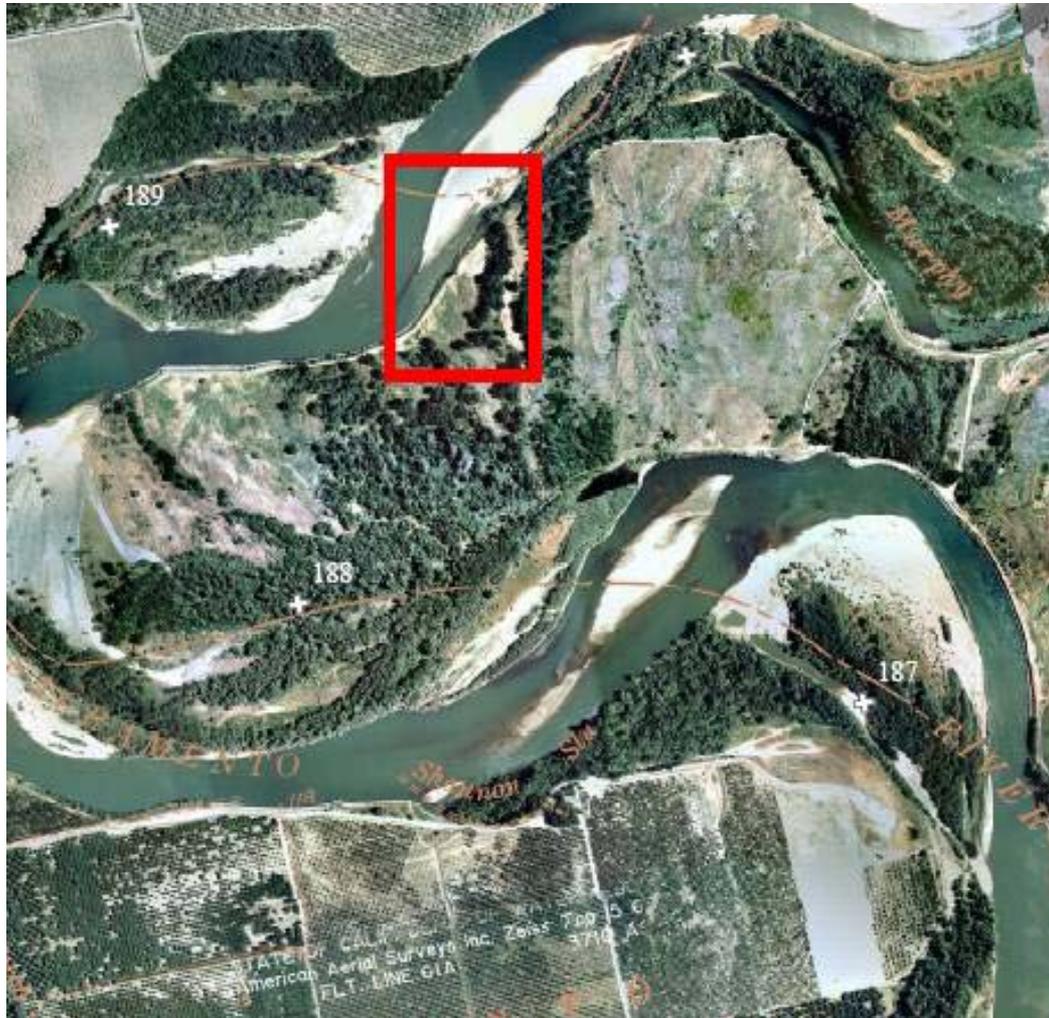
Figure 2. Example of a scour channel that forms on the downstream end of a point bar, providing seasonally inundated, shallow-water habitat that can support rearing of salmonid fry. (Photo Source: CDWR 1999)

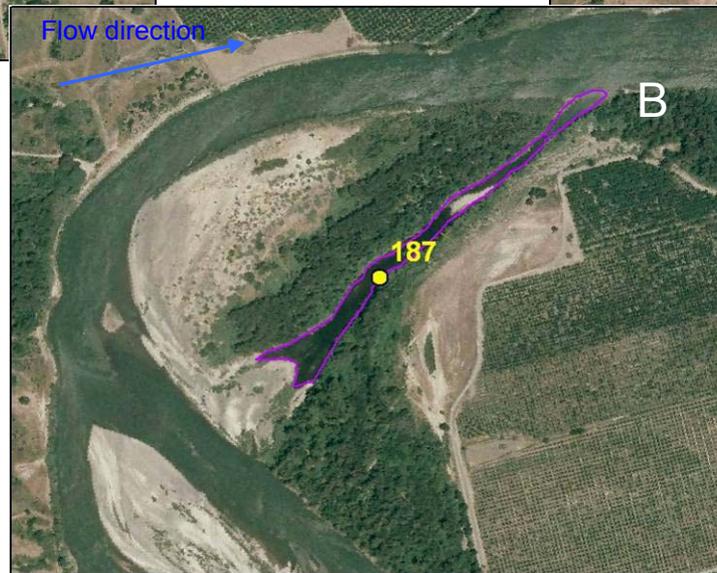
Figure 3. Examples of off channel water bodies studied for inundation flows on the Sacramento River: (A) Type 1- probe channel eroding behind an active point bar, (B) Type 2- an abandoned channel on the inside of a meander bend as the mainstem continues to erode outward, and (C) Type 3- a former main channel position on the outside of a bend that is abandoned as the main channel cuts behind a point bar.

¹ See Figure 3 for illustration of morphologic types.

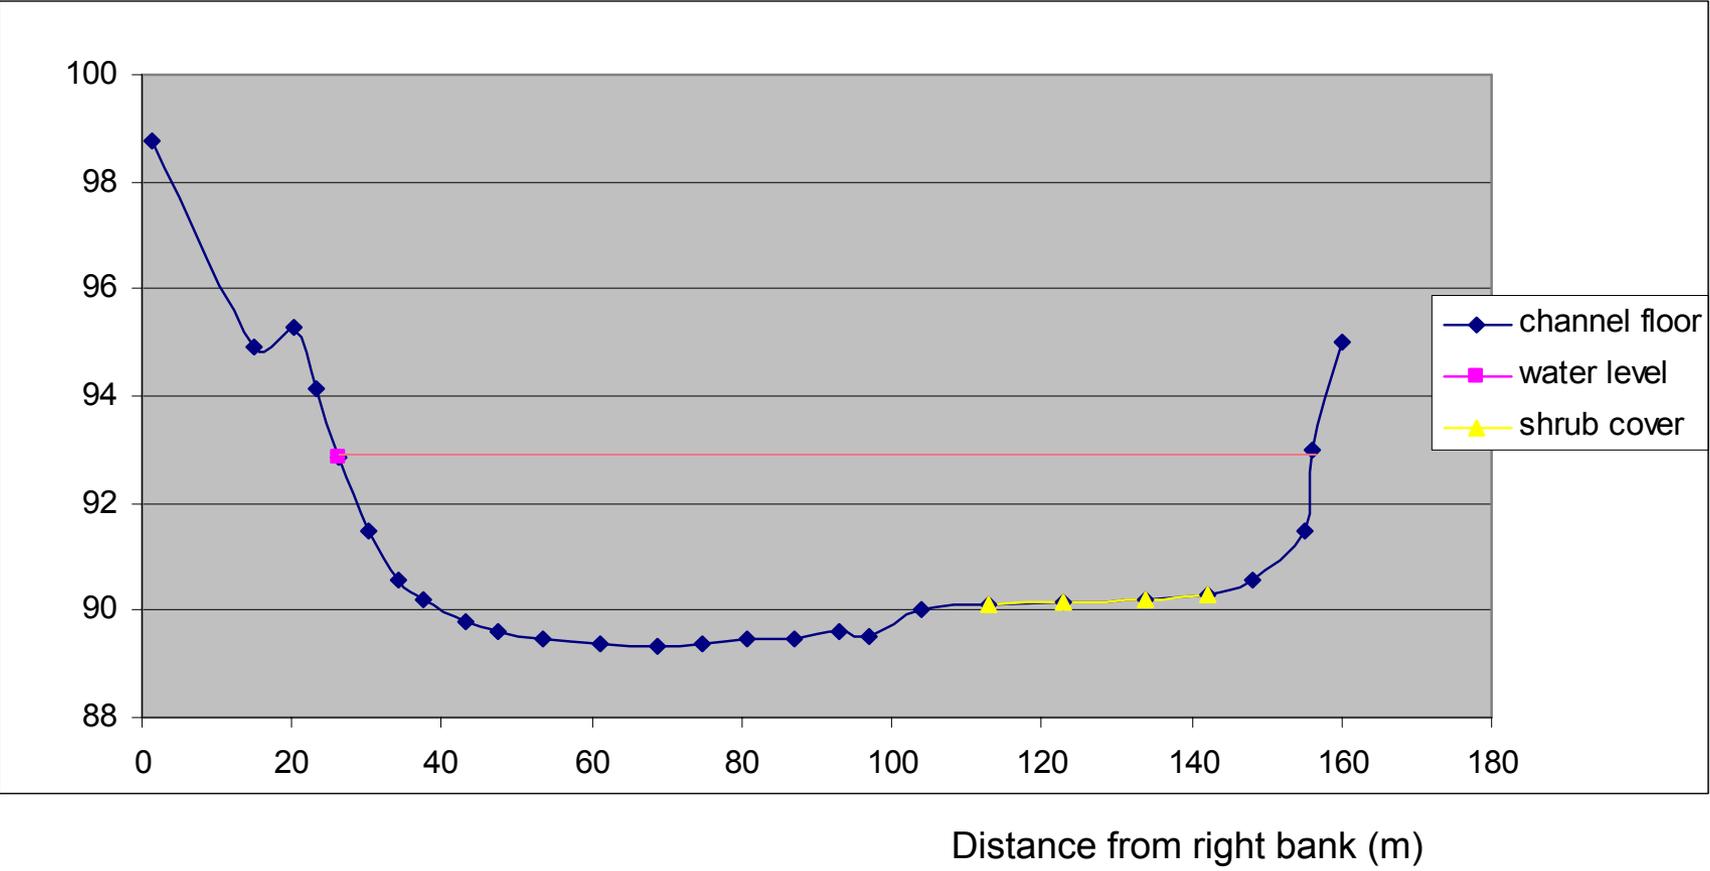
Figure 15. Cross section of Jacinto OCWB.

Figures 13-19 show cross sections of OCWB study sites in the Sacramento River surveyed in March 2006 (with follow-up surveys at lower flows as needed). The x-axis is horizontal distance (m) across the channel (left bank to right bank unless otherwise noted) and the y-axis is elevation (m) above an arbitrary datum. Note that some of the legends use French terms: *terrain* is ground surface, *eau* is water surface elevation, *niveau fin* is the base of the fine-grained sediment accumulated over the former channel gravel, and *arbustes immerges* is bushes submerged by water. These cross sections demonstrate the narrowing that has occurred post-cutoff. The main channel width is roughly 100 m, but the abandoned channels have narrowed, most to around 60 m (Capay to about 30 m). The depth of fine sediment shown for Phelan (Figure 13) is consistently about 3 m across this channel.

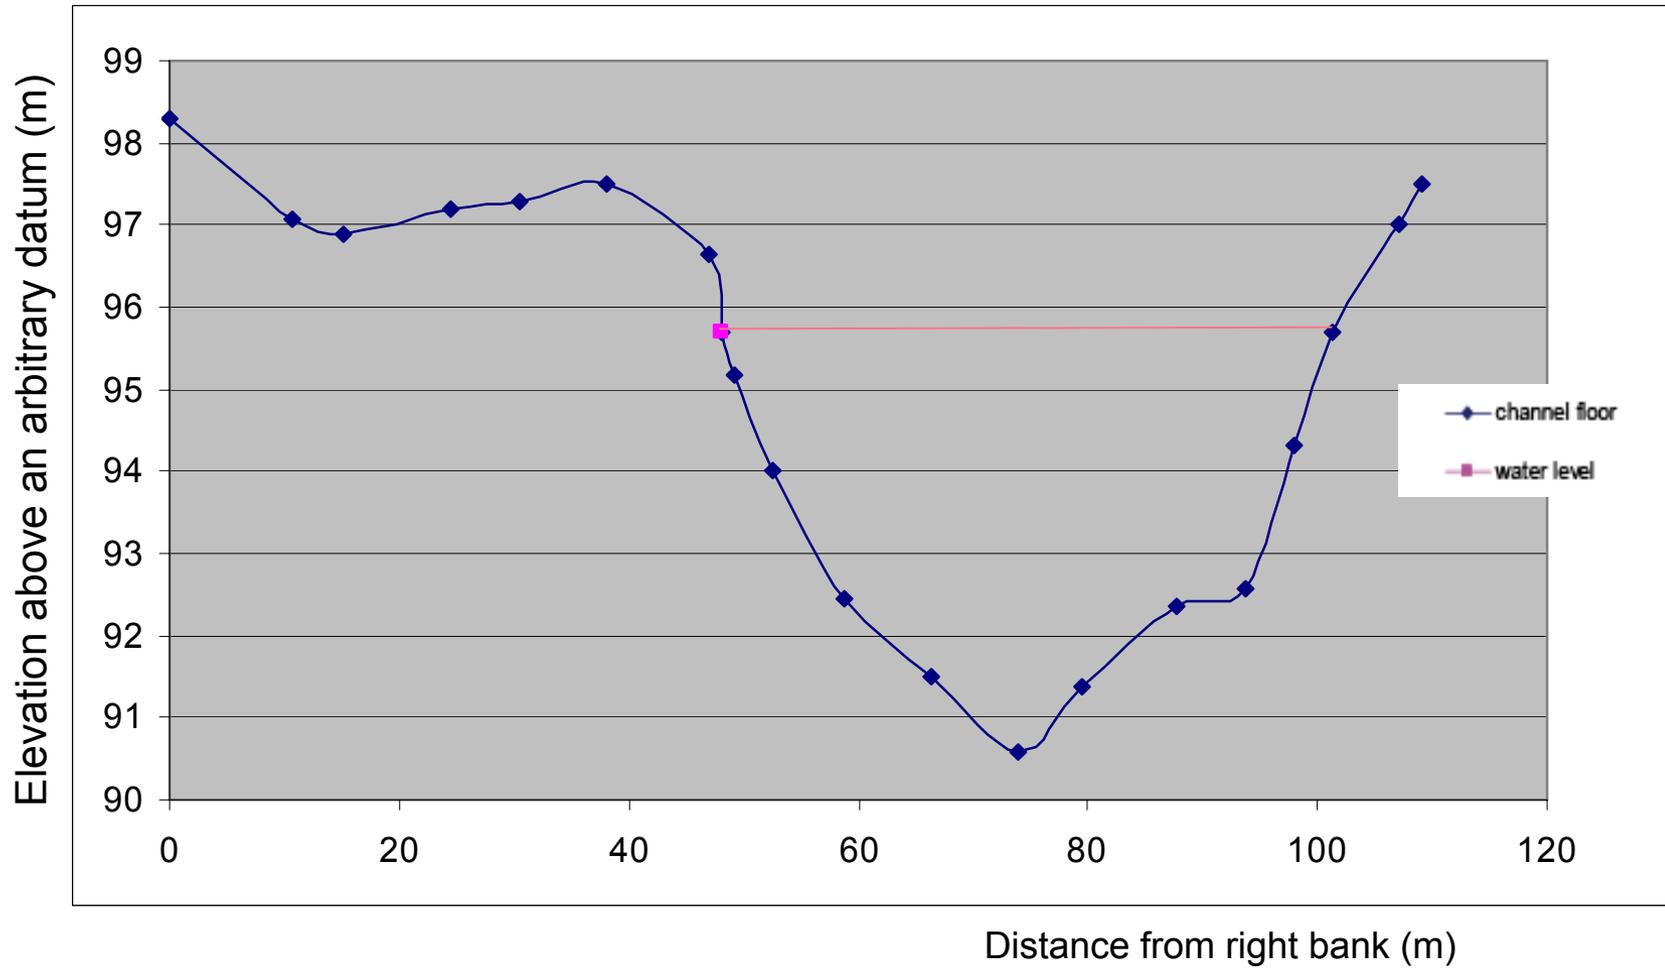
Figure 18. Cross section of Jenny Lind Bend OCWB.

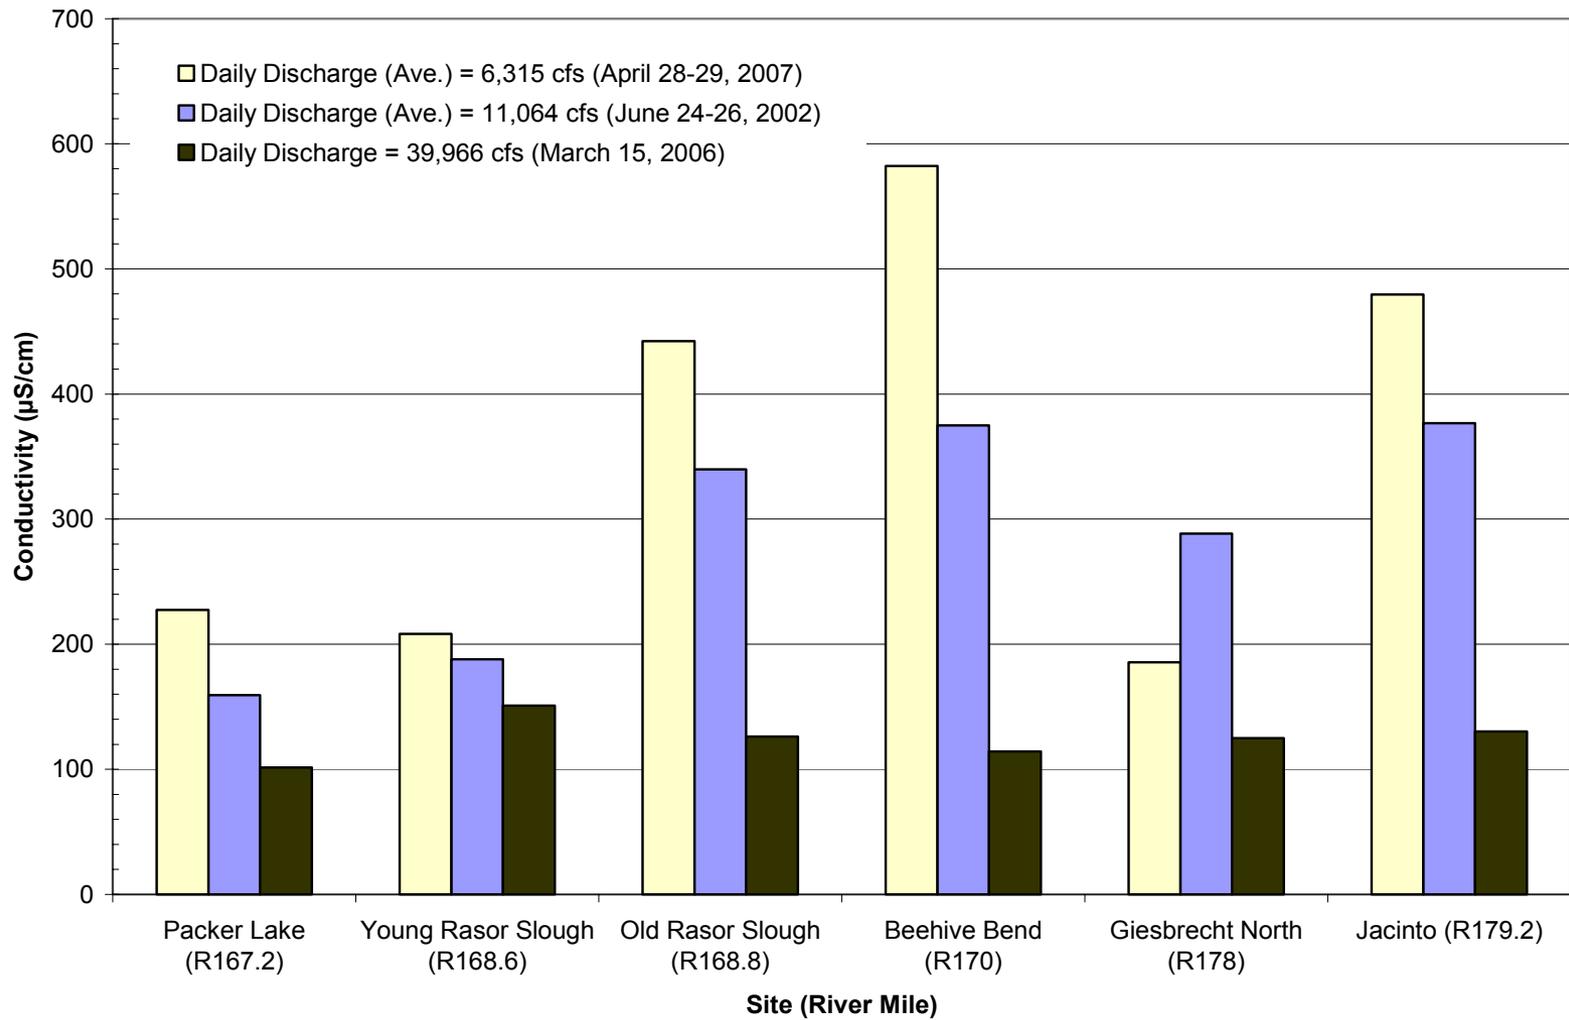
Figure 19. Cross section of Young Razor slough OCWB.

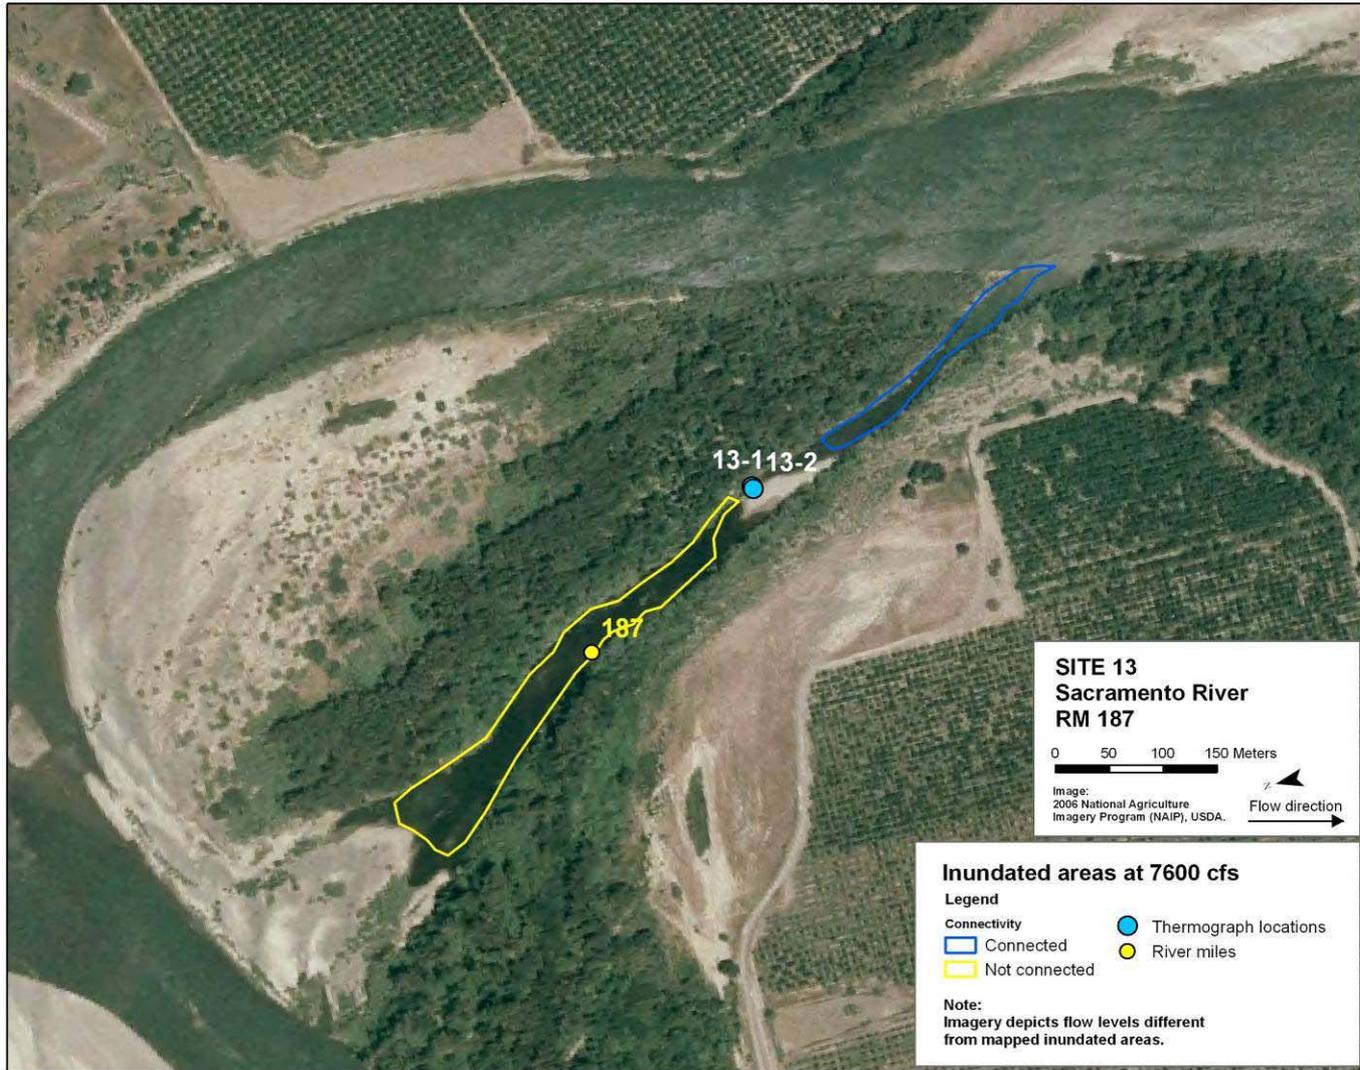
Figure 20. Conductivity measurements for selected OCWB sites taken during a range of Sacramento River discharge rates.

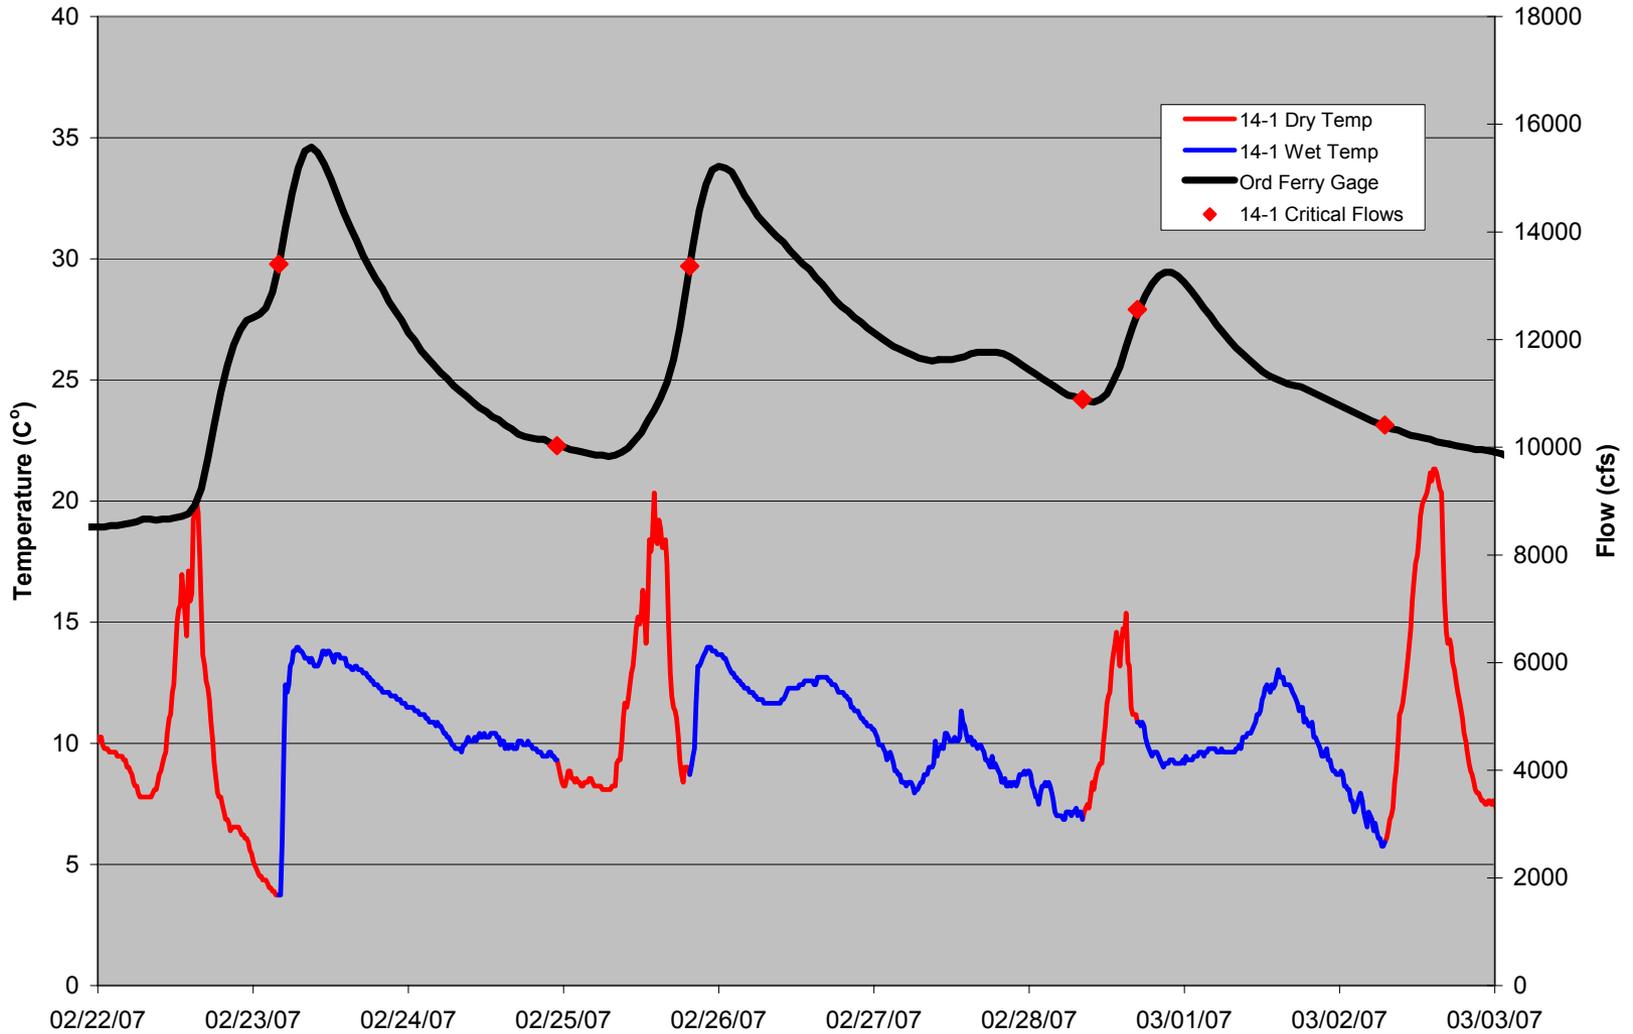
Site 14

Figure 23. Thermograph data for site 14 (RM 189R) and discharge at Ord Ferry between 2/22/07 and 3/3/07. Critical flow points depict thermograph changes between dry and wet status.

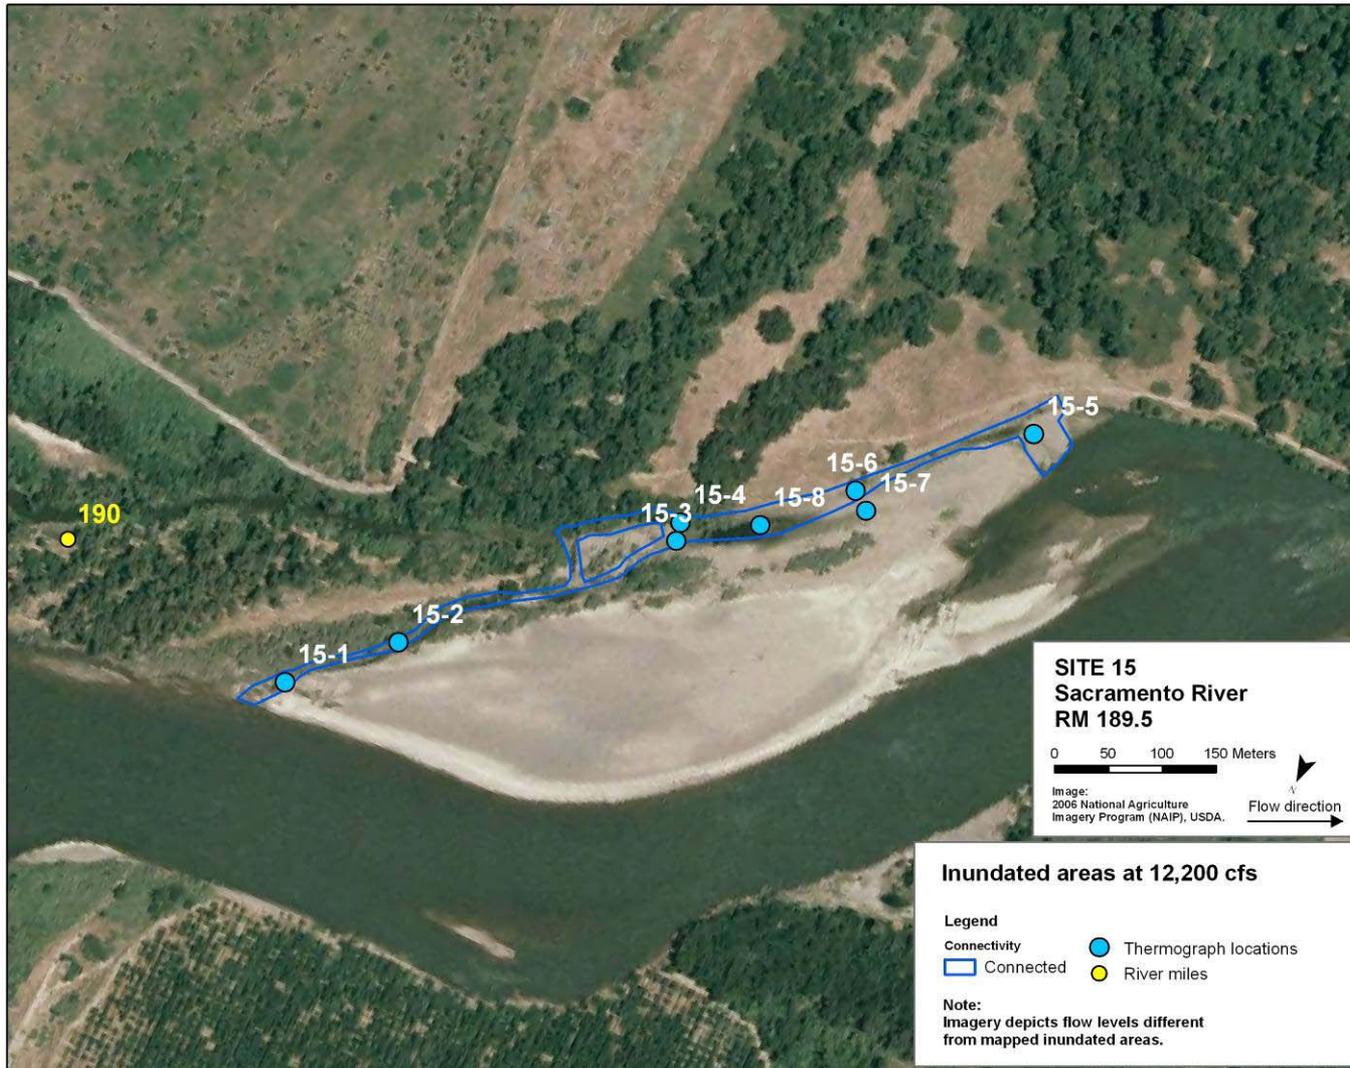
Site 15

Figure 24d. Inundated areas of site 15 (RM 189.5L) at flows of 12,200 cfs , areas based on thermograph temperature records and field surveys.

Thermograph data indicates that the threshold flow for mainstem connection of all the pools along site 15's longitudinal axis is about 12,200 cfs (Figure 24d). However, the discharge for inlet connection varied from 11,900 to 12,800 (median of 12,200 cfs) during the three storm peaks (Figure 25); this variability may be attributed to local stage effects associated with Stony Creek which enters the Sacramento on the opposite bank just upstream from Site 15's inlet. These local stage effects may not be consistently reflected at the same flow level at the Ord Ferry

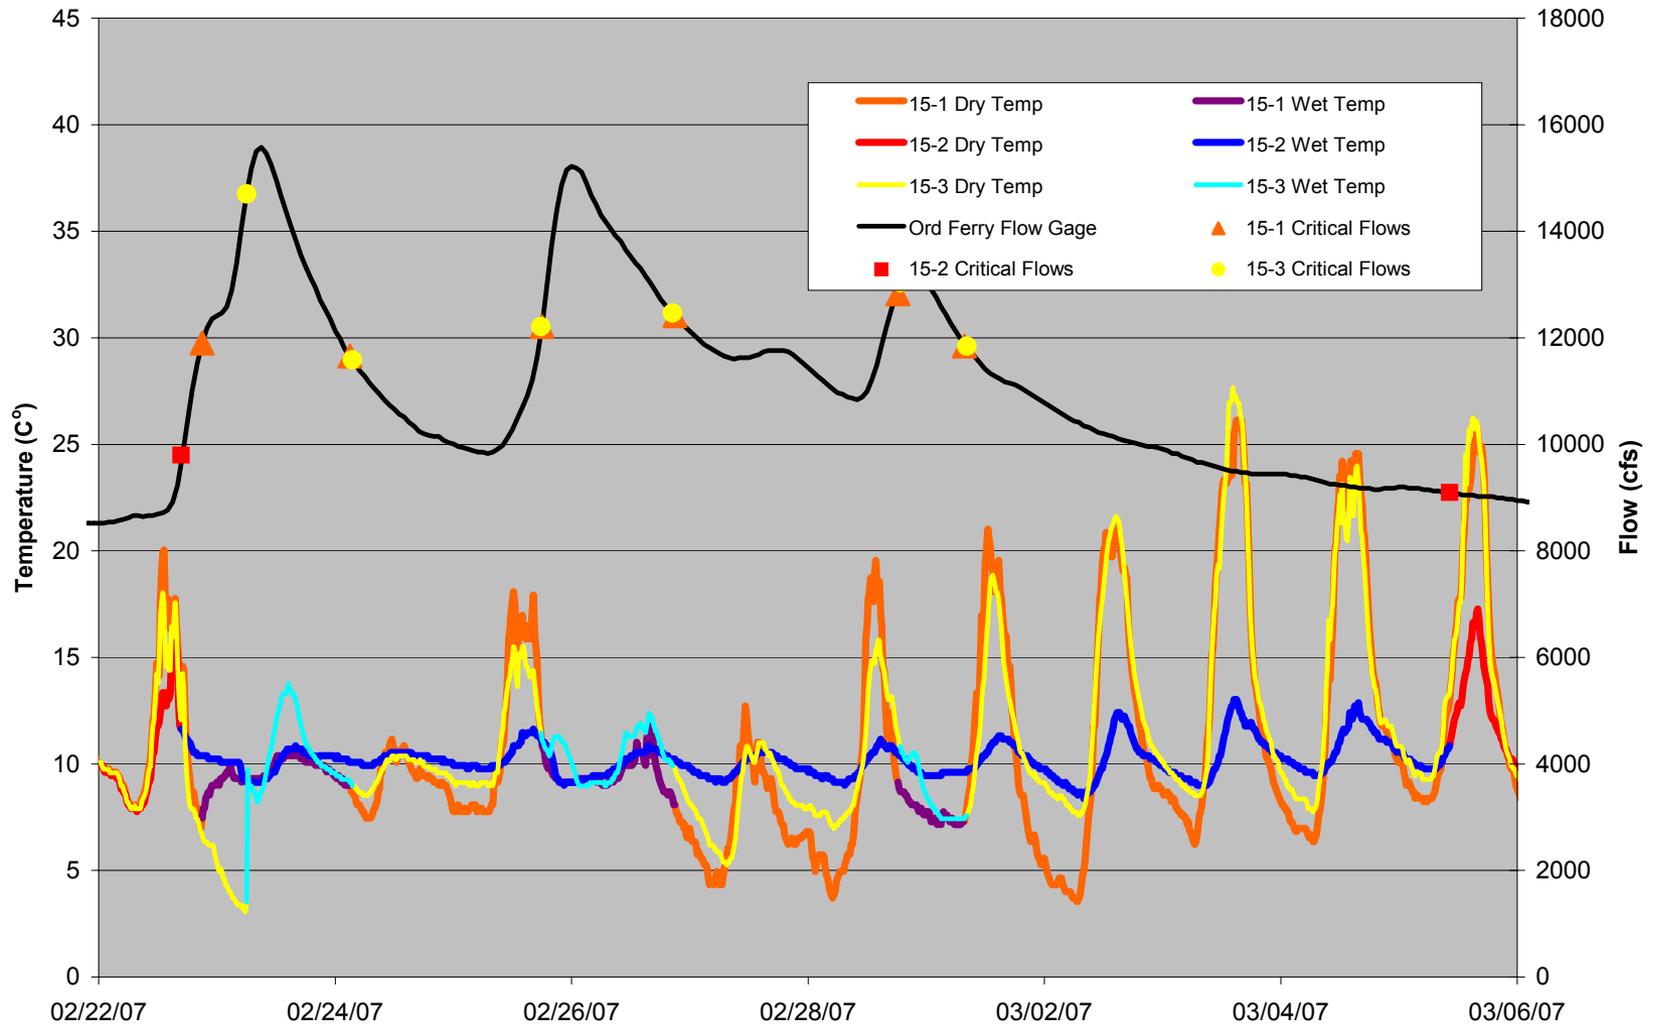
Figure 25a. Thermograph data for site 15 (RM 189.5L) and discharge at Ord Ferry between 2/22/07 and 3/6/07. Critical flow points depict thermograph changes between dry and wet status.

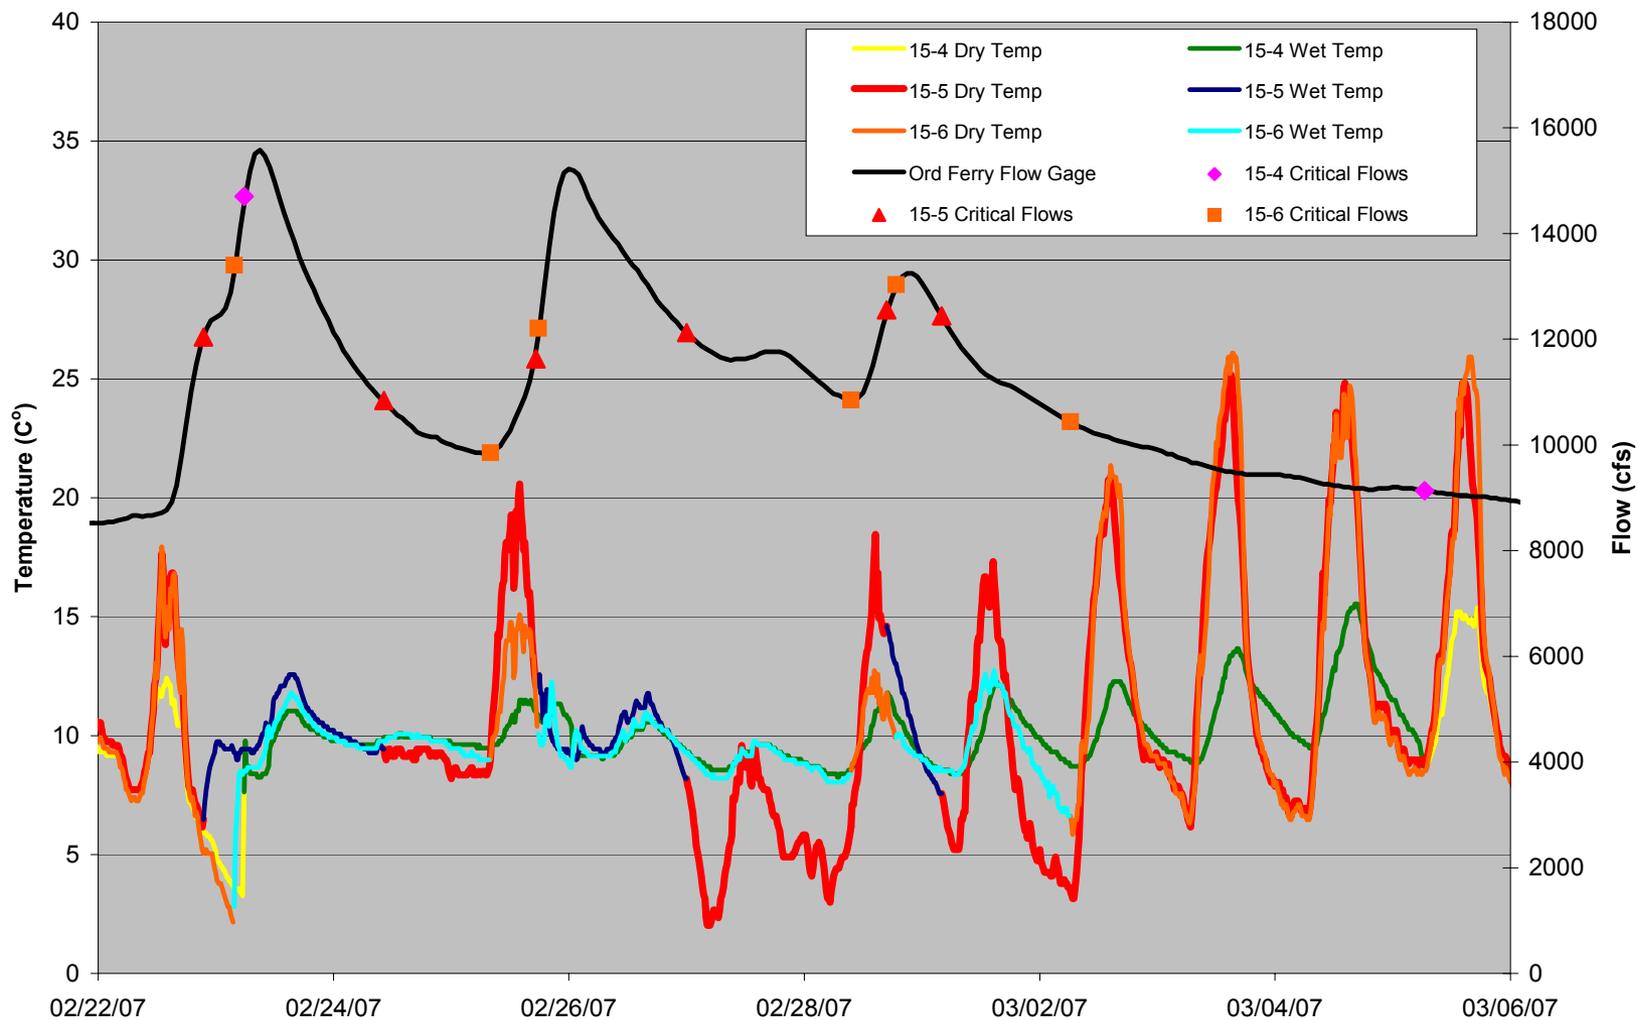
Site 15

Figure 25b. Thermograph data for site 15 (RM 189.5L) and discharge at Ord Ferry between 2/22/07 and 3/6/07. Critical flow points depict thermograph changes between dry and wet status.

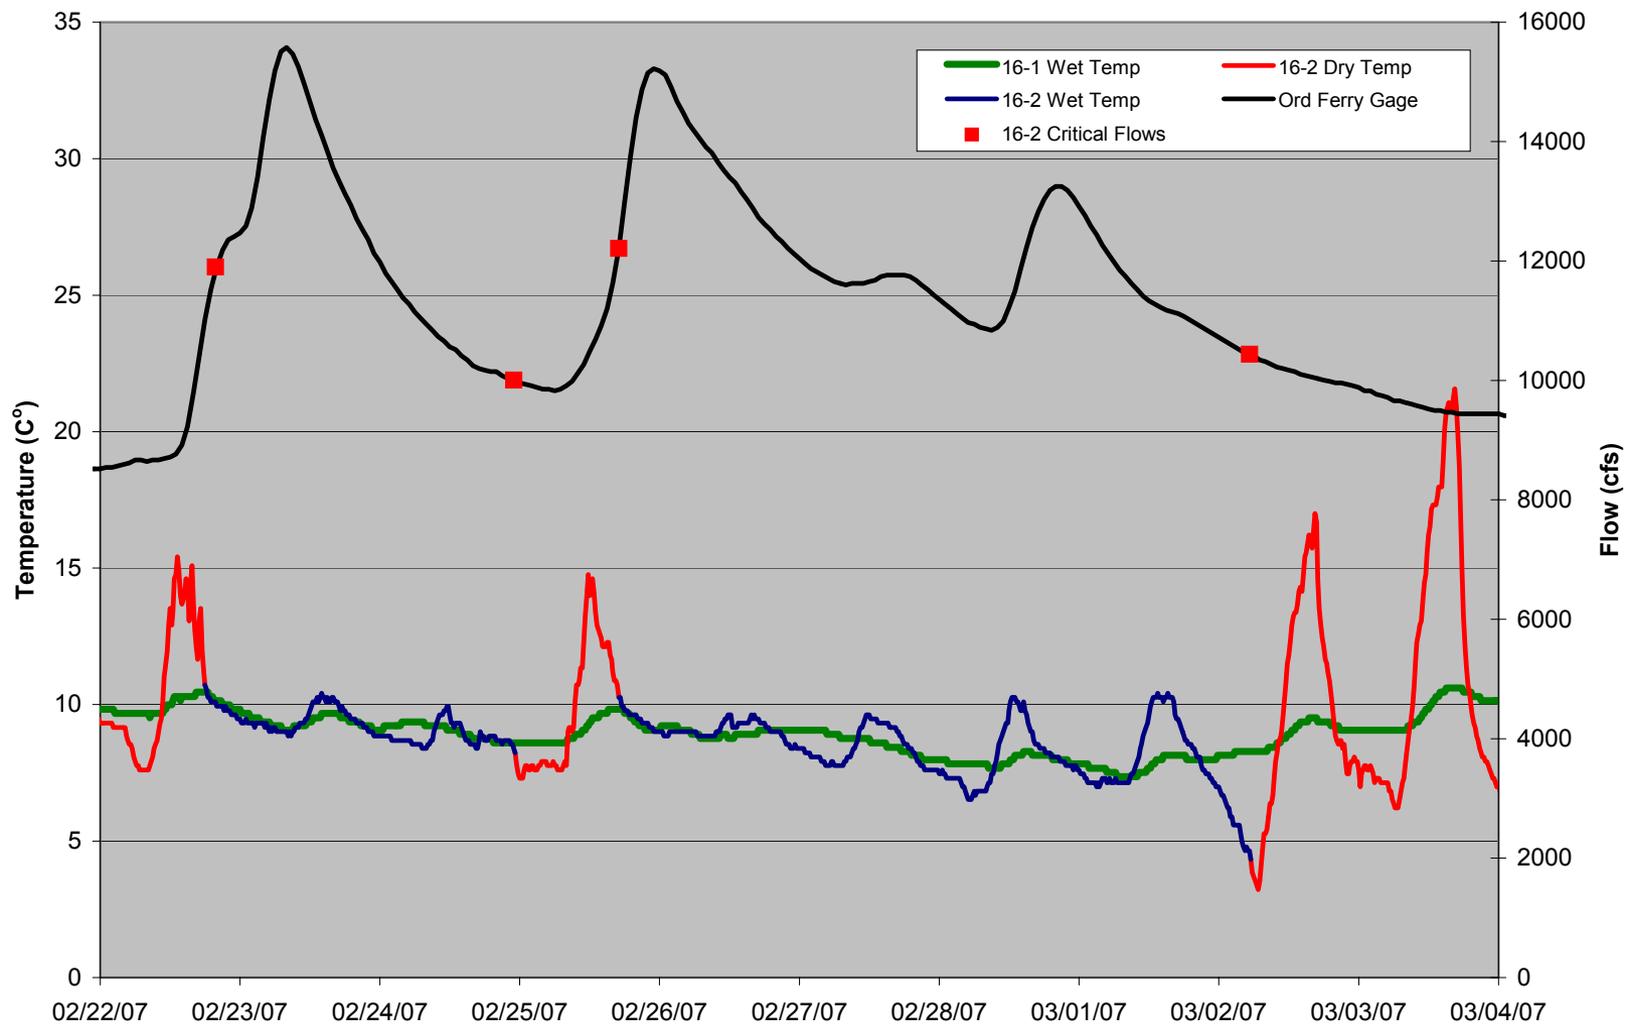
Site 16

Figure 27. Thermograph data for site 16 (RM 191L) and discharge at Ord Ferry between 2/22/07 and 3/4/07. Critical flow points depict thermograph changes between dry and wet status.

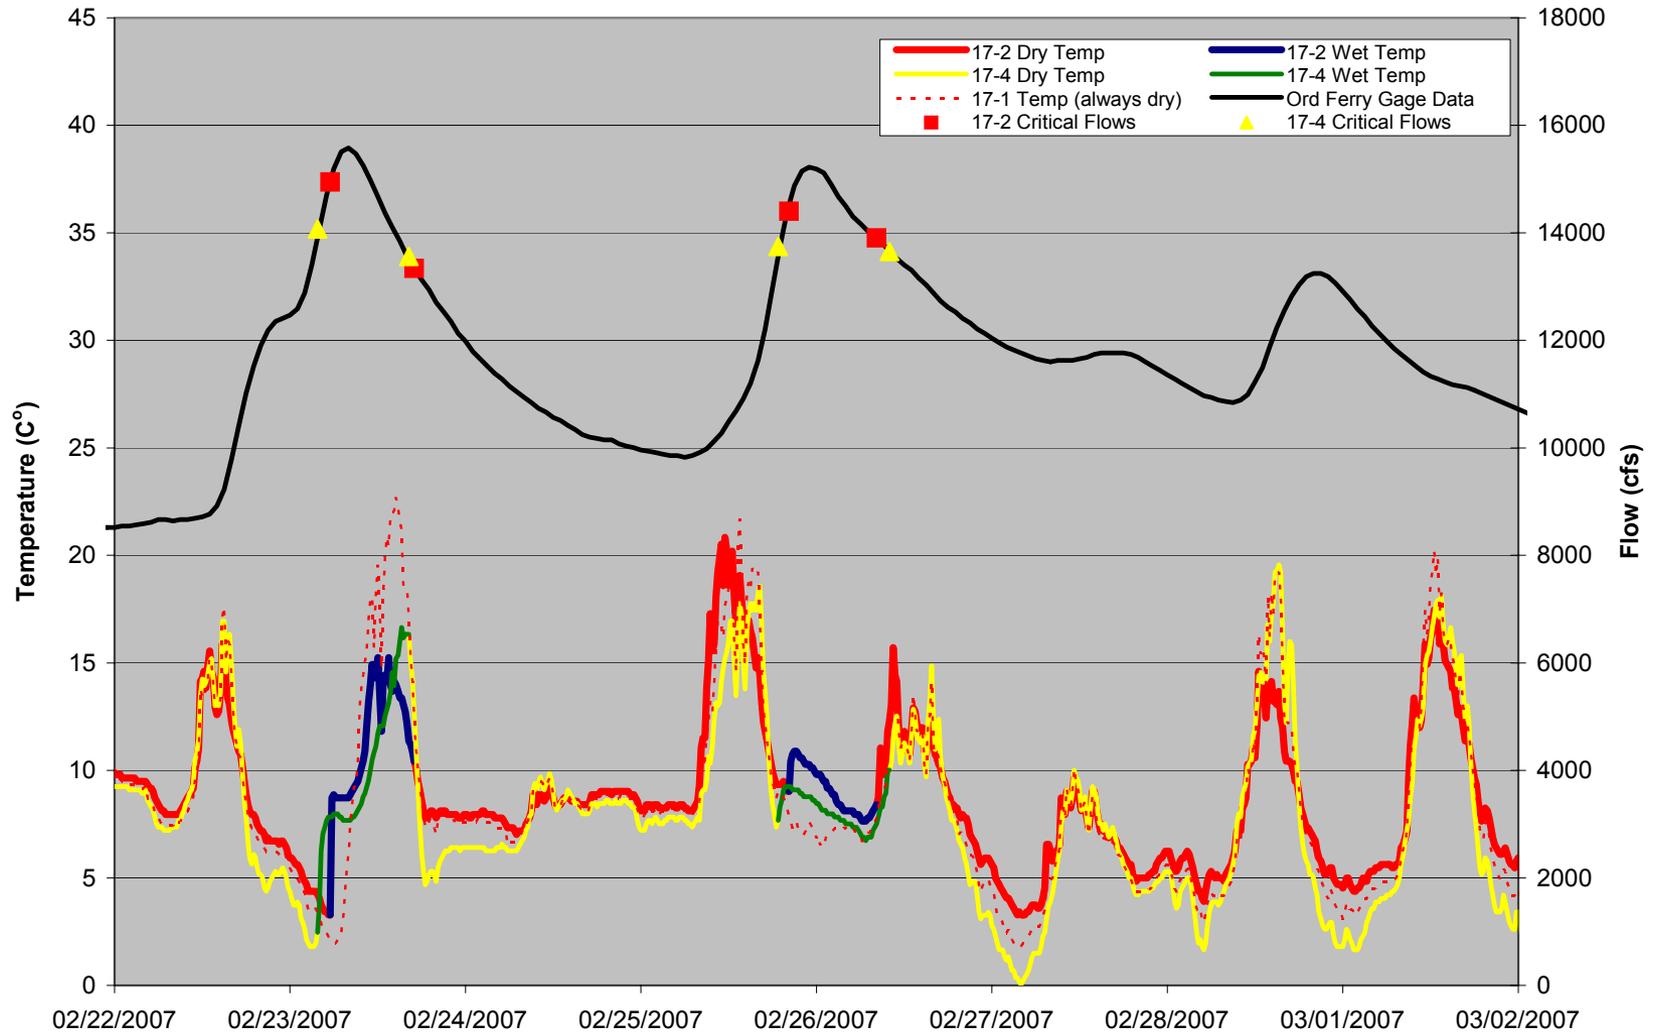
Site 17

Figure 29. Thermograph data for site 17 (RM 191.7R) and discharge at Ord Ferry between 2/22/07 and 3/2/07. Critical flow points depict thermograph changes between dry and wet status.

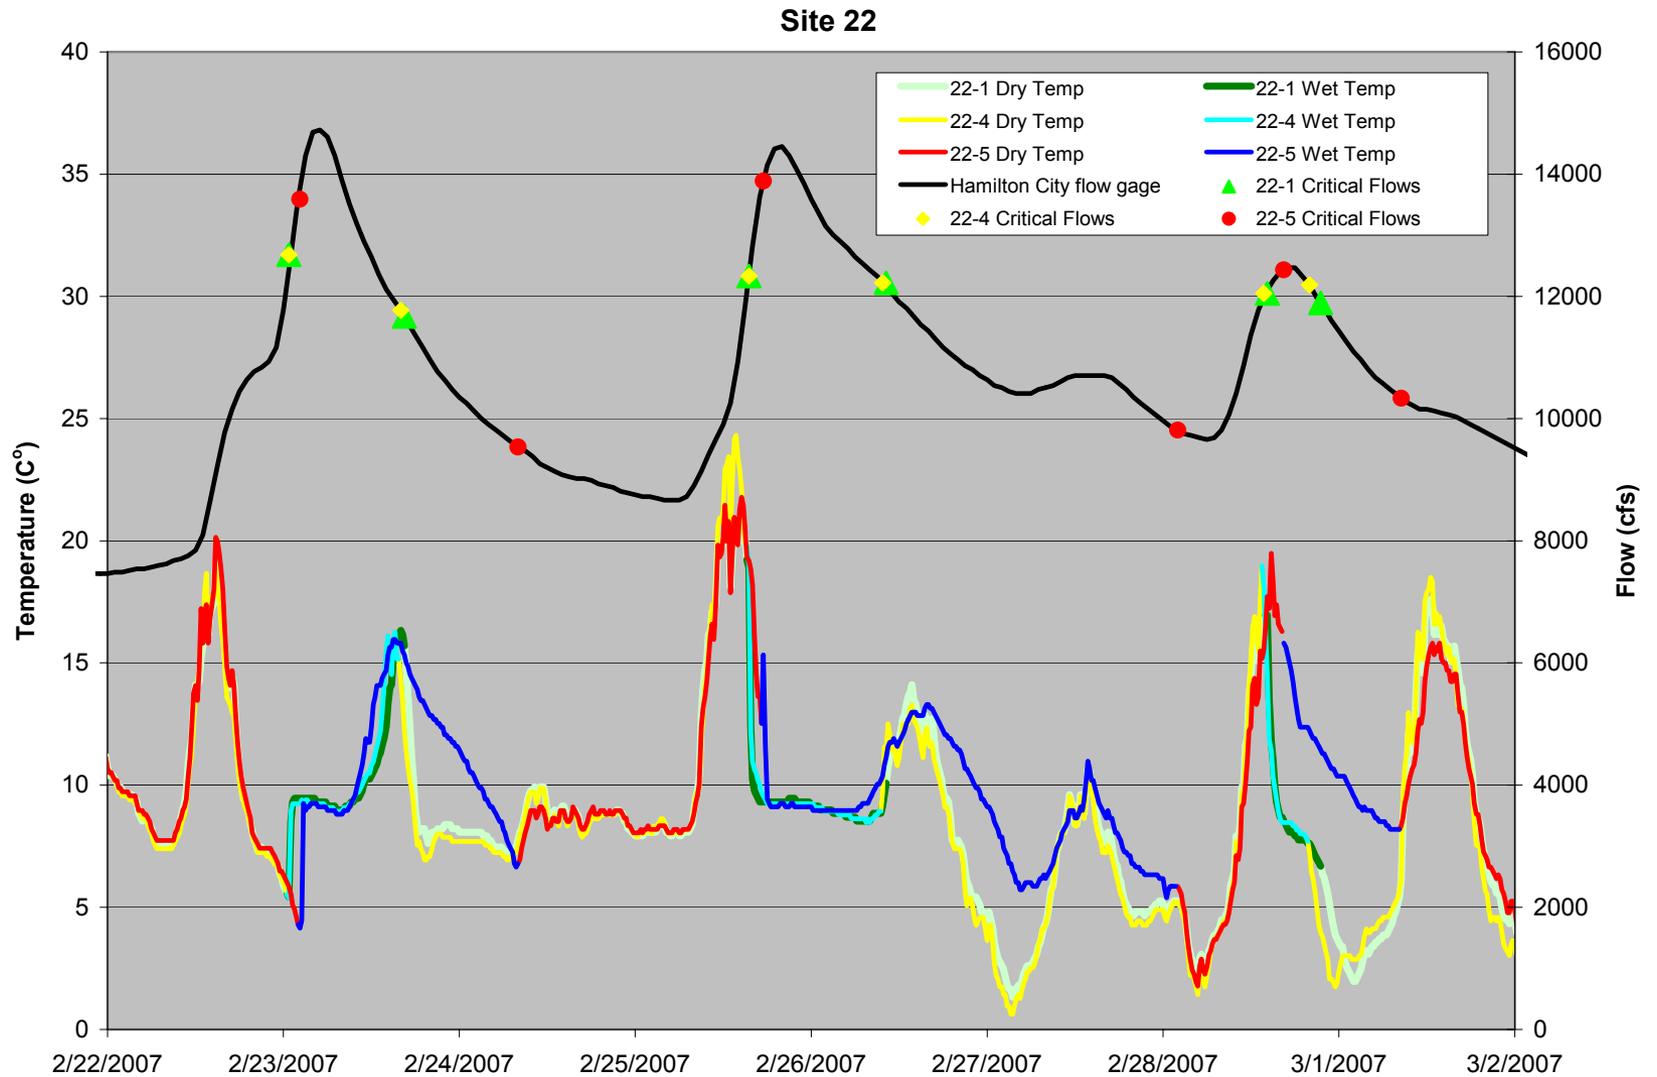
Figure 31. Thermograph data for site 22 (RM 203R) and discharge at Hamilton City between 2/22/07 and 3/2/07. Critical flow points depict thermograph changes between dry and wet status.

Chinook salmon and California Roach (*Lavinia symmetricus*) were observed in the isolated pools at this site. Small gravel and sand compose the majority of the substrate at site 22. *Ludwigia* is abundant in the small pools and throughout the site.

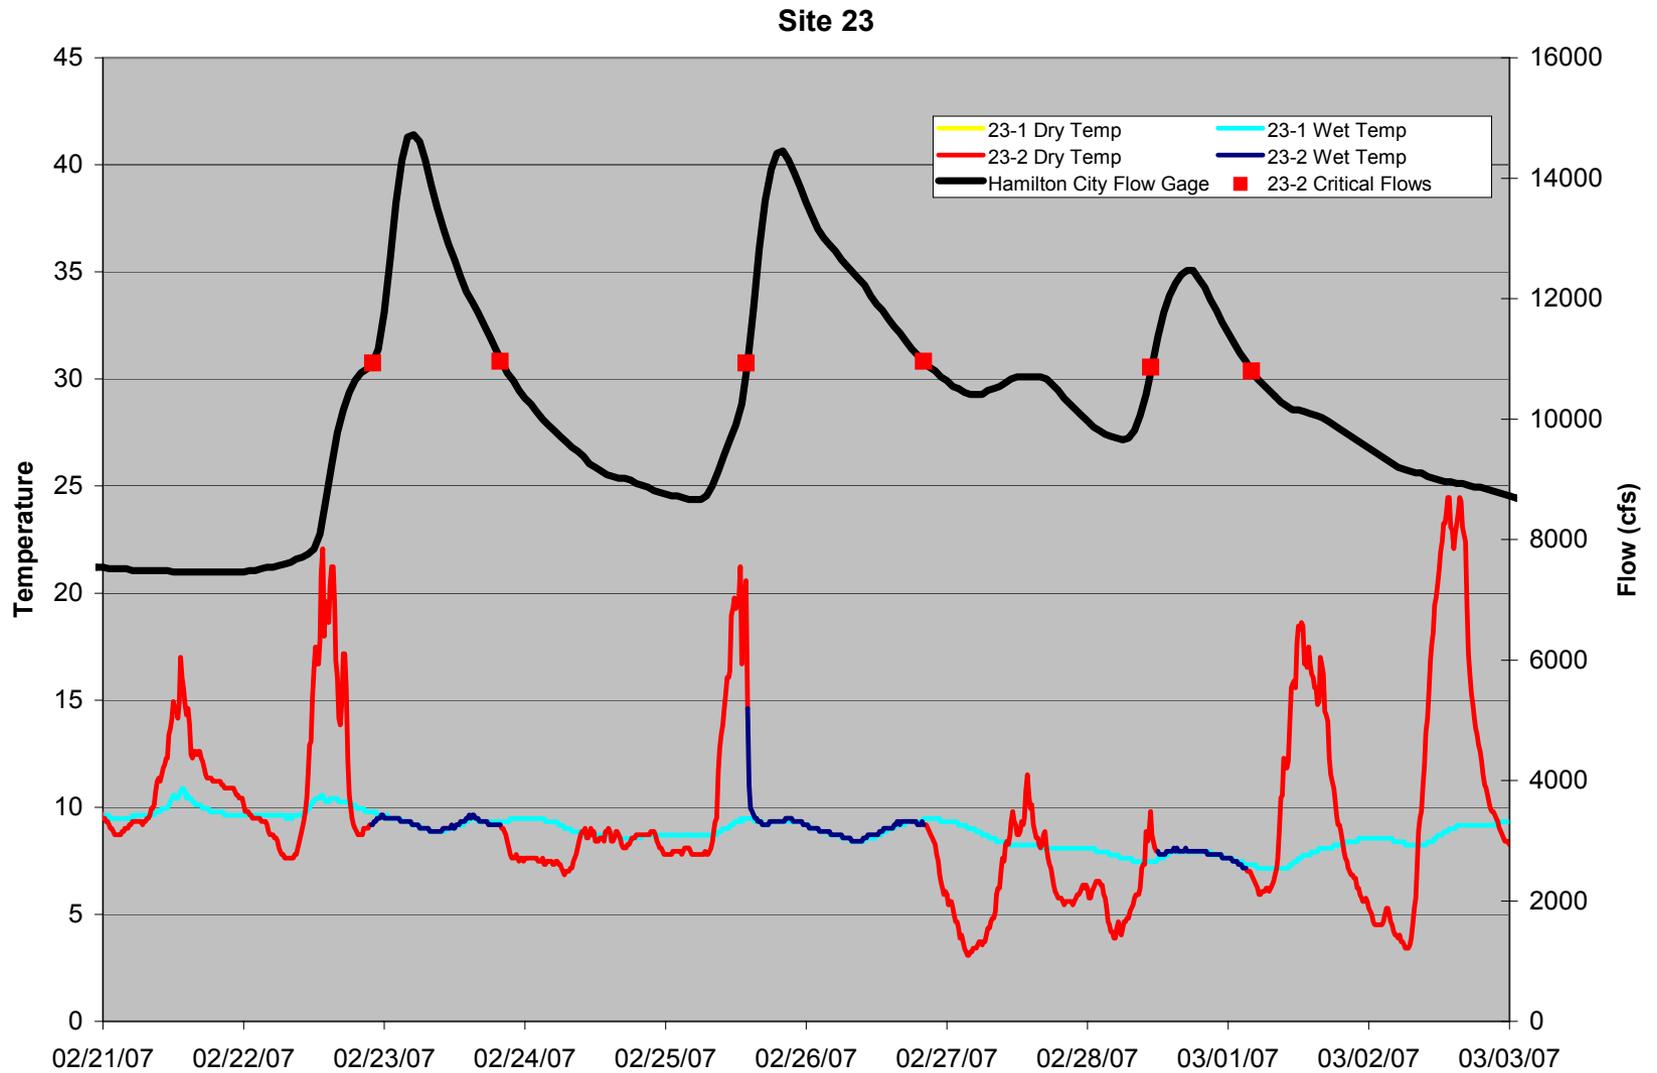
Figure 33. Thermograph data for site 23 (RM 203L) and discharge at Hamilton City between 2/21/07 and 3/3/07. Critical flow points depict thermograph changes between dry and wet status.
