Sacramento River Ecological Flows Study: Off-Channel Habitat Study Final Report

Kondolf, G. M. and Stillwater Sciences. 2007. Sacramento River Ecological Flows Study: Off-Channel Habitat Study Results. Technical Report prepared for The Nature Conservancy, Chico, California by G. Mathias Kondolf and Stillwater Sciences, Berkeley, California

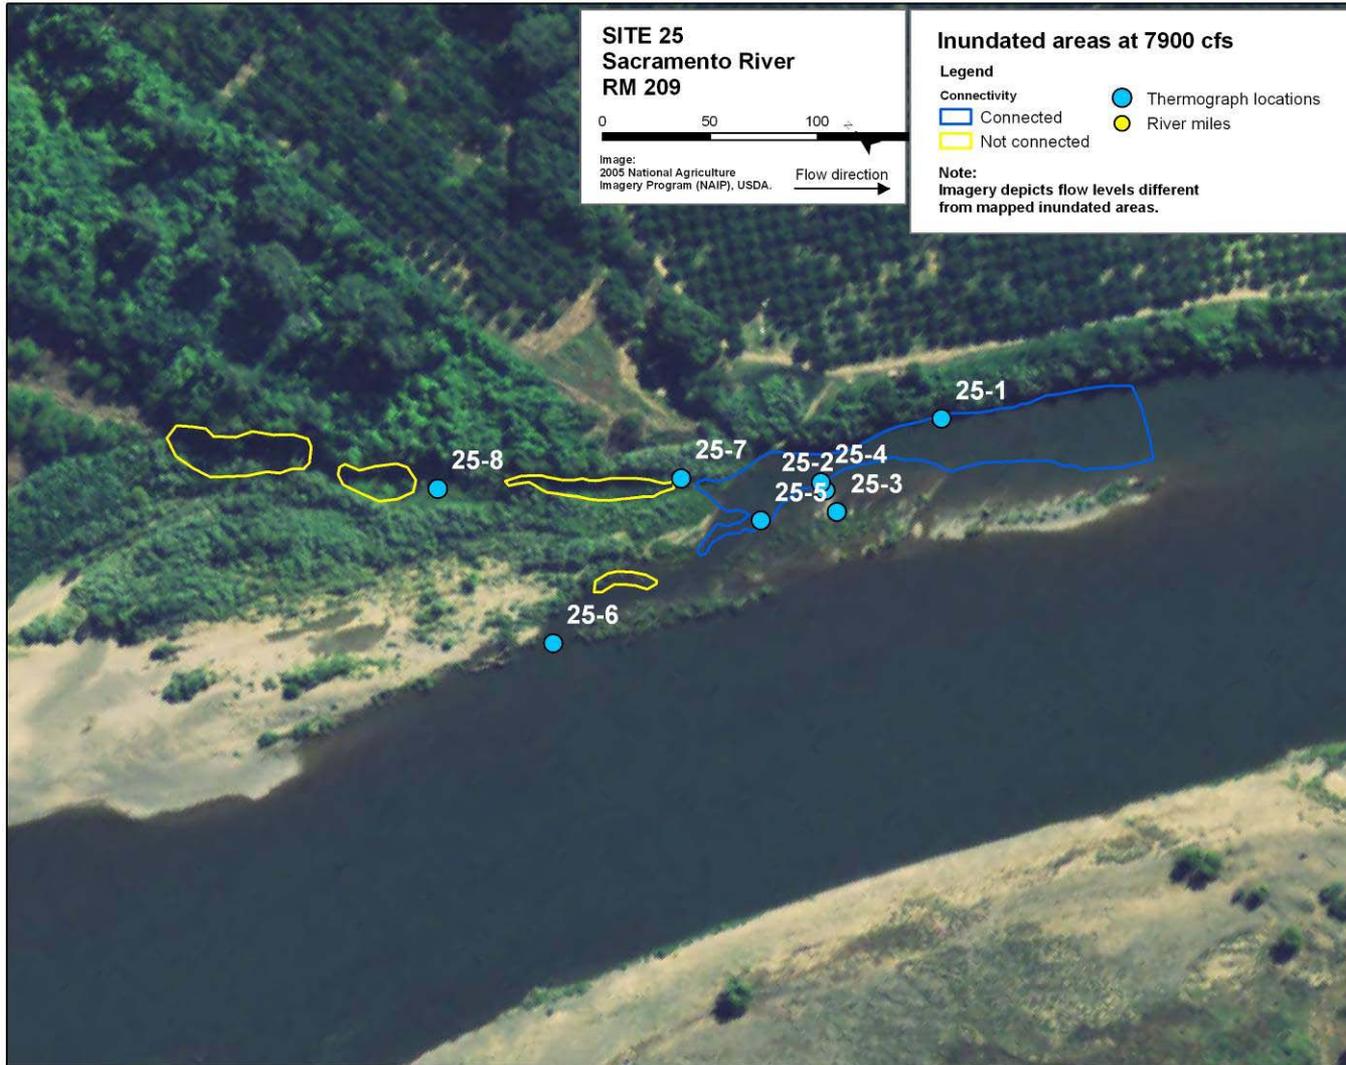
Figure 34a. Inundated areas of site 25 (RM 209L) at flows of 7,900 cfs, areas observed and drawn during field mapping.

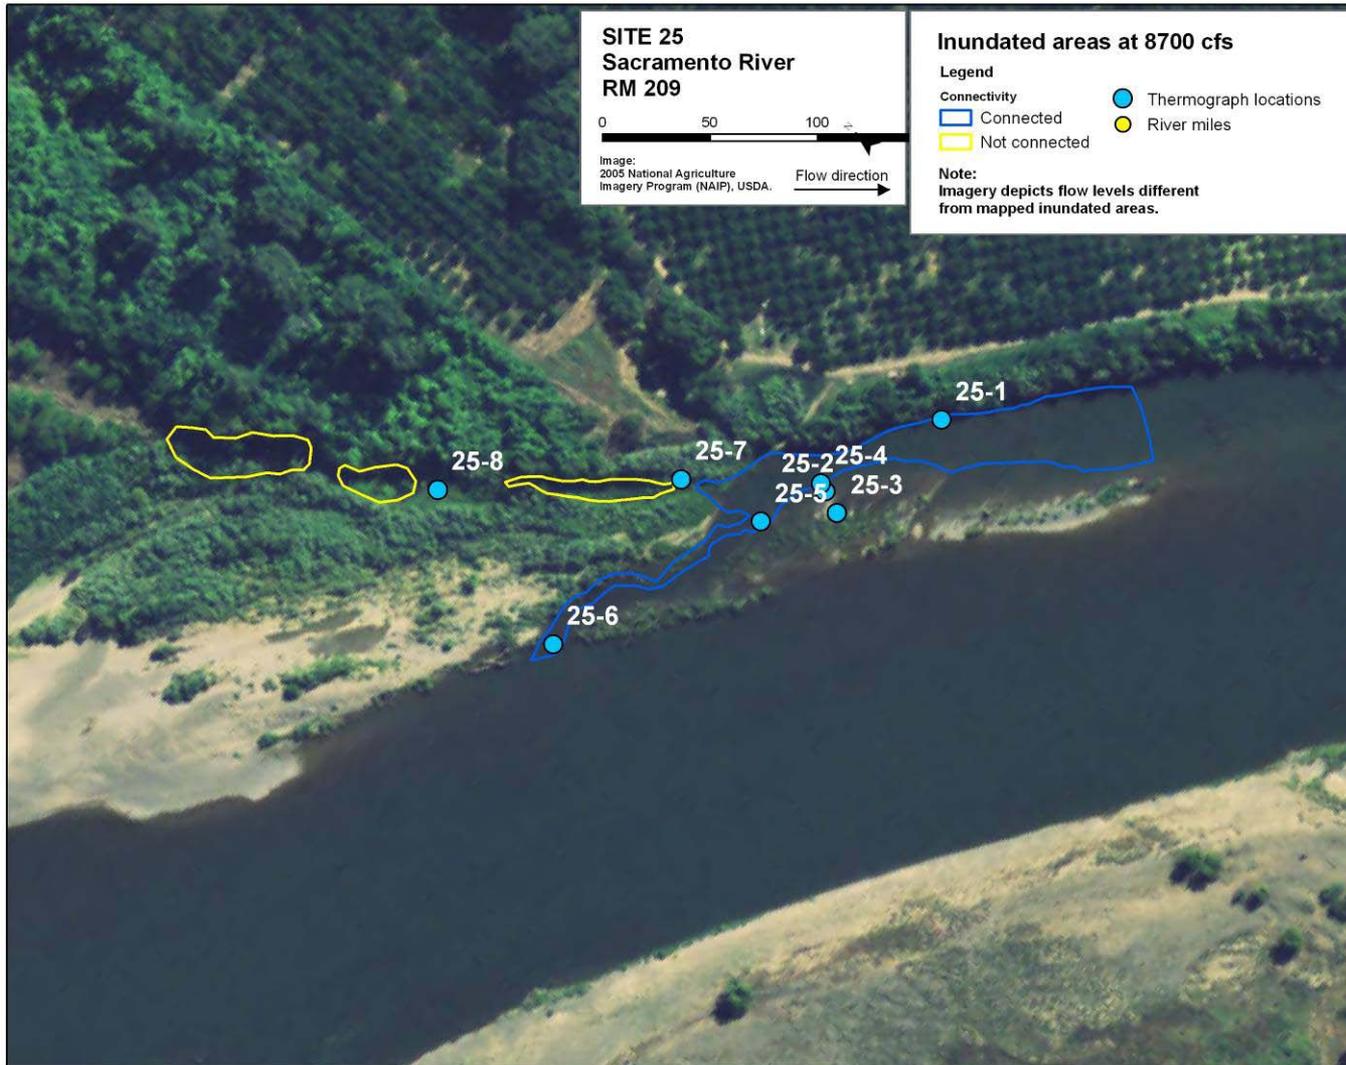
Figure 34b. Inundated areas of site 25 (RM 209L) at flows of 8,700 cfs, areas observed and drawn during field mapping.

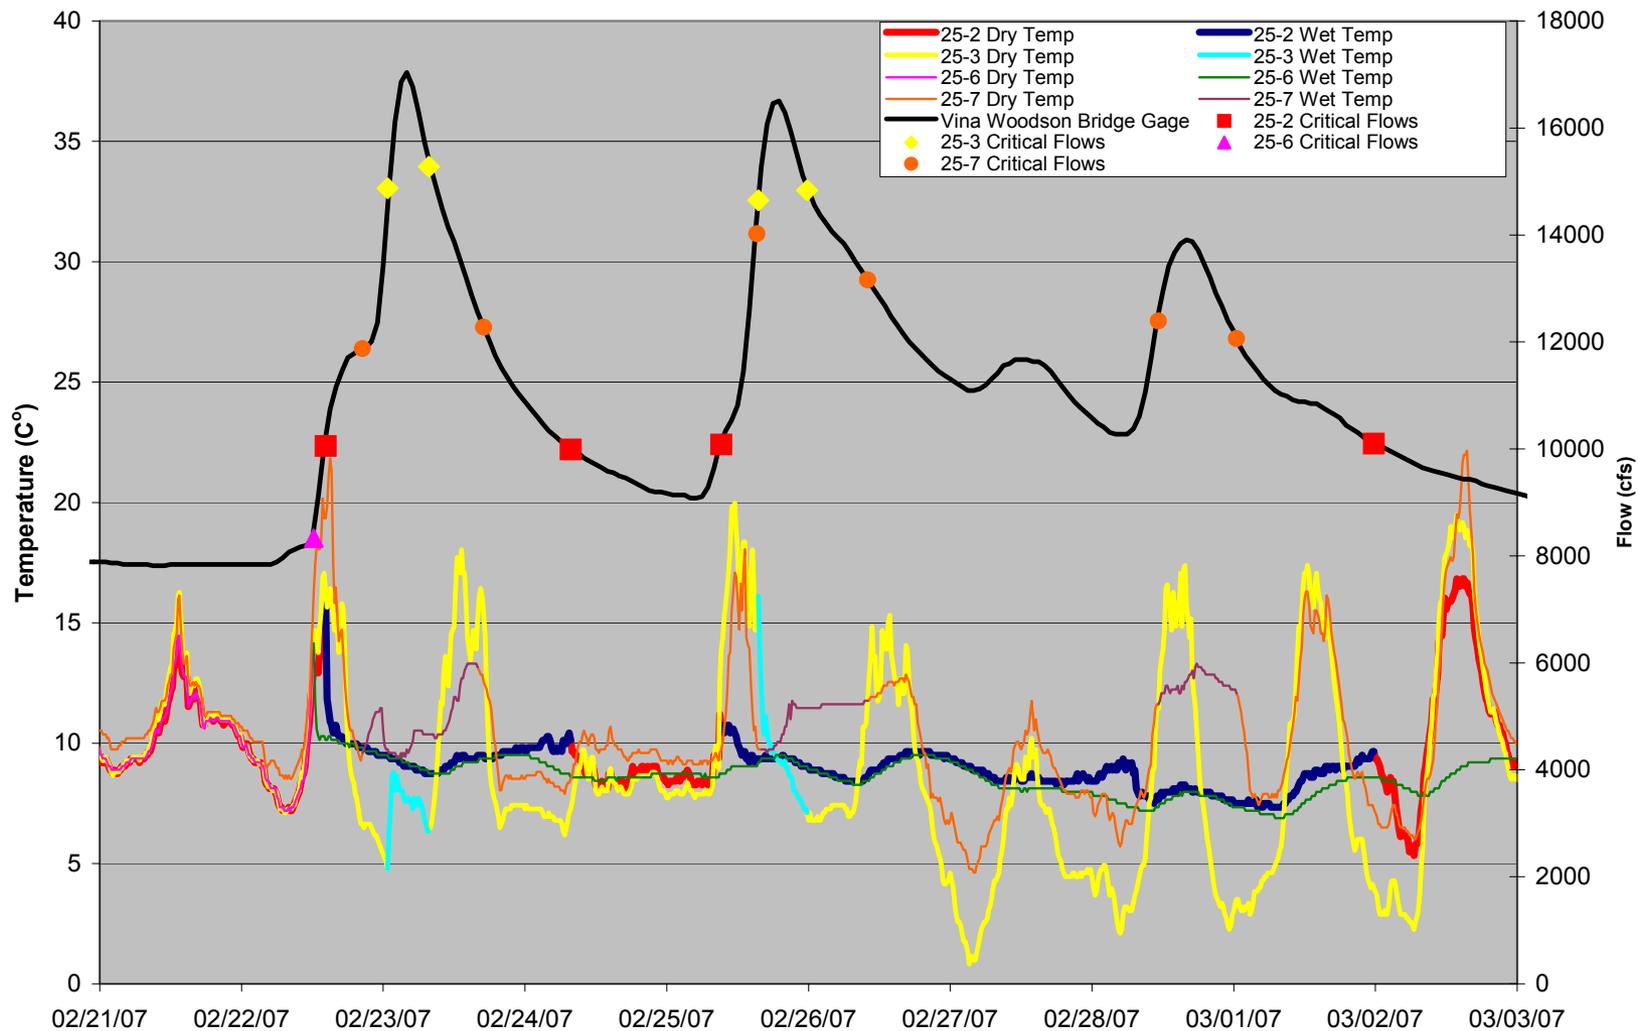
Site 25

Figure 36. Thermograph data for site 25 (RM 209L) and discharge at Vina Woodson Bridge between 2/21/07 and 3/3/07. Critical flow points depict thermograph changes between dry and wet status.

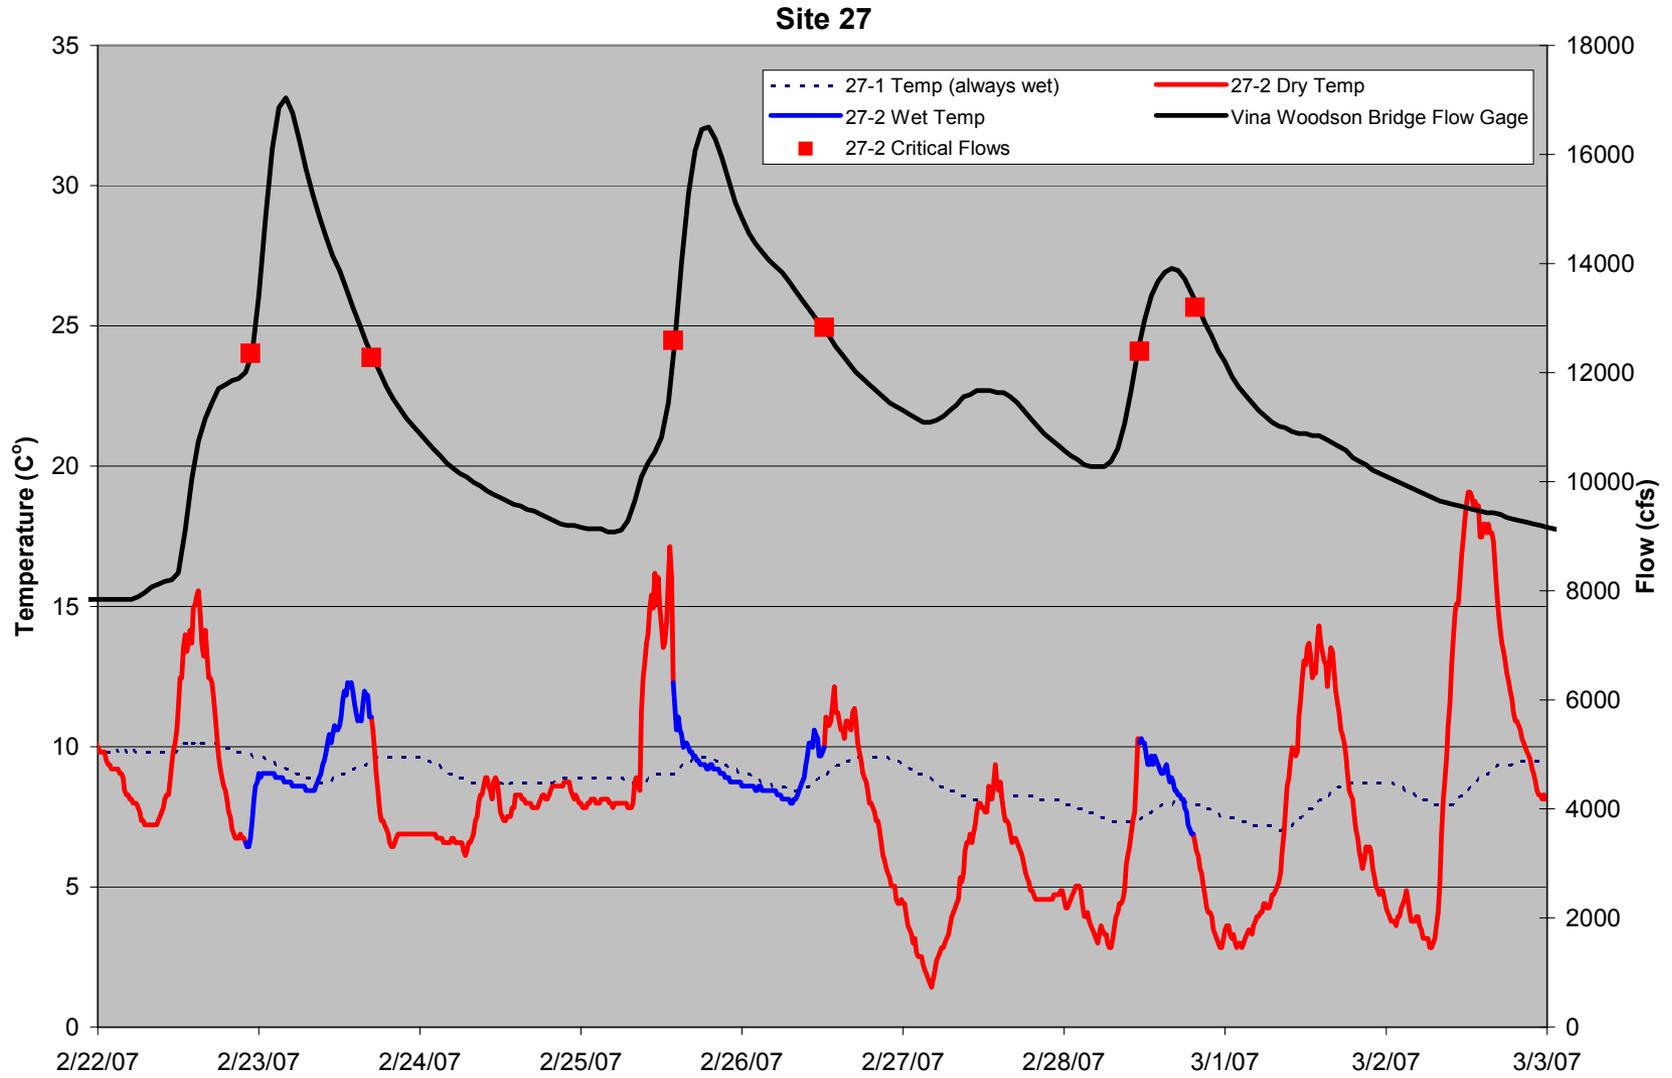
Figure 38. Thermograph data for site 27 (RM 211L) and discharge at Vina Woodson Bridge between 2/22/07 and 3/3/07. Critical flow points depict thermograph changes between dry and wet status.

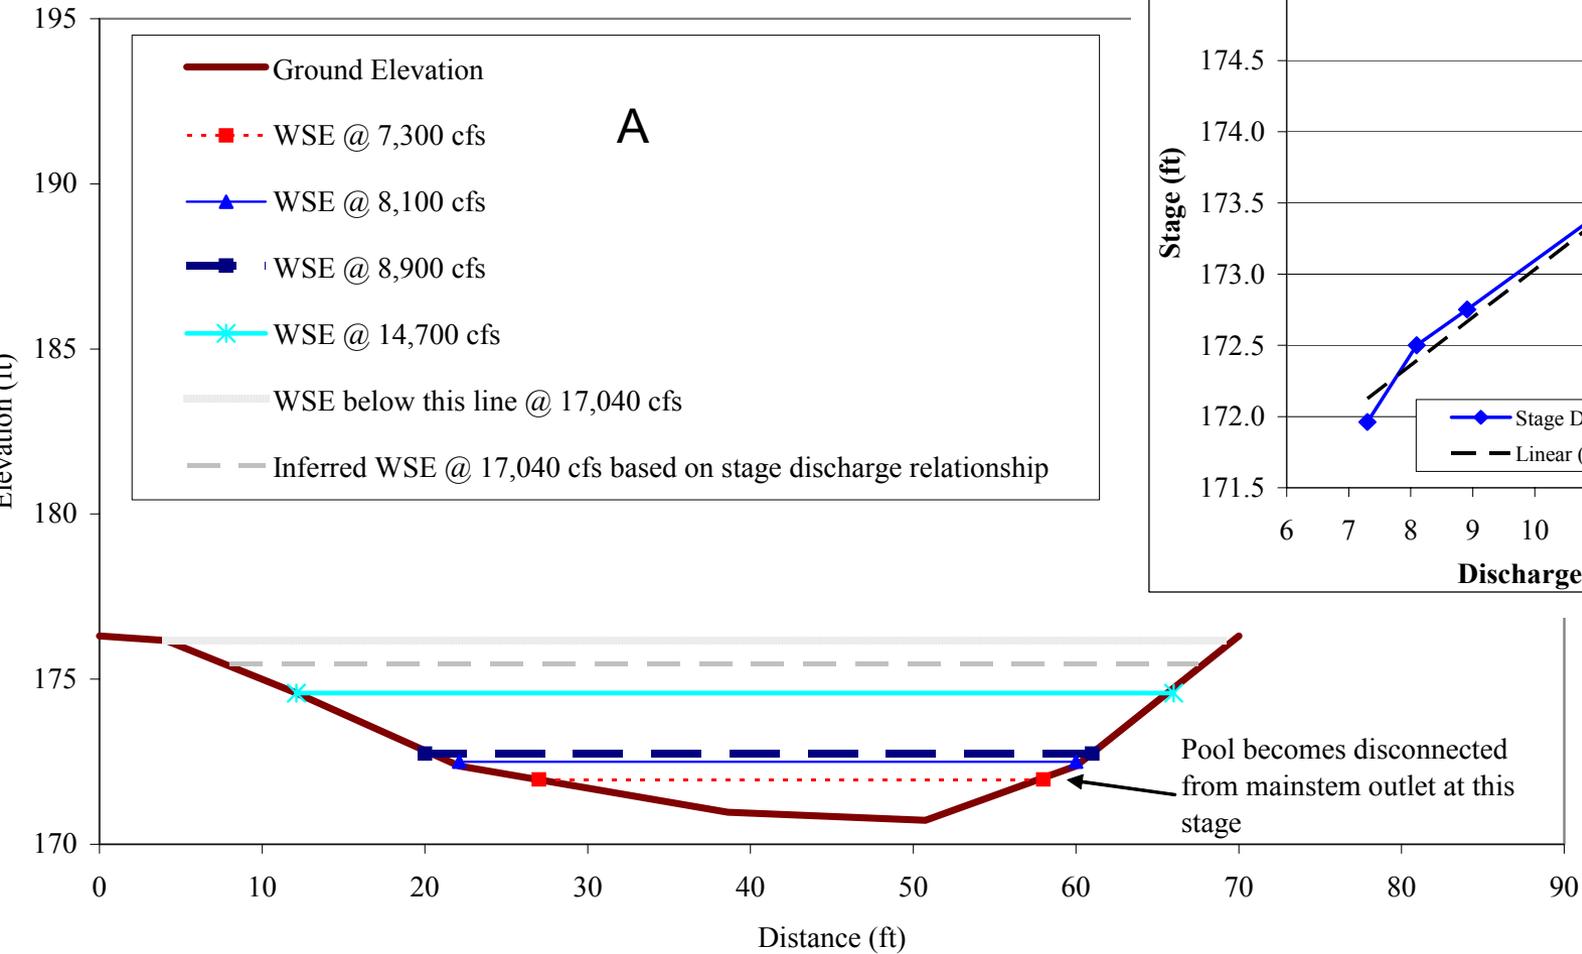
XS Plot for OCWB Study Site 33, Sacramento River RM 235.3

Figure 40. Study site 33 (RM 221.6R) , (A) cross section plot with known water surface elevations, and (B) plot of stage – discharge relationships at cross section.

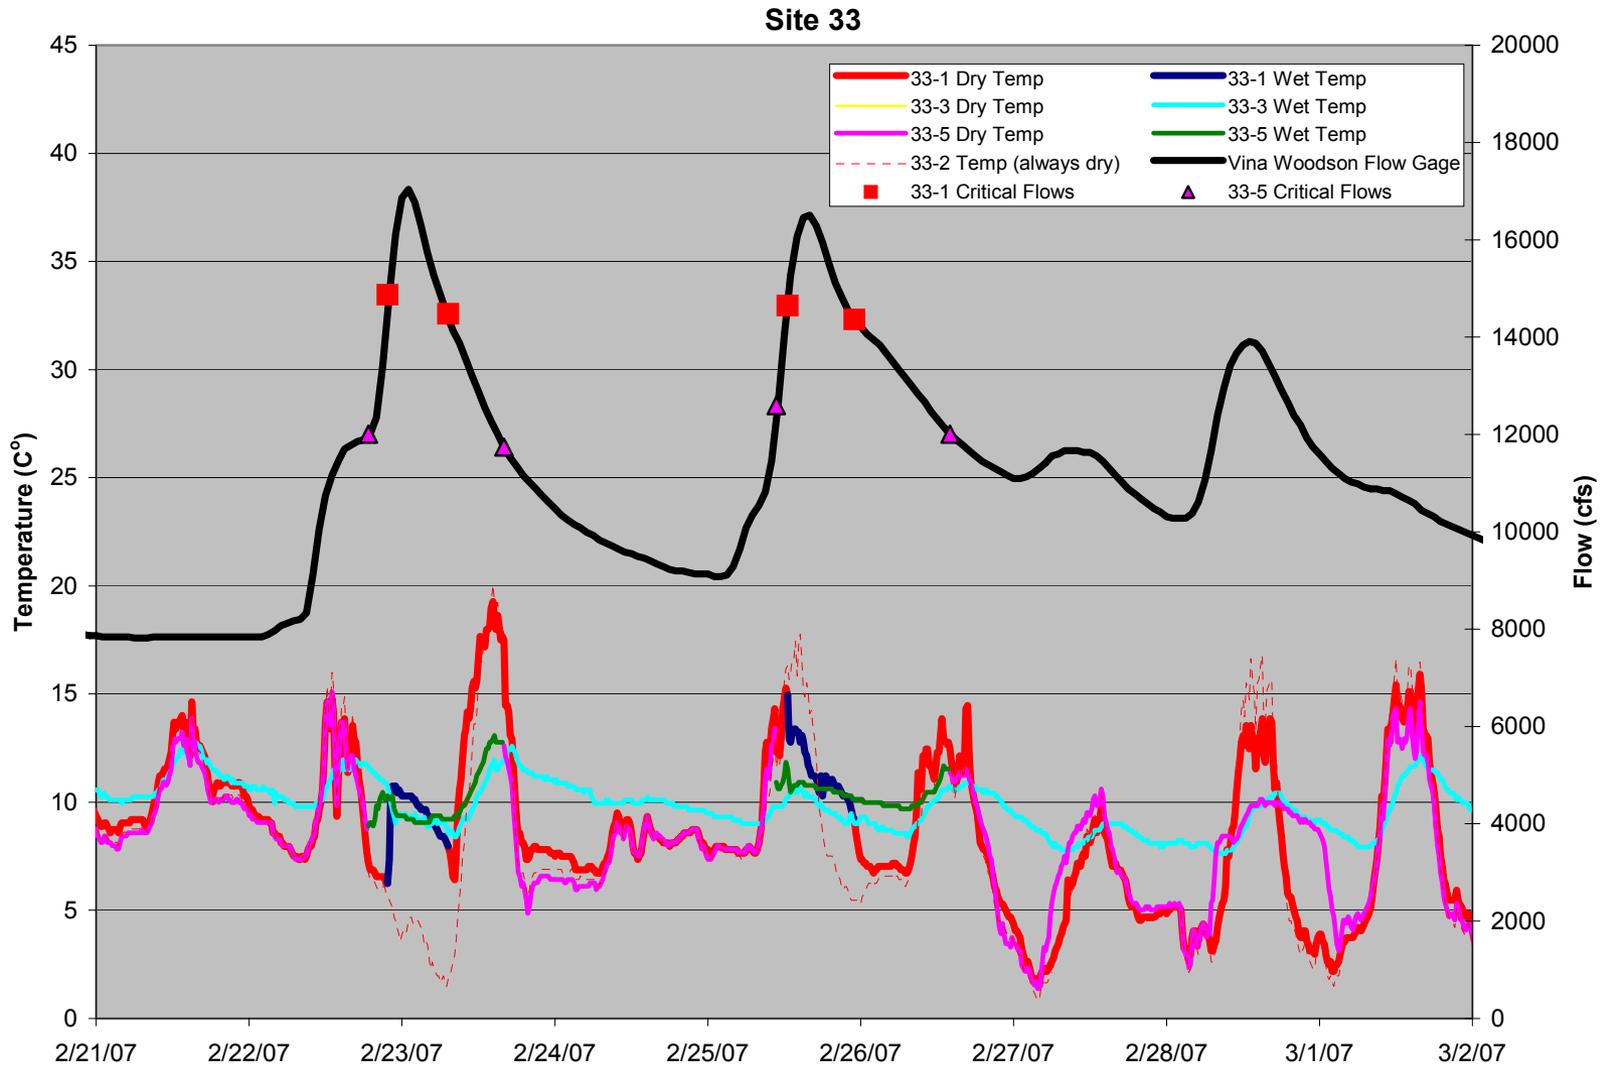
Figure 41. Thermograph data for site 33 (RM 221.6R) and discharge at Vina Woodson Bridge between 2/21/07 and 3/2/07. Critical flow points depict thermograph changes between dry and wet status.

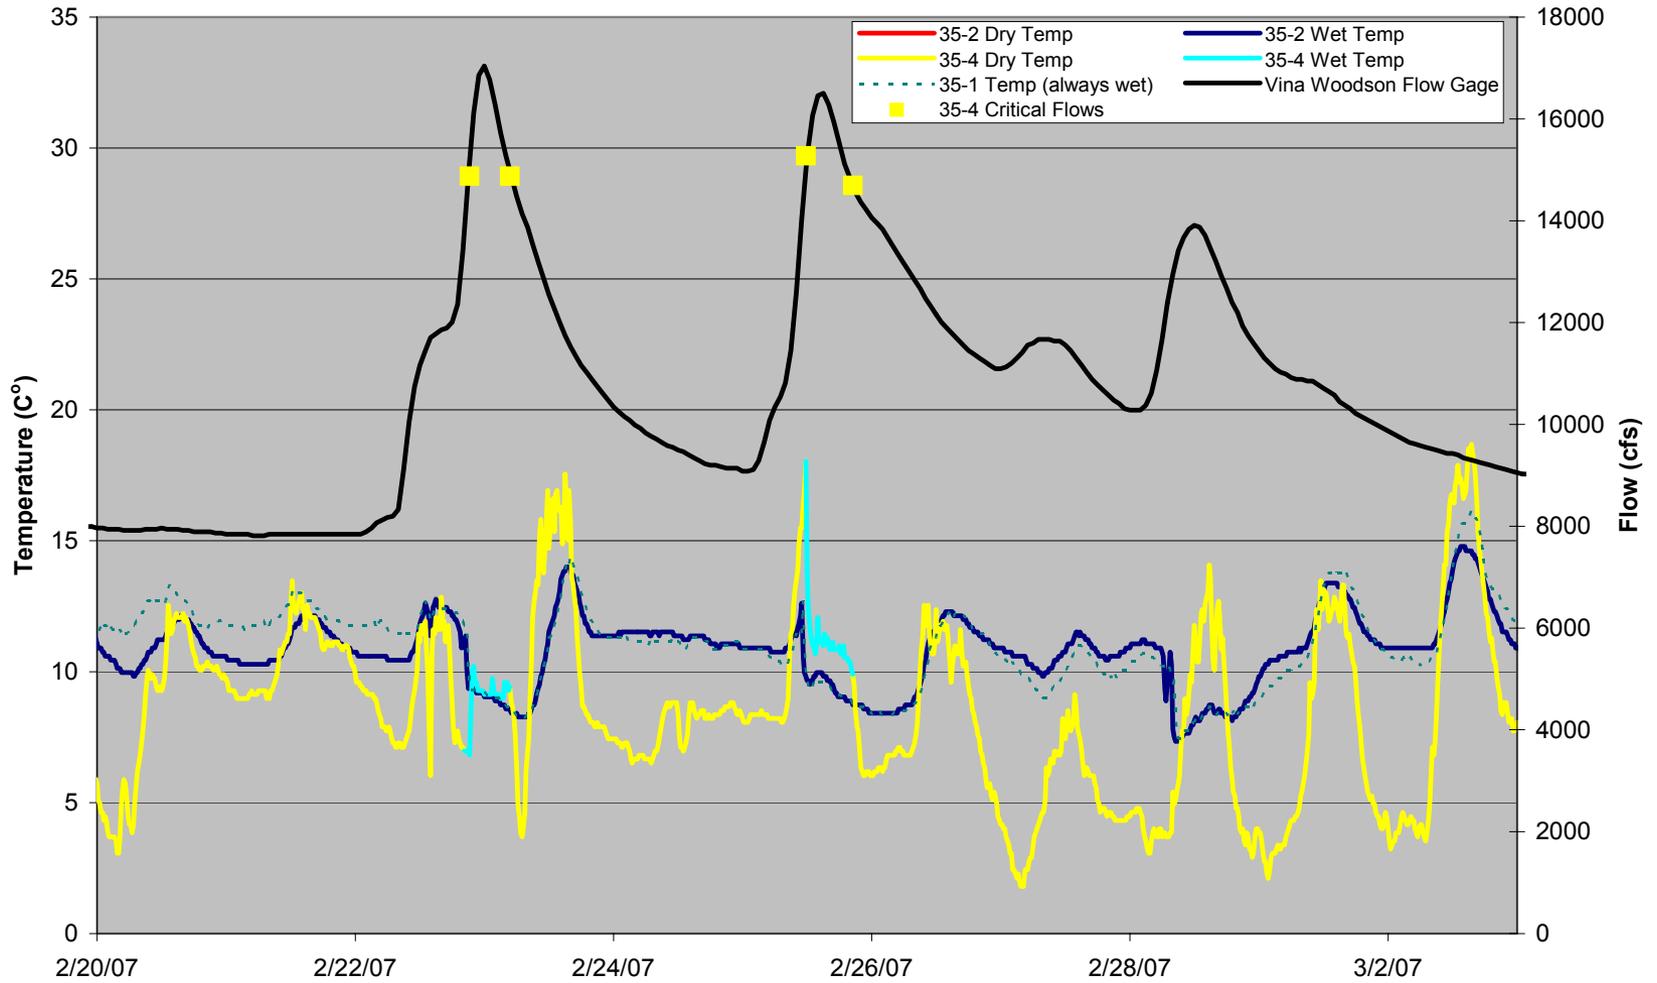
Site 35

Figure 44. Thermograph data for site 35 (RM 226.5L) and discharge at Vina Woodson Bridge between 2/20/07 and 3/3/07. Critical flow points depict thermograph changes between dry and wet status.

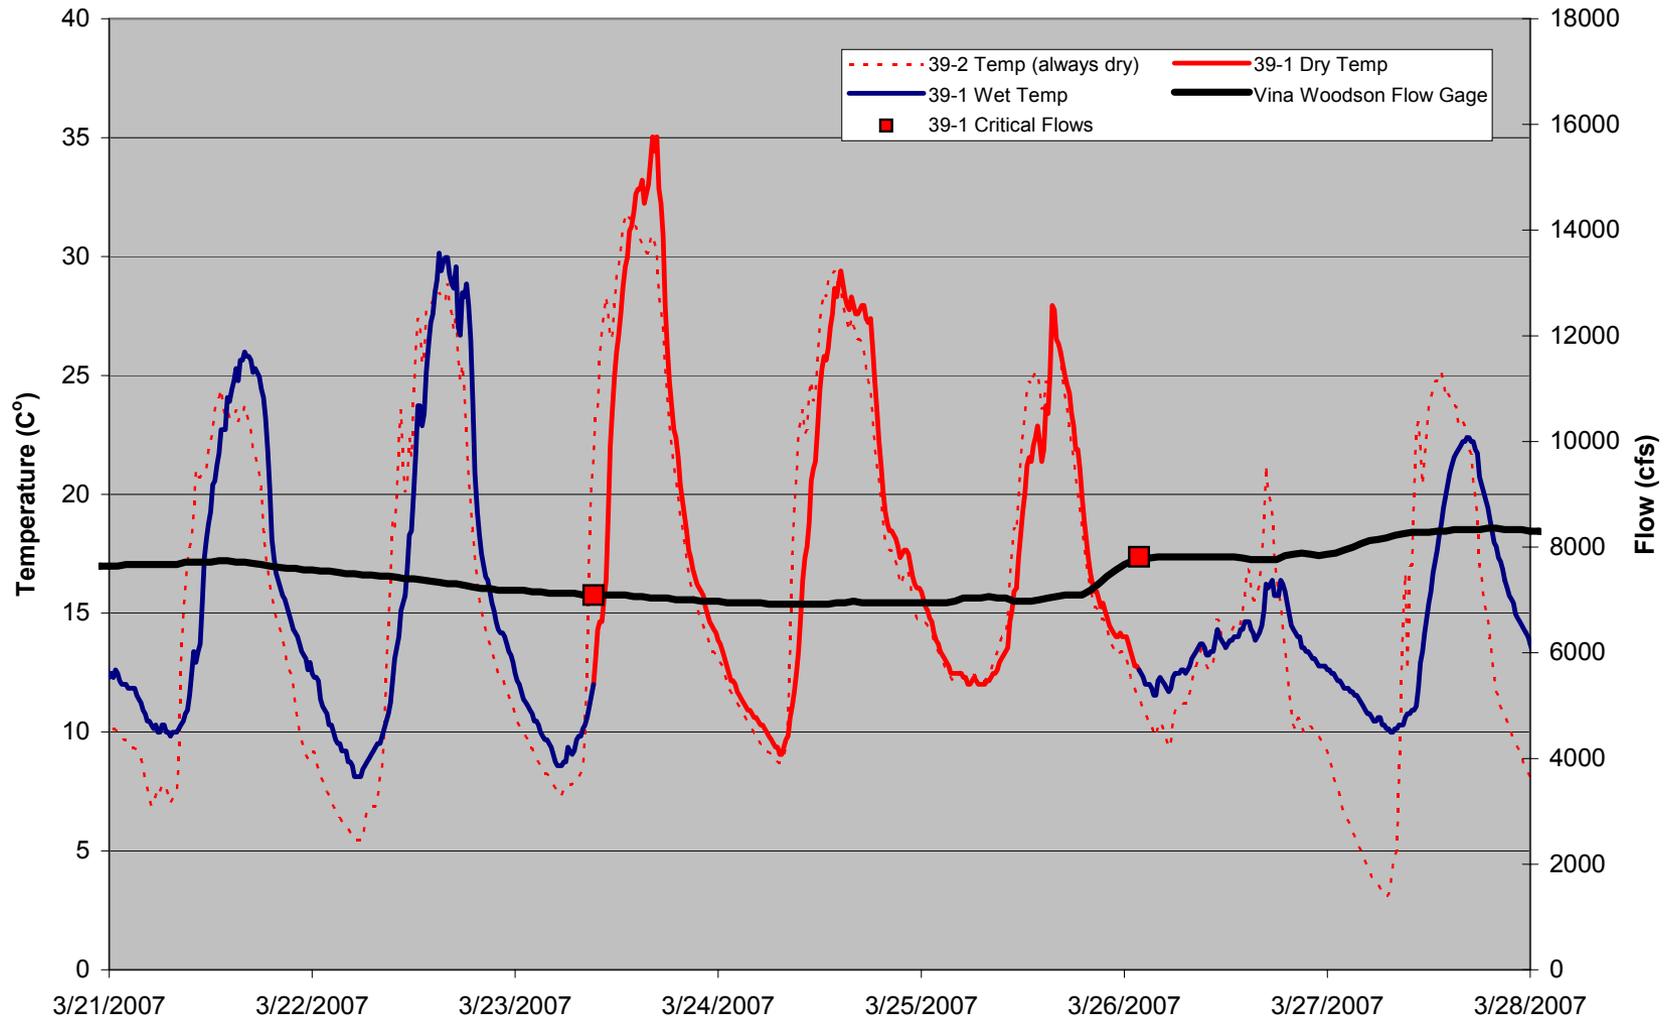
Site 39

Figure 46. Thermograph data for site 39 (RM 232.8L) and discharge at Vina Woodson Bridge between 3/21/07 and 3/28/07. Critical flow points depict thermograph changes between dry and wet status.

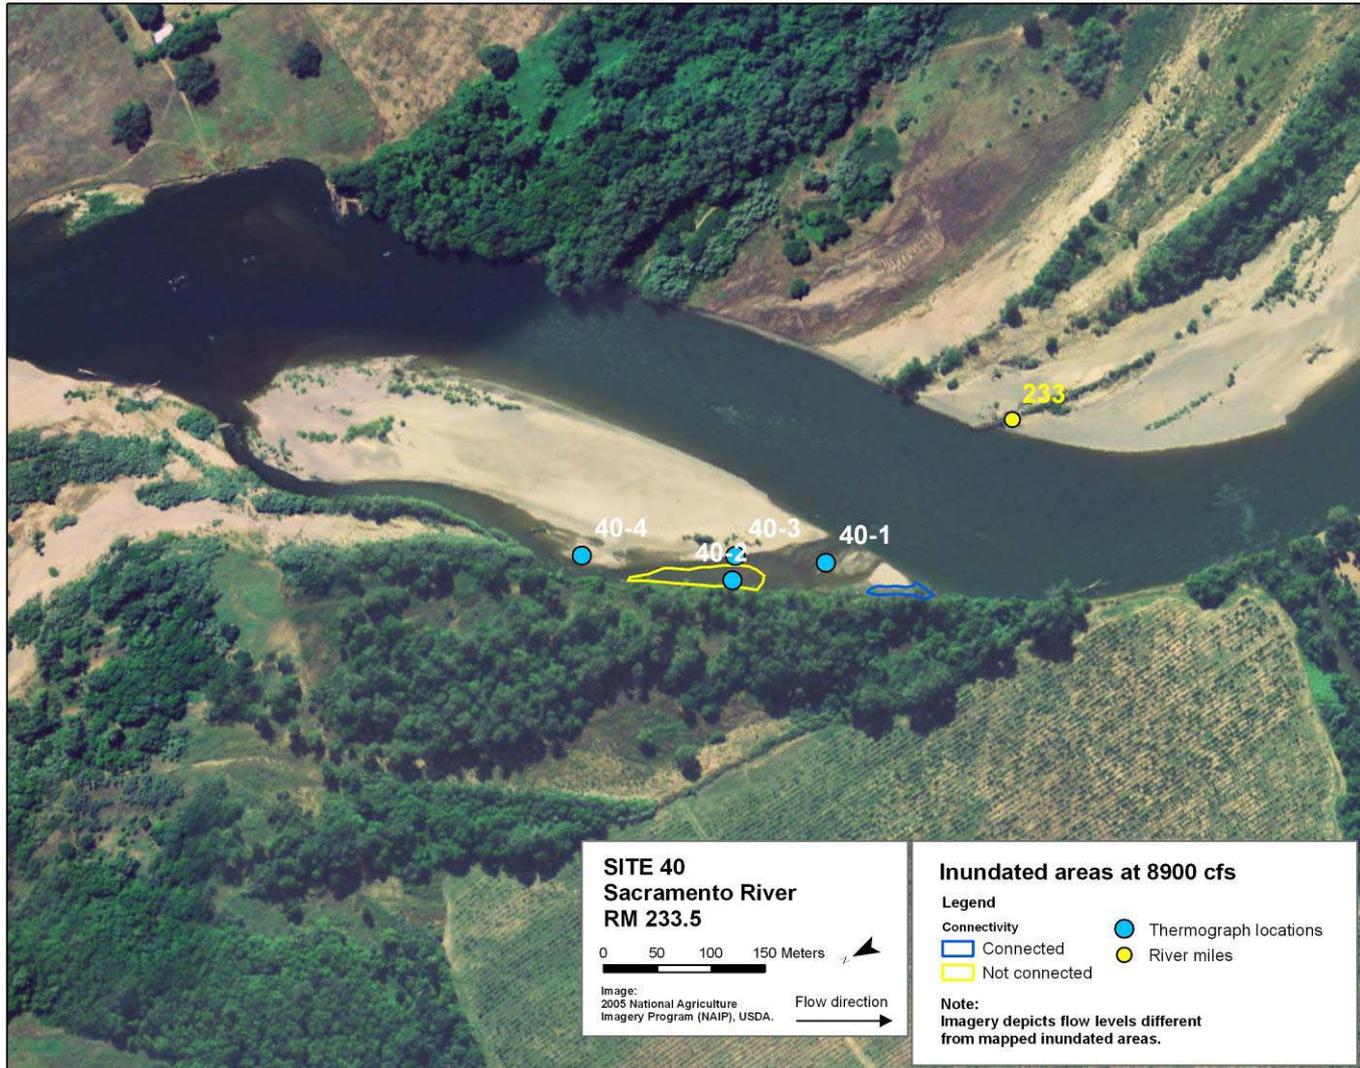
Figure 47a. Inundated areas of site 40 (RM 233.5R) at flows of 8,900 cfs , areas observed and drawn during field mapping.

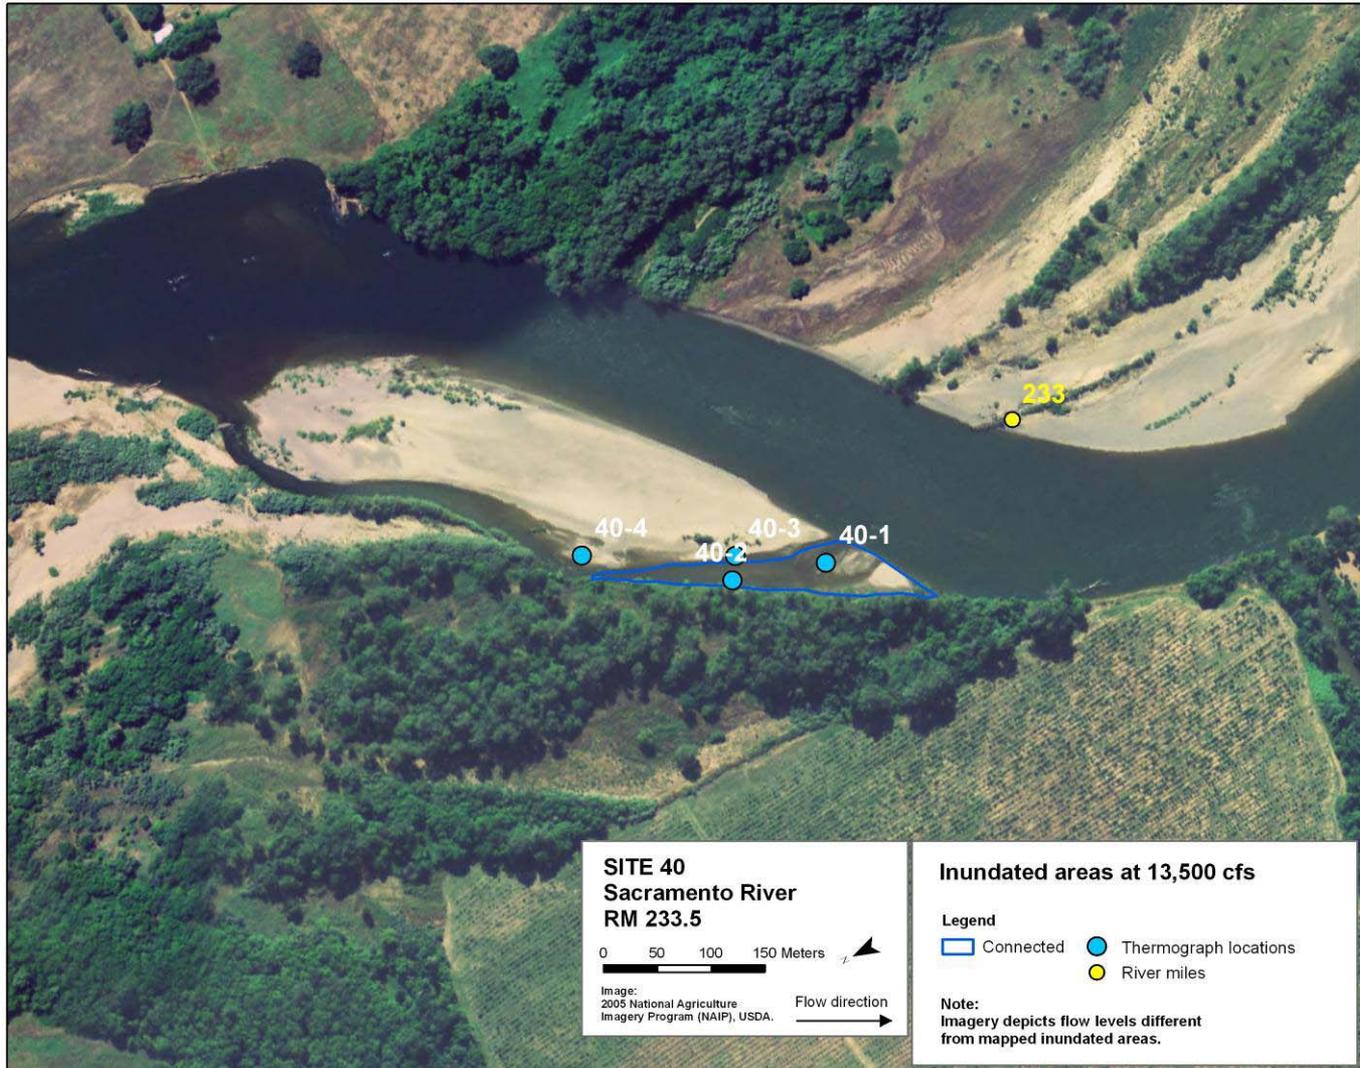
Figure 47b. Inundated areas of site 40 (RM 233.5R) at flows of 13,500 cfs , areas based on thermograph temperature records and field surveys.

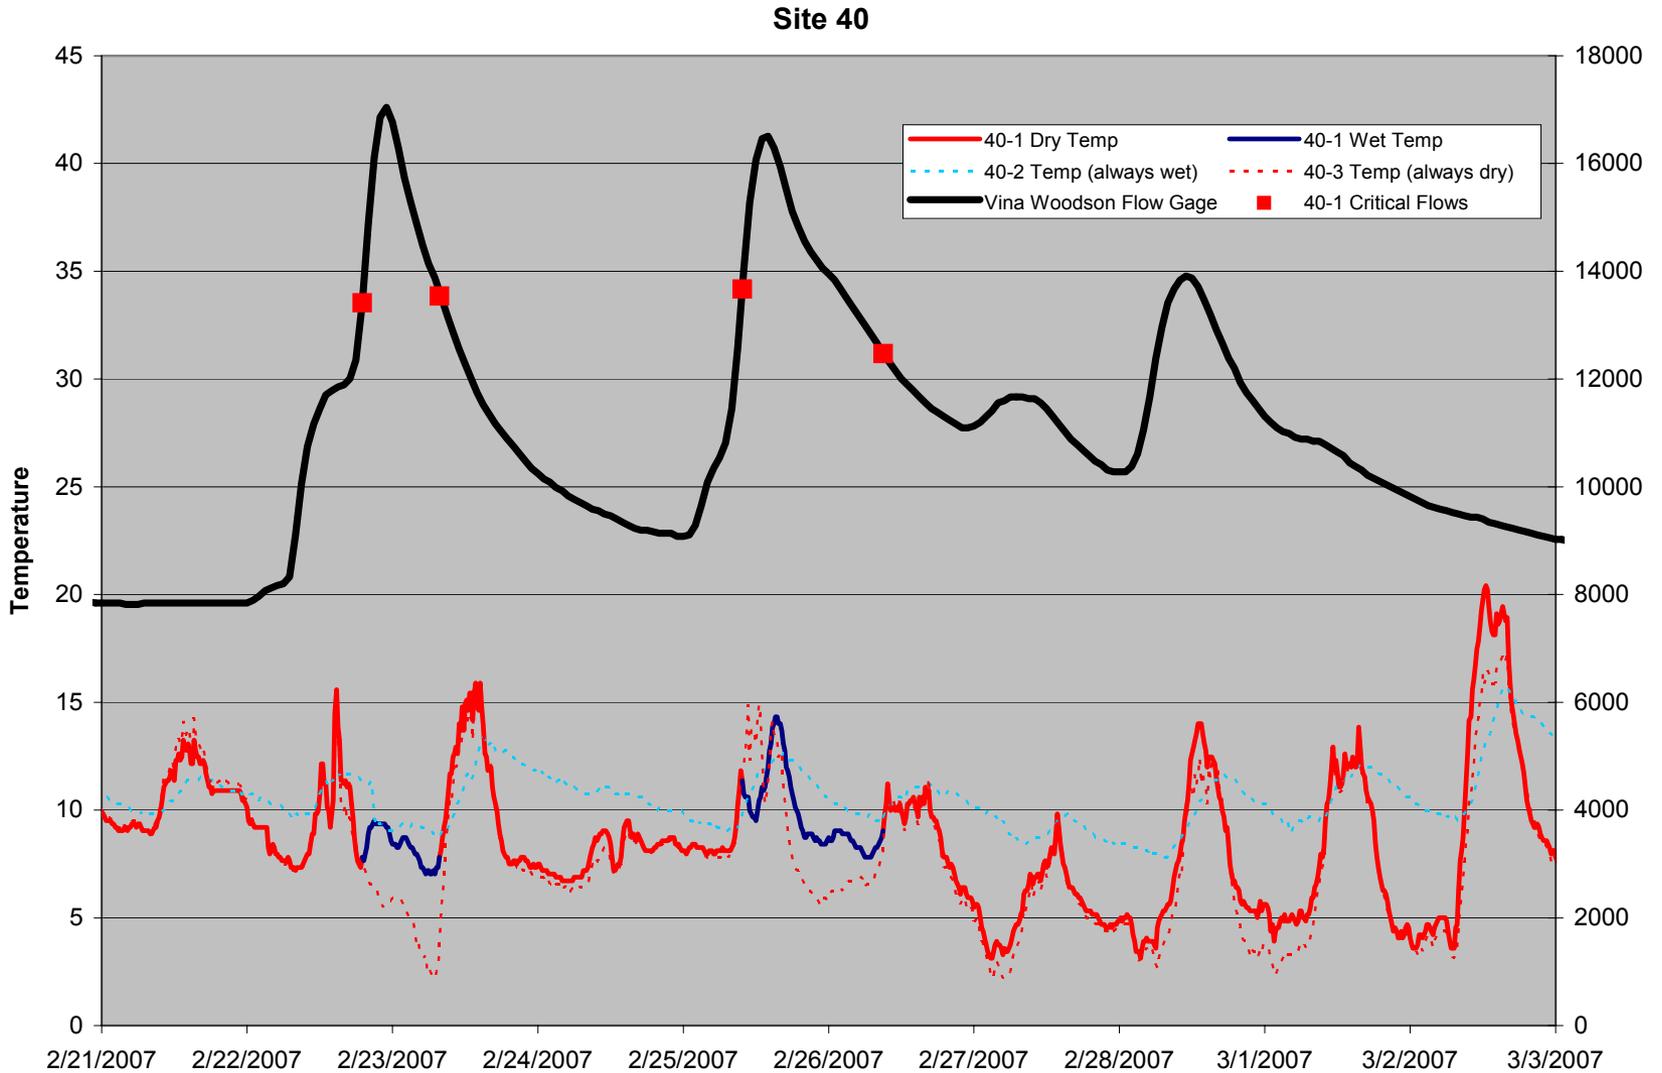
Figure 48. Thermograph data for site 40 (RM 233.5R) and discharge at Vina Woodson Bridge between 2/21/07 and 3/3/07. Critical flow points depict thermograph changes between dry and wet status.

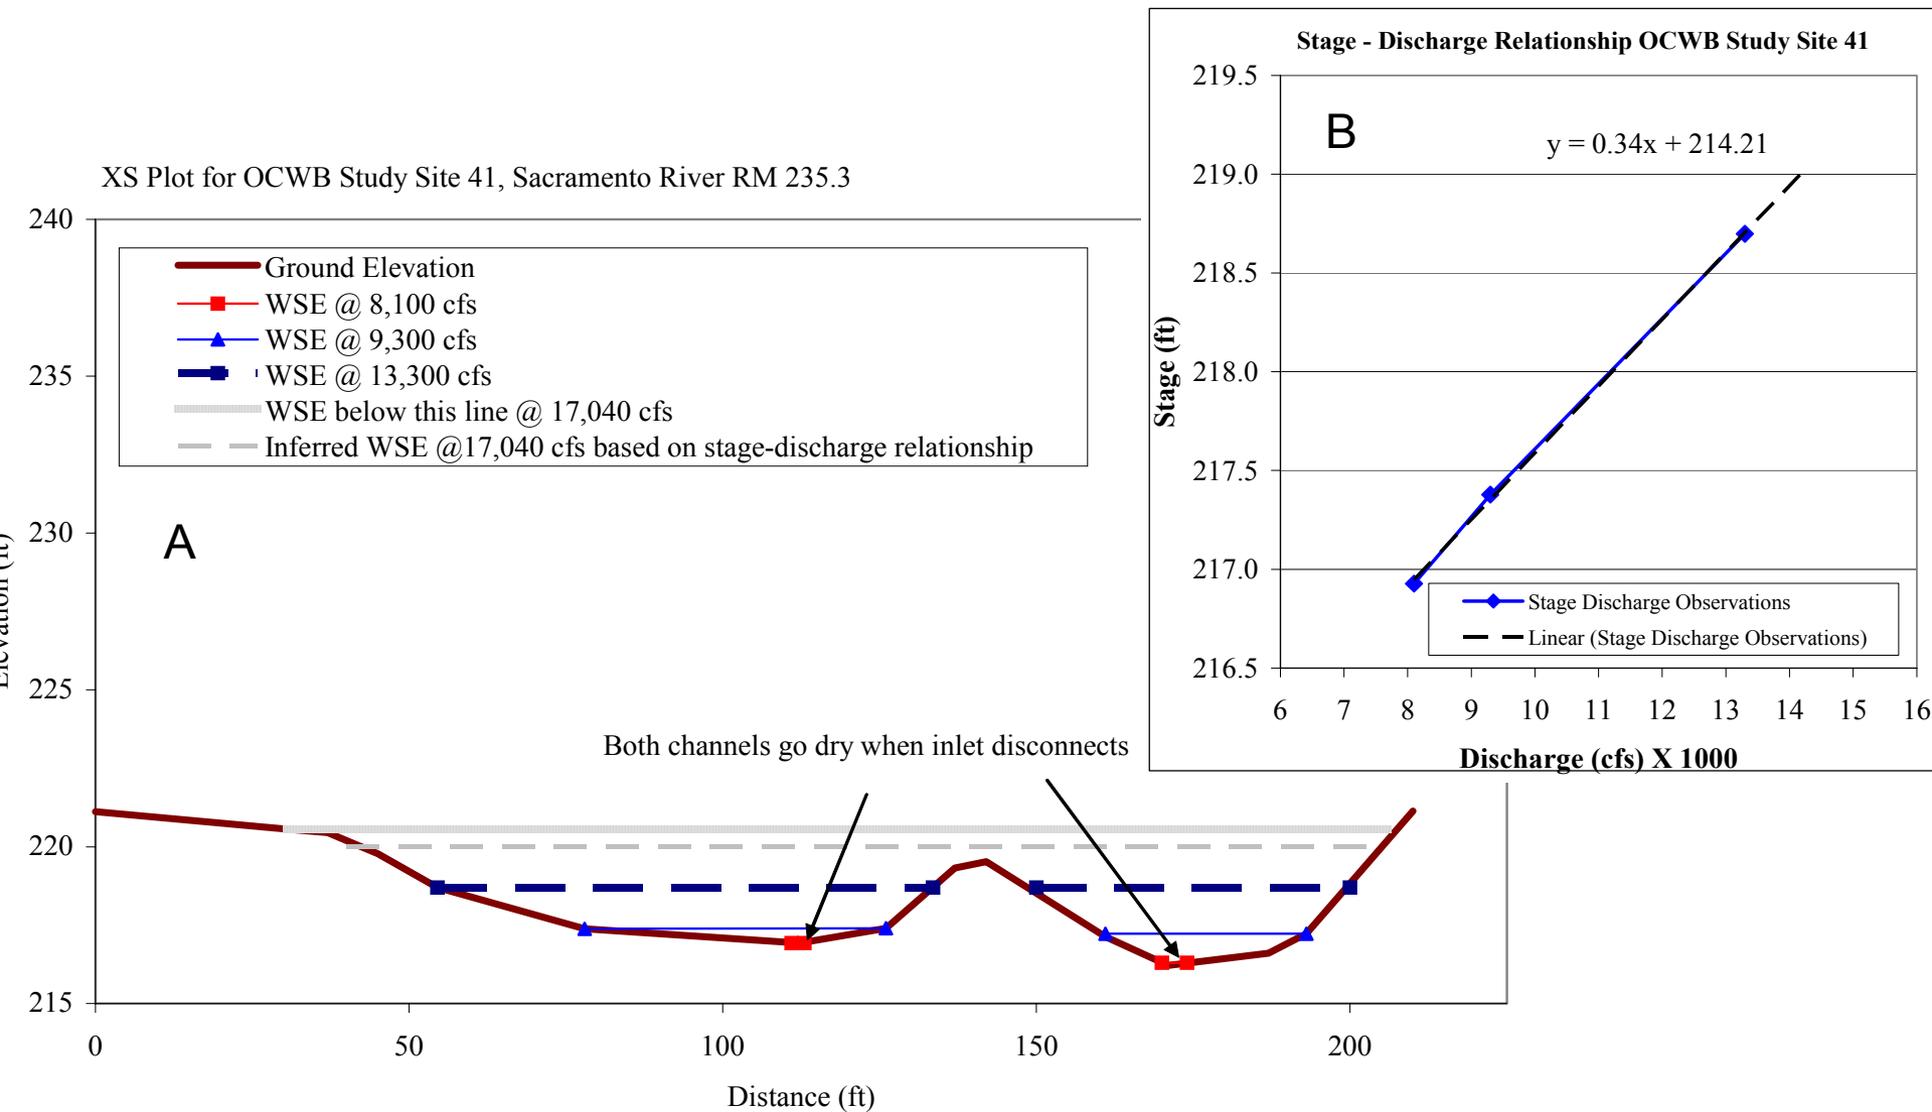
Figure 50. Study site 41 (RM 235.3R) , (A) cross section plot with known water surface elevations, and (B) plot of stage – discharge relationships at cross section.

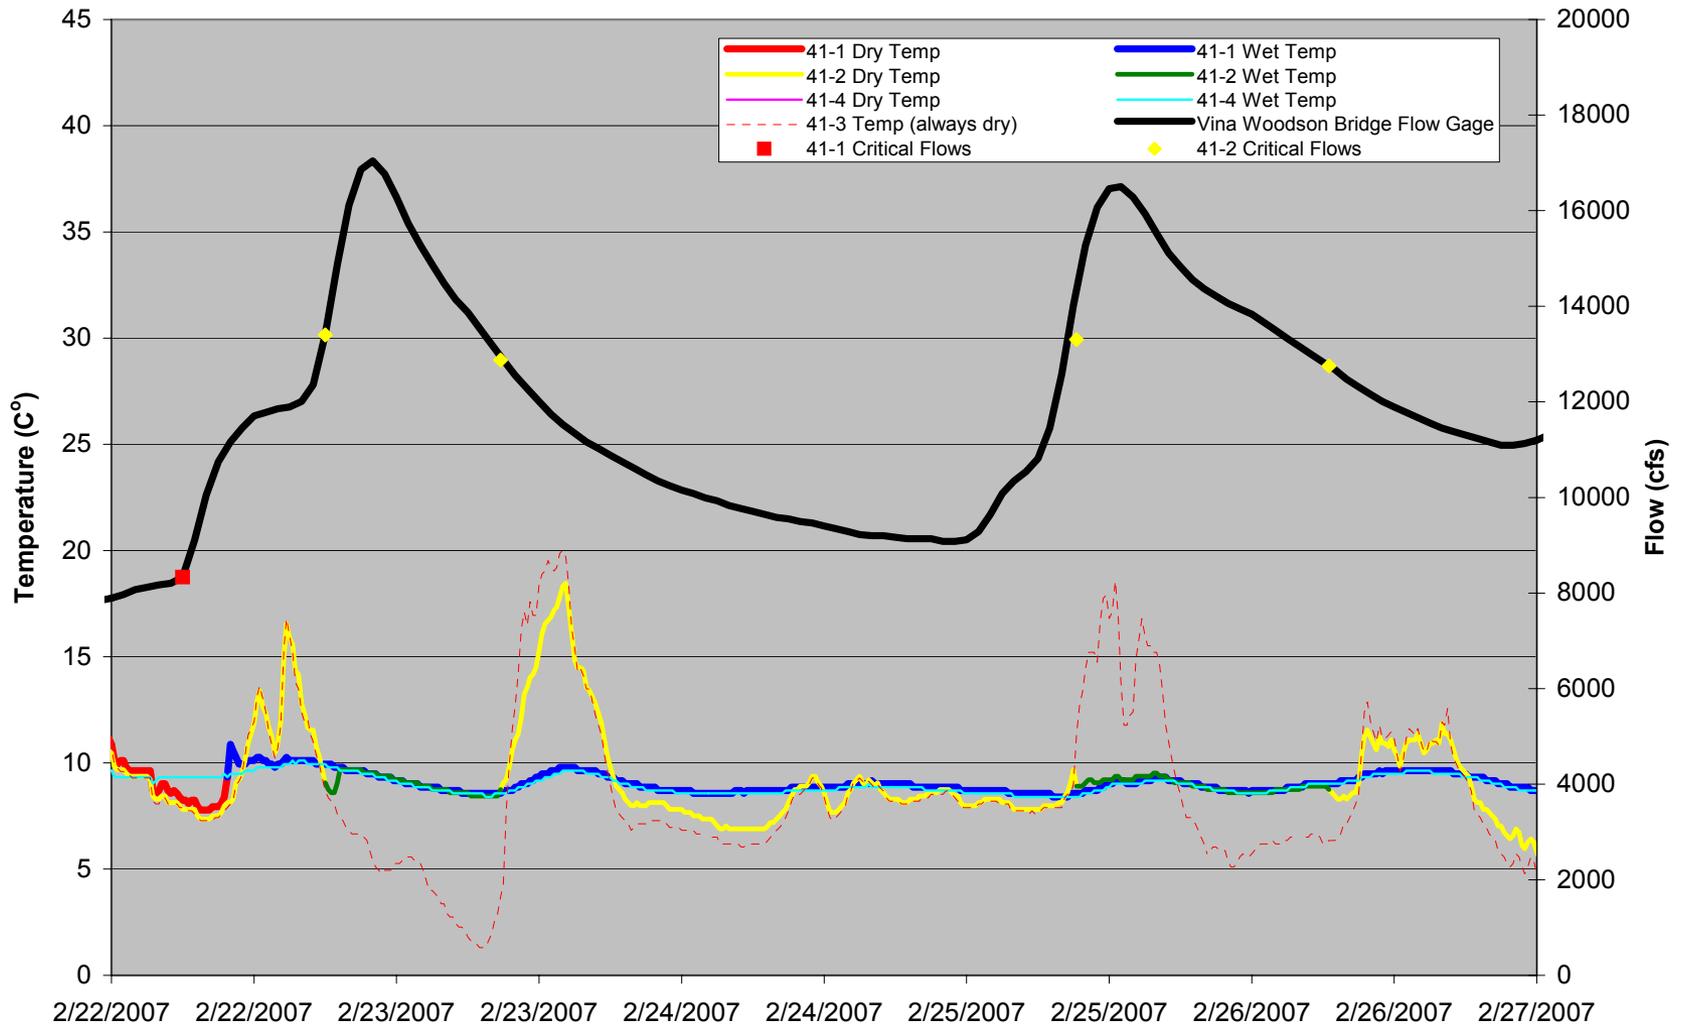
Site 41

Figure 51. Thermograph data for site 41 (RM 235.3R) and discharge at Vina Woodson Bridge between 2/22/07 and 2/27/07. Critical flow points depict thermograph changes between dry and wet status.
