Sacramento River Ecological Flows Study: Off-Channel Habitat Study Final Report

Kondolf, G. M. and Stillwater Sciences. 2007. Sacramento River Ecological Flows Study: Off-Channel Habitat Study Results. Technical Report prepared for The Nature Conservancy, Chico, California by G. Mathias Kondolf and Stillwater Sciences, Berkeley, California

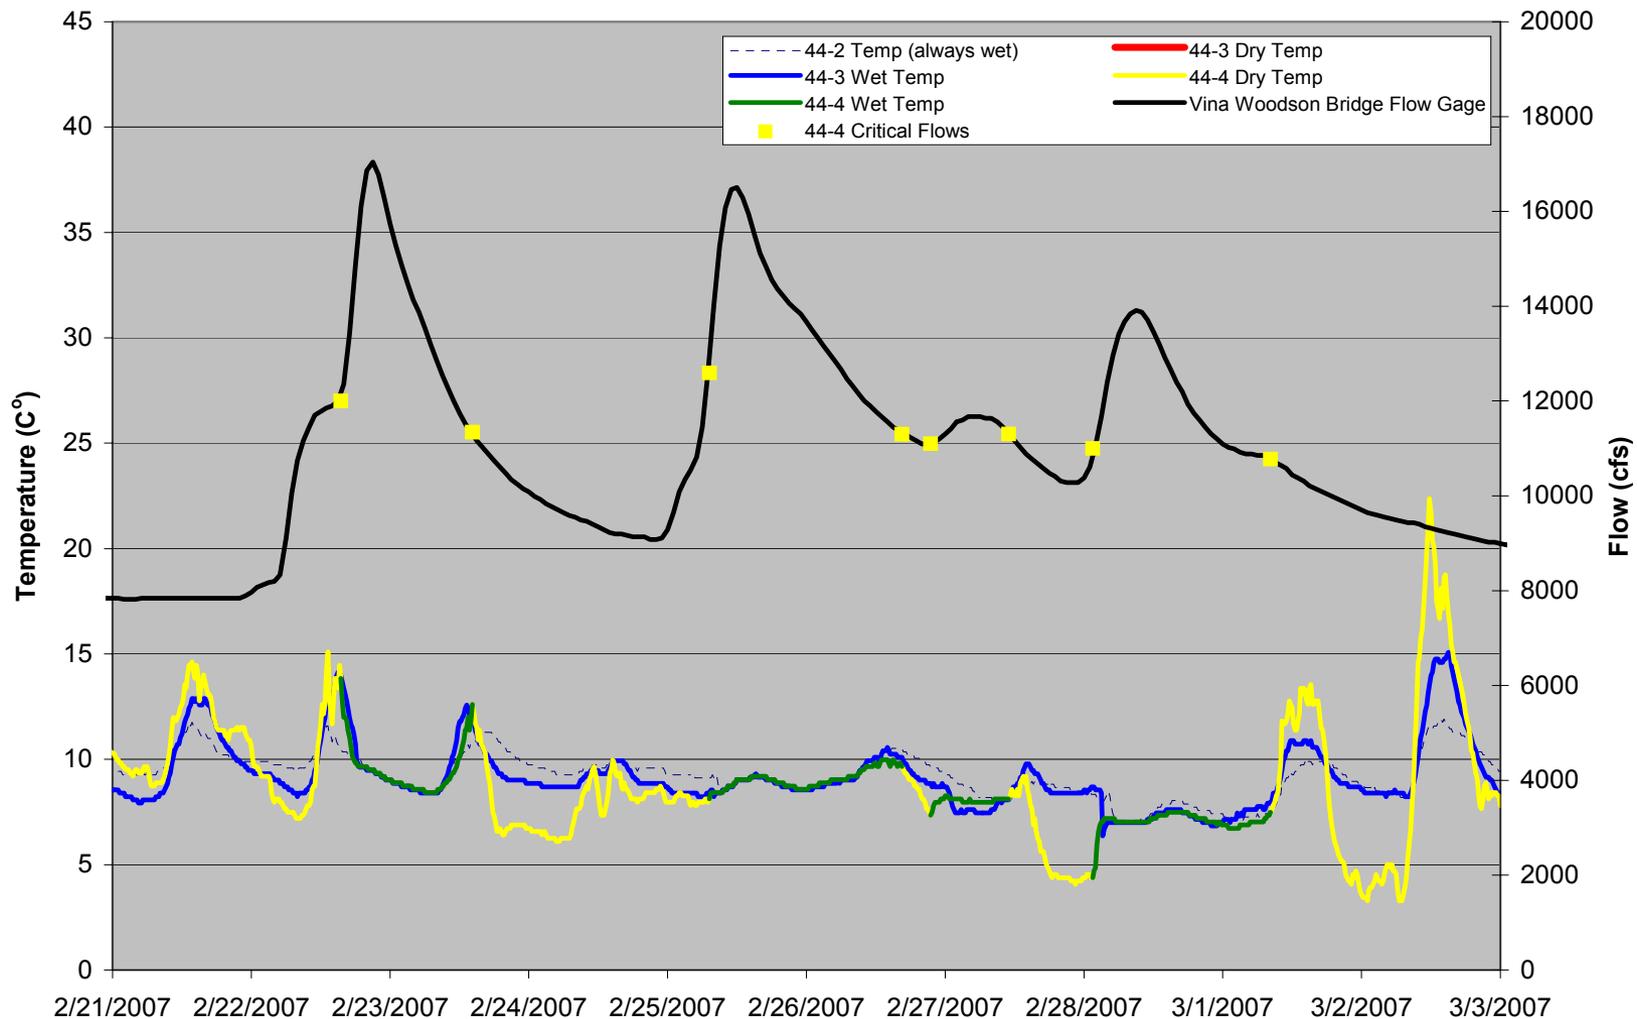
Site 44

Figure 53. Thermograph data for site 44 (RM 239.5R) and discharge at Vina Woodson Bridge between 2/21/07 and 3/3/07. Critical flow points depict thermograph changes between dry and wet status.

The dominant substrate in the site is gravel that is intermixed with sand and cobble. *Ludwigia* was sparsely located throughout the site, with its most abundant location at the outlet. A relatively large number of juvenile Chinook salmon as well as five Sacramento sucker were observed in multiple pools that were marginally connected to the mainstem (Photo 5); Chinook and Sacramento sucker were also observed during thermograph retrieval in late April. Beaver activity was noted in site 44 in two locations, with one beaver dam influencing the channel hydraulics.

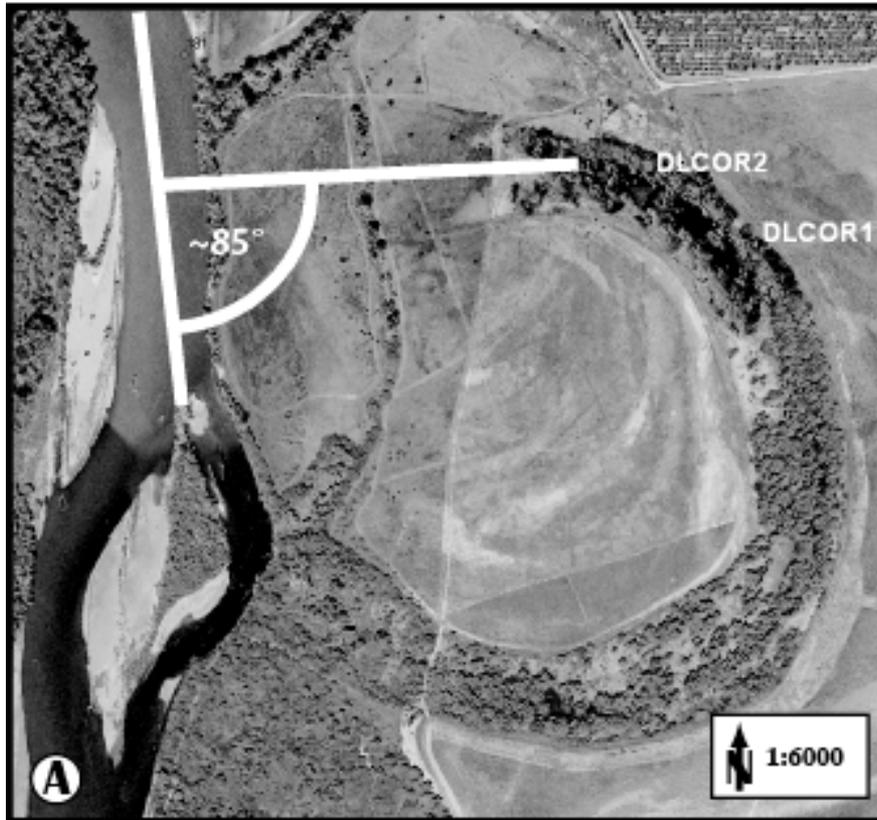
Figure 54. (A) Aerial photo of Duck Lake near river mile 181 taken in 2004. The diversion angle and core locations are shown within the photo. (B) Granulometric profile for core DLCOR1.

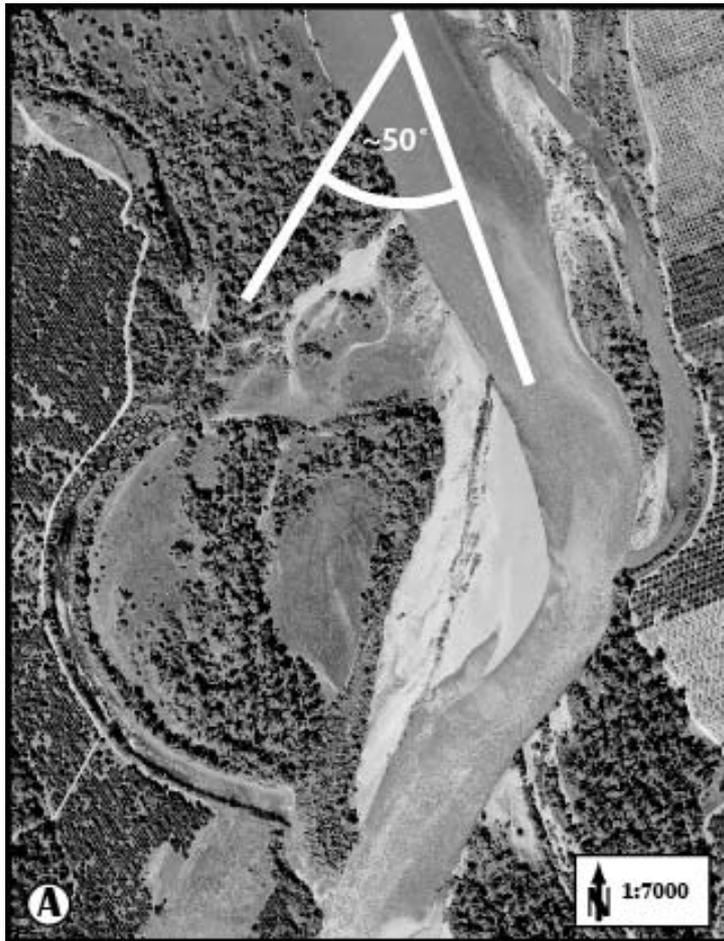
Figure 57. (A) Aerial photo of La Barranca near river mile 237 taken in 2004. The diversion angle and the core location are shown within the photo. (B) Granulometric profile for core LBCOR1.

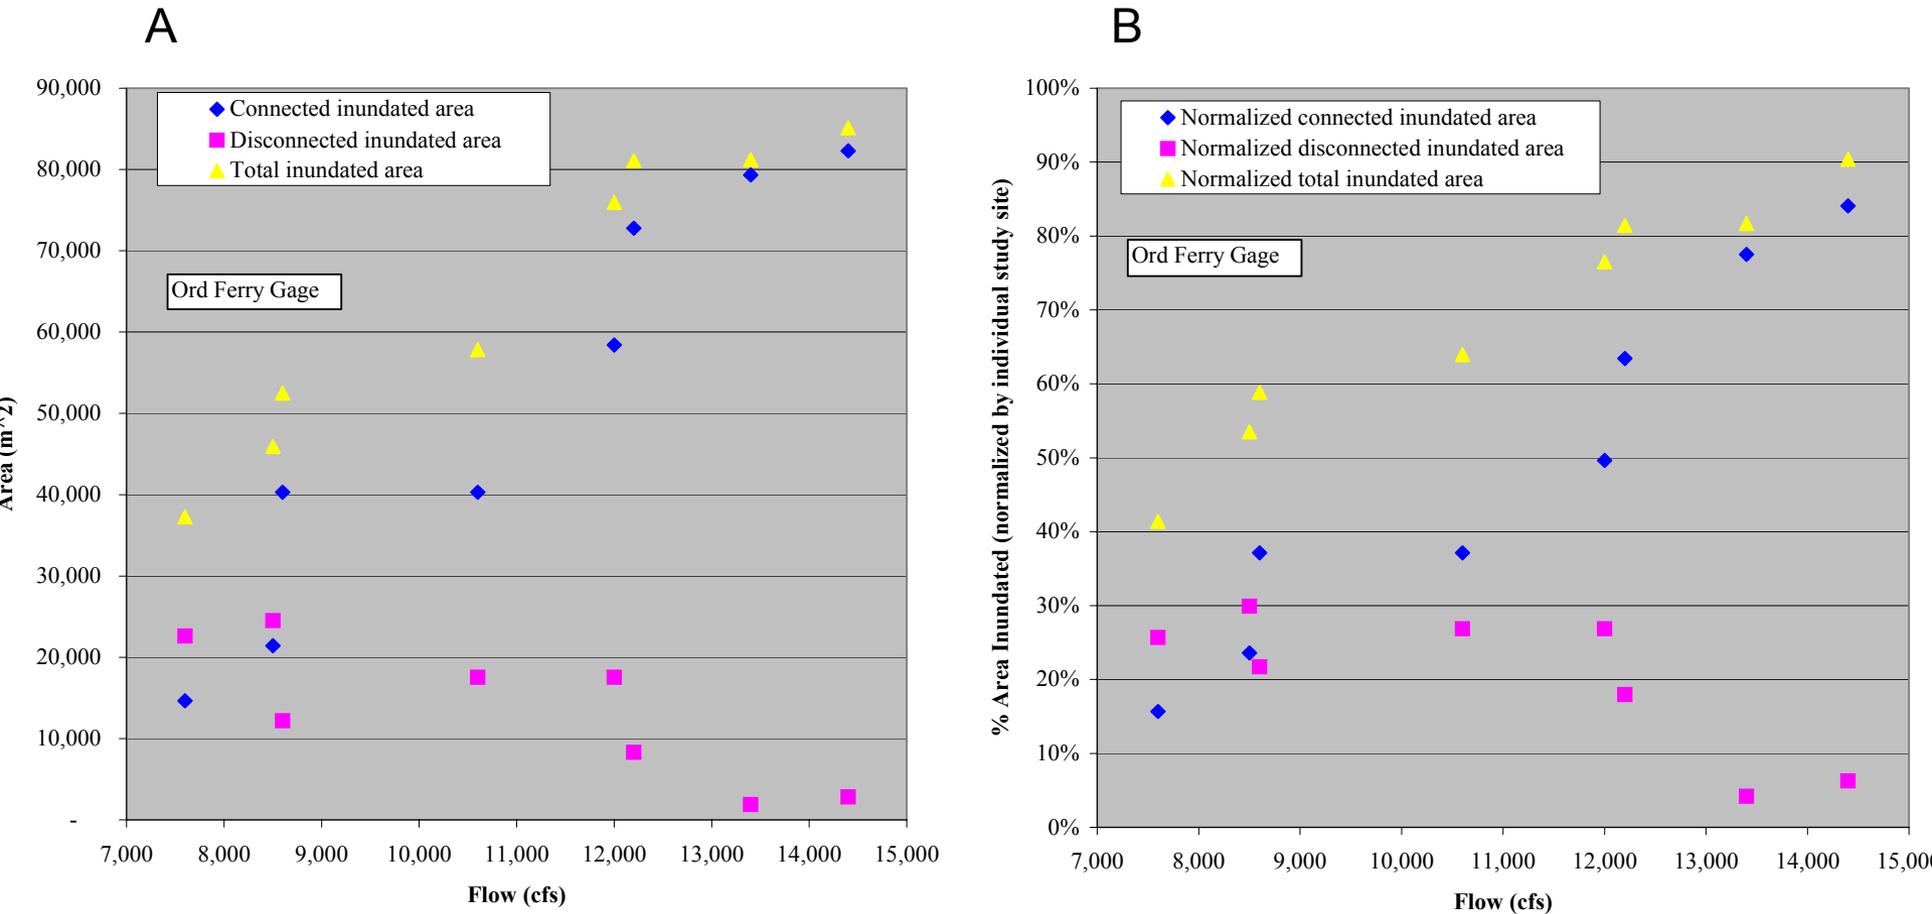
Figure 65. (A) Cumulative connected, disconnected, and total inundated area at 5 study sites related to the Ord Ferry gauge on the Sacramento River. **(B)** Normalized connected, disconnected, and total inundated area at study sites related to Ord Ferry gauge on the Sacramento River. Each site is normalized by its maximum potential inundated area that could be characterized by the thermograph deployment, such that each site has equal weight in determining the % inundated area.

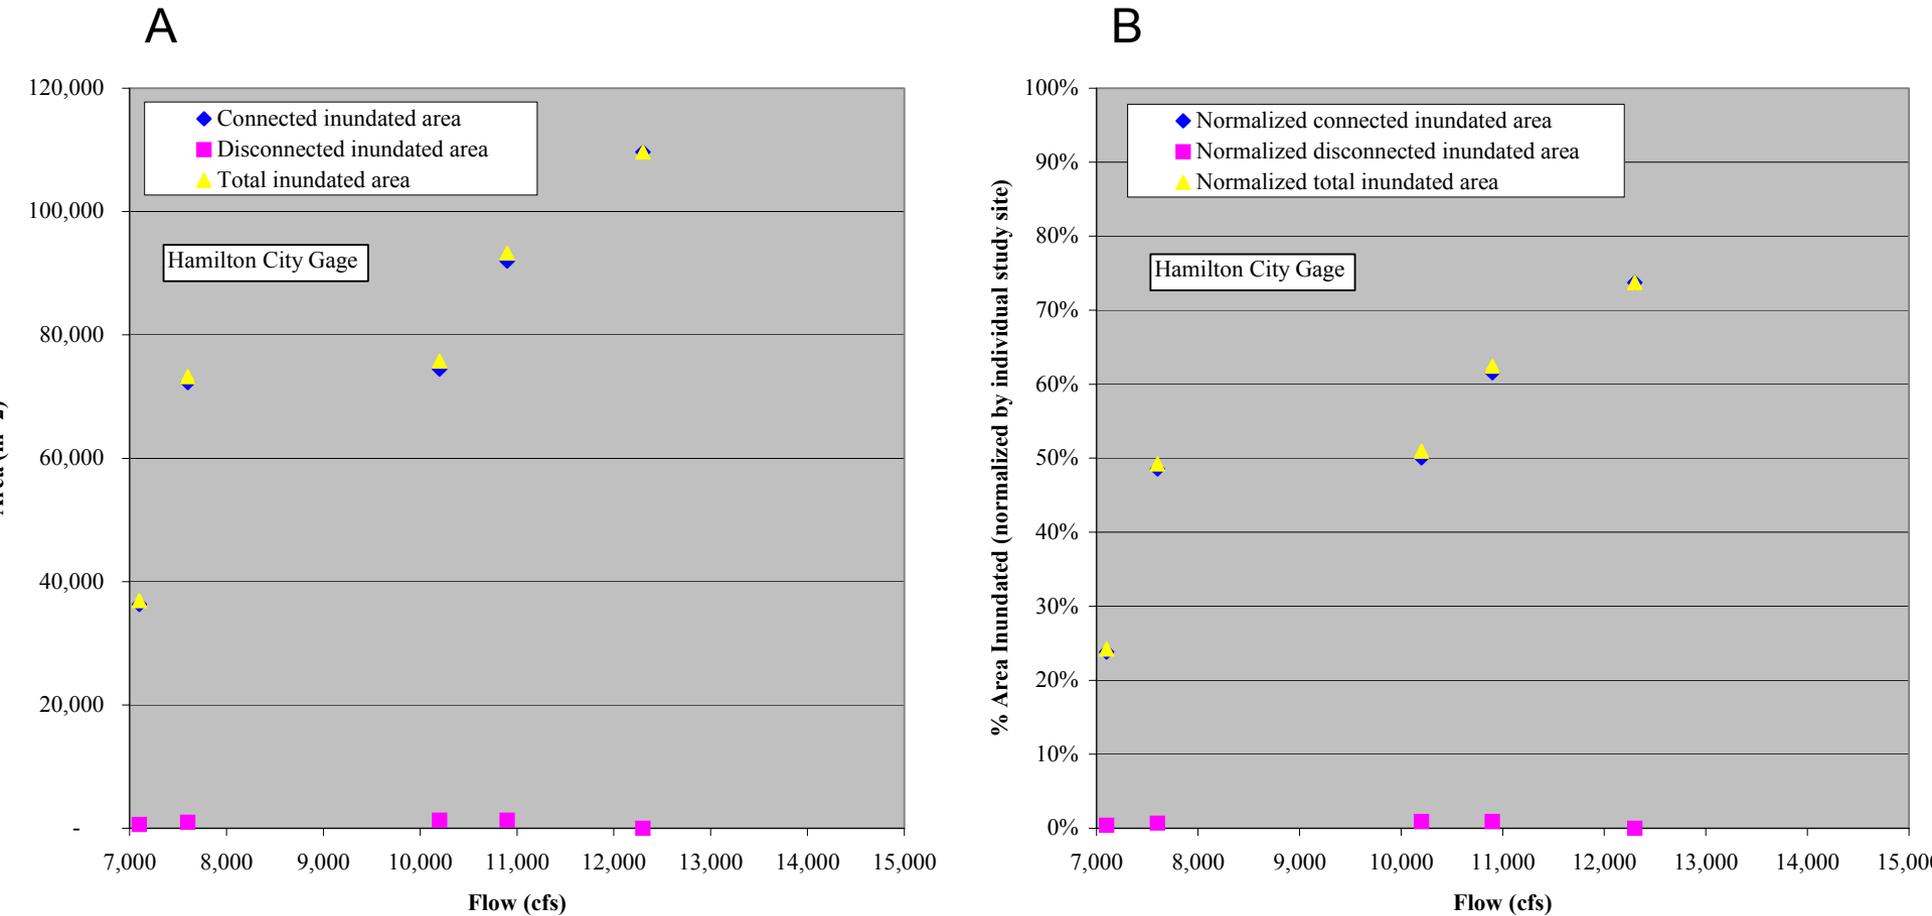
Figure 66. (A) Cumulative connected, disconnected, and total inundated area at 2 study sites related to the Hamilton City gauge on the Sacramento River. **(B)** Normalized connected, disconnected, and total inundated area at study sites related to Hamilton City gauge on the Sacramento River. Each site is normalized by its maximum potential inundated area that could be characterized by the thermograph deployment, such that each site has equal weight in determining the % inundated area.

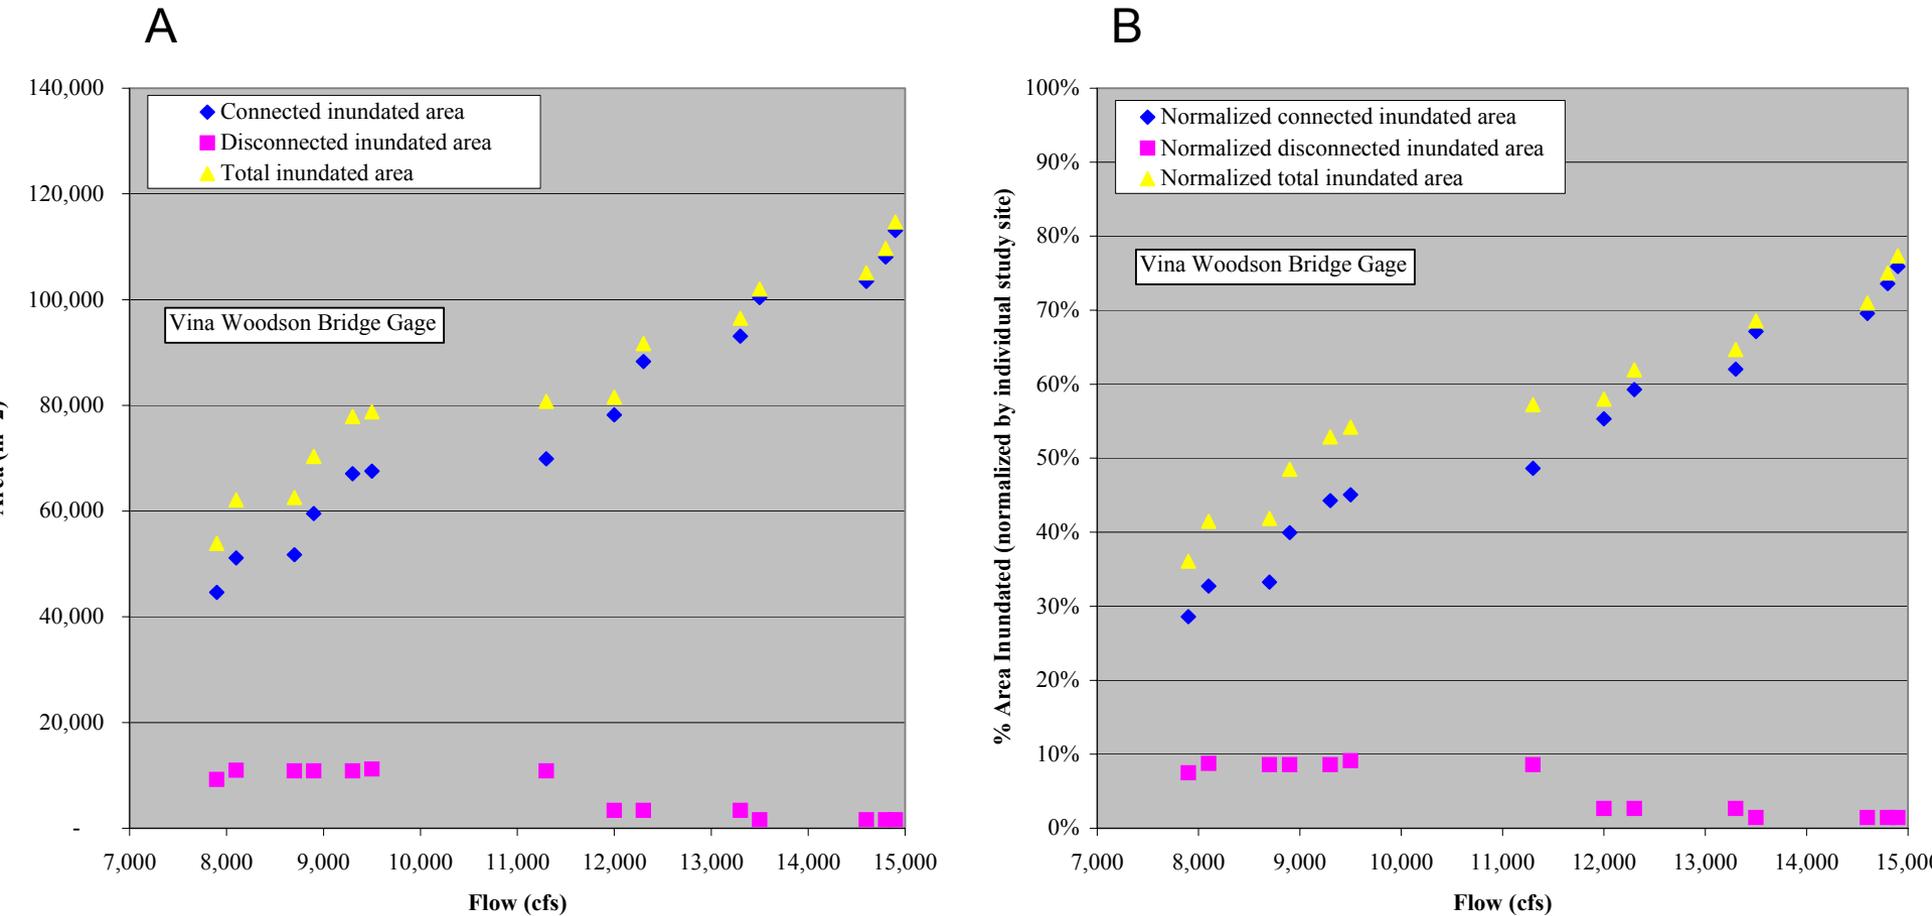
Figure 67. (A) Cumulative connected, disconnected, and total inundated area at 8 study sites related to the Vina Woodson Bridge gauge on the Sacramento River. **(B)** Normalized connected, disconnected, and total inundated area at study sites related to Vina Woodson Bridge gauge on the Sacramento River. Each site is normalized by its maximum potential inundated area that could be characterized by the thermograph deployment, such that each site has equal weight in determining the % inundated area.

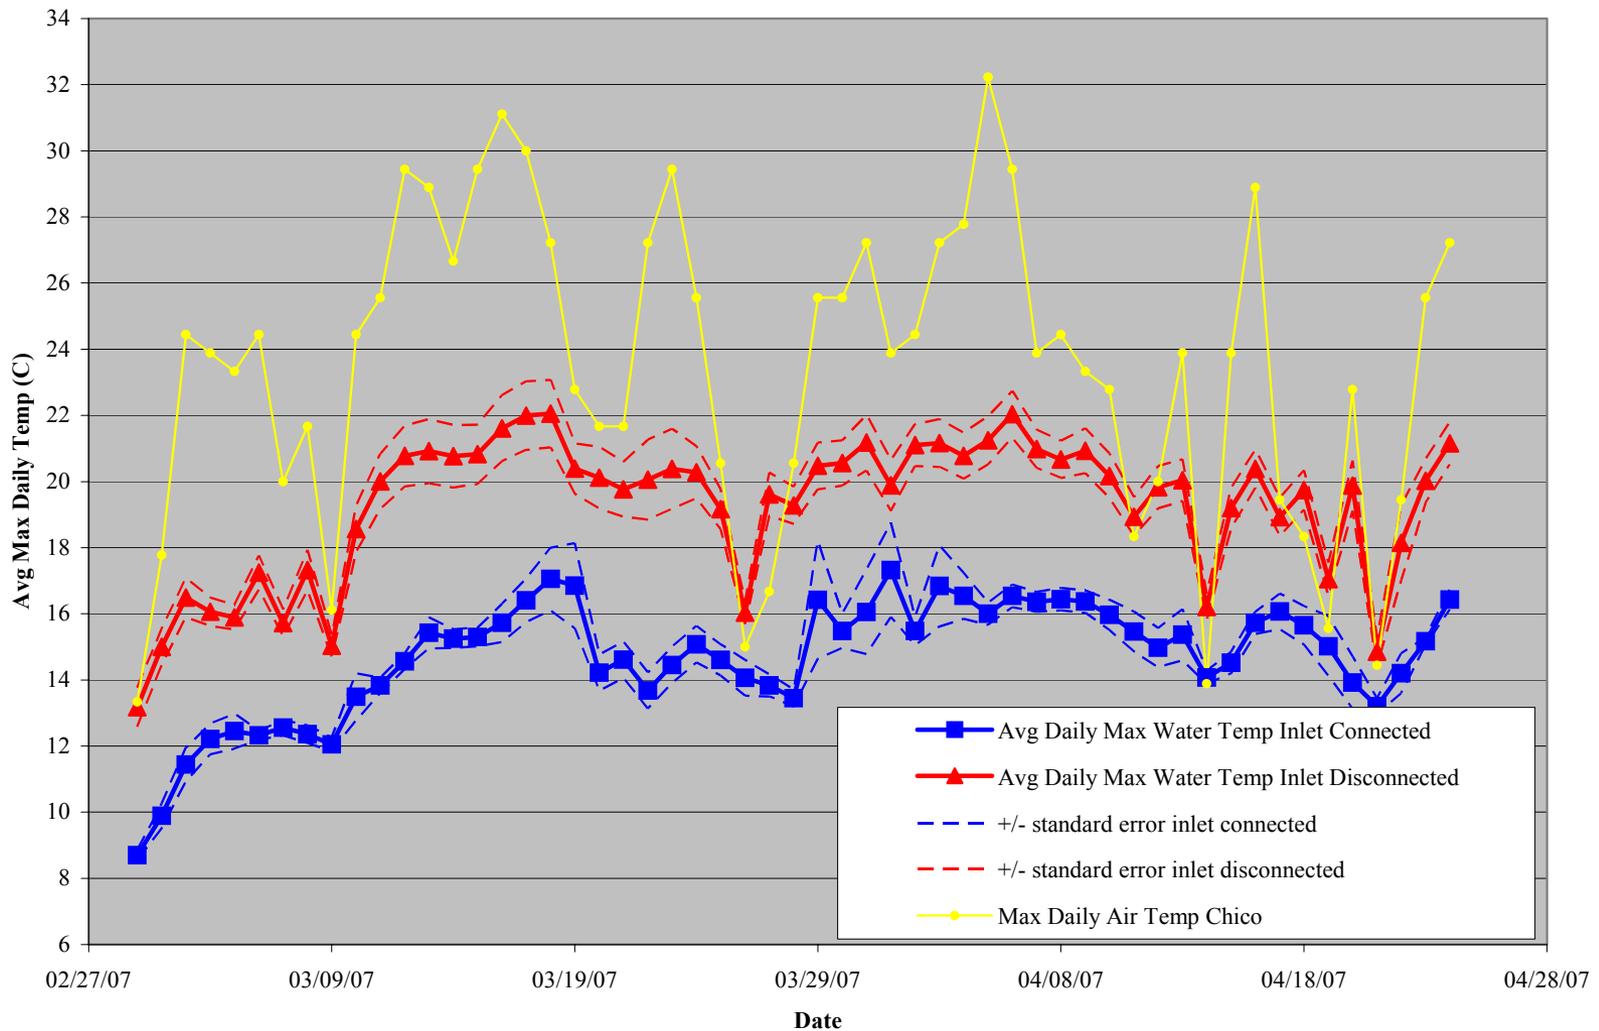
Figure 69. Average maximum daily water temperatures for submerged thermographs with inlets connected and disconnected to the mainstem. The maximum daily air temperature from Chico, CA (site maintained by CDF) is also displayed.

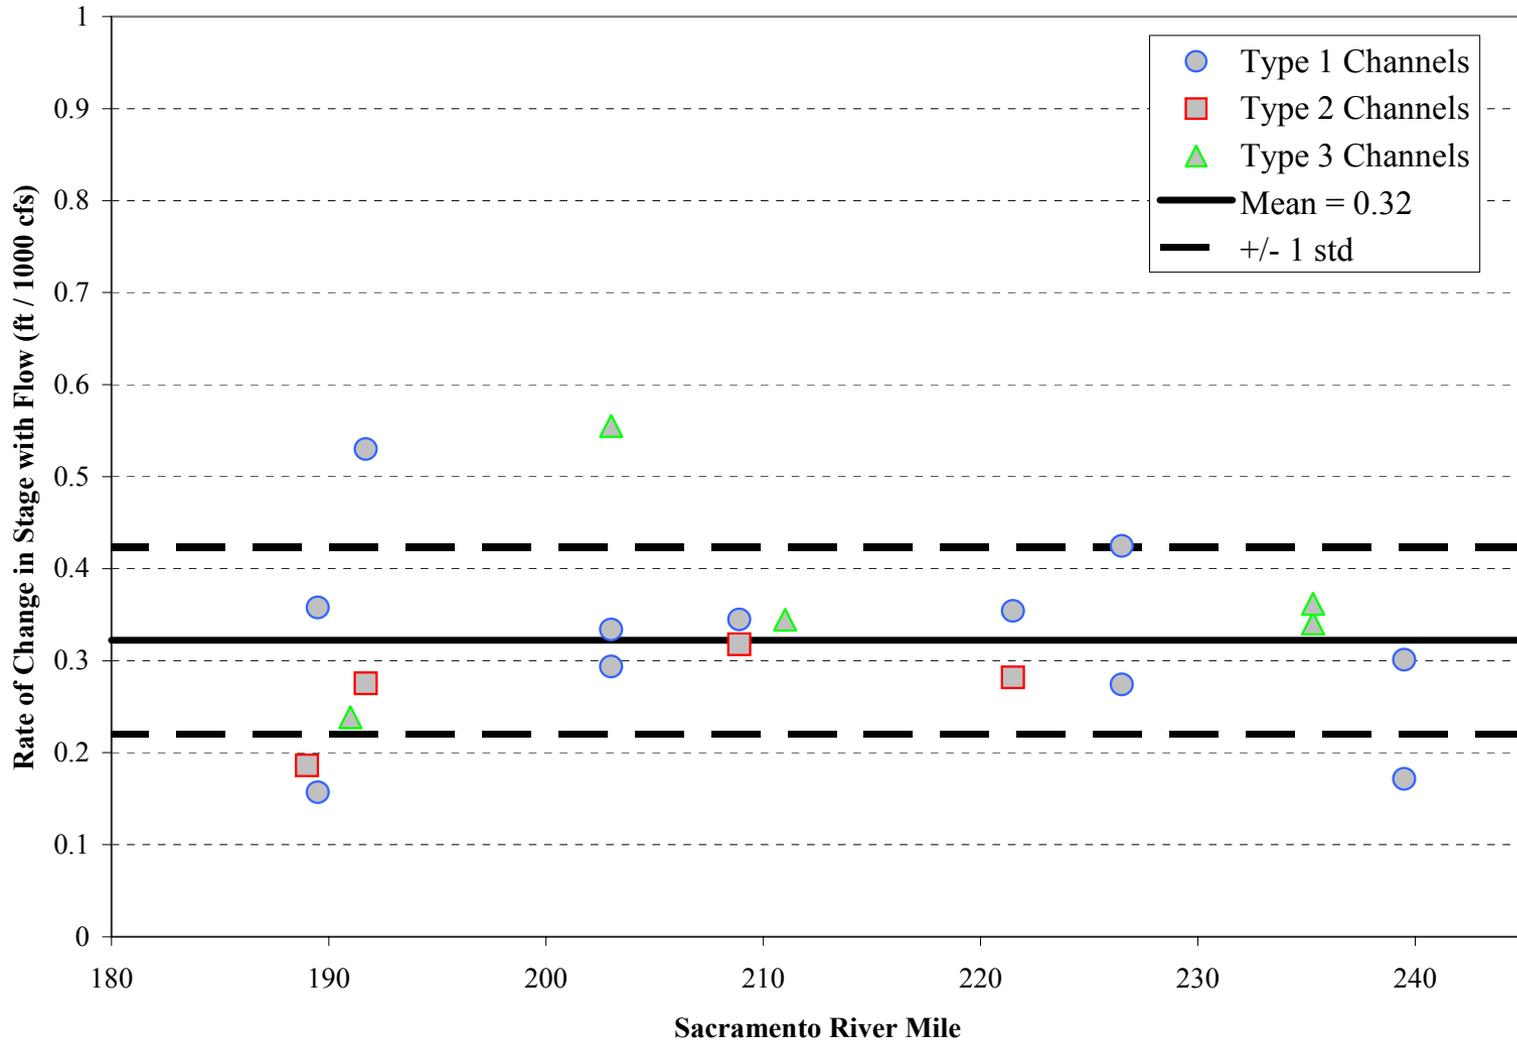
Figure 70. Rates of stage change (ft) within OCWB study sites per 1,000 cfs changes in mainstem Sacramento River discharge for type 1, 2, and 3 OCWB channels.

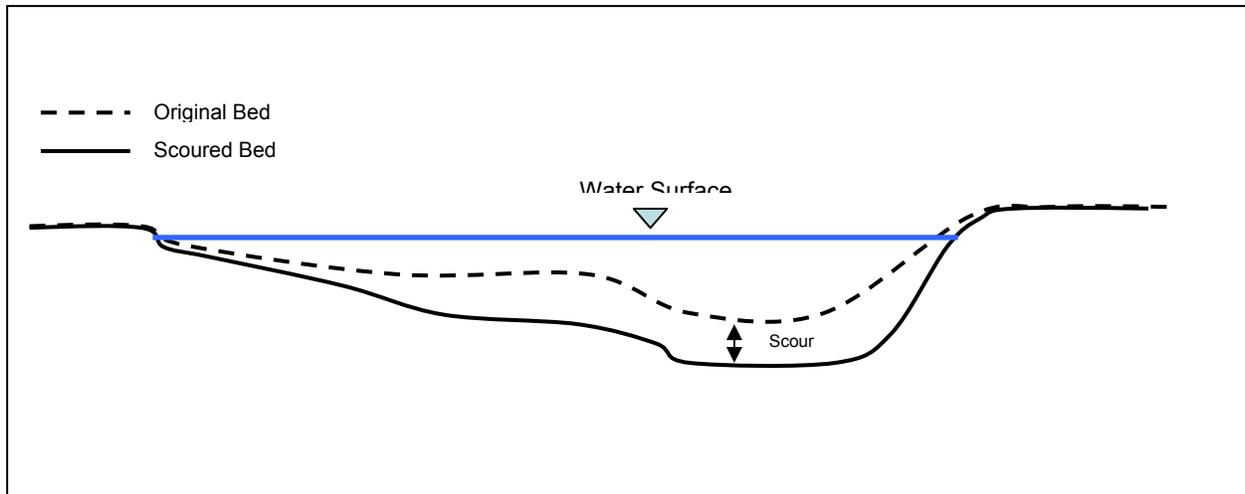
Figure 1. CDWR found thalweg depths in armored bends of the middle Sacramento River to be 6 ft deeper, on average, than those at eroding bank sites. Both CDFG(1983) and CDWR (1994) hypothesized that armored banks induce deeper scour of the bed and cause the cross-sectional slope of the channel to become more steep, thereby reducing the area of channel with suitable hydraulics to support salmonid spawning and rearing.

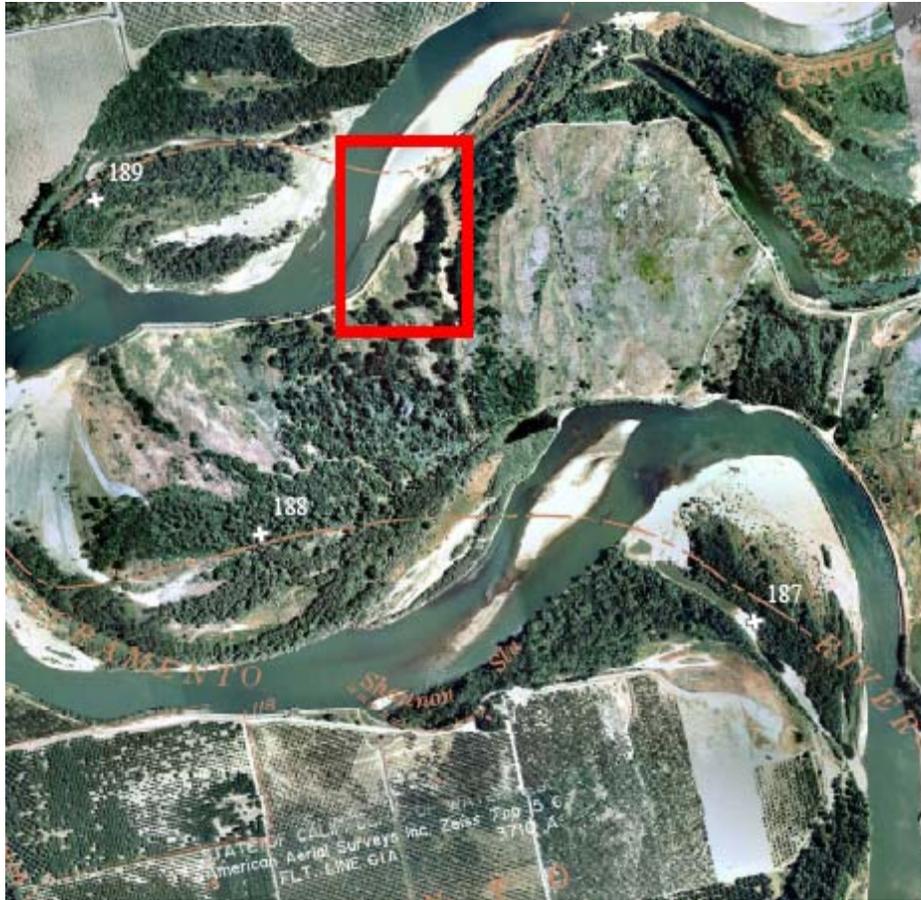
Figure 2. Example of a scour channel that forms on the downstream end of a point bar. (Photo Source: CDWR 1999)
